Rail Accident Report

Landslip and derailment at Loch Eilt, north-west Scotland 22 January 2018

Report 10/2018
August 2018

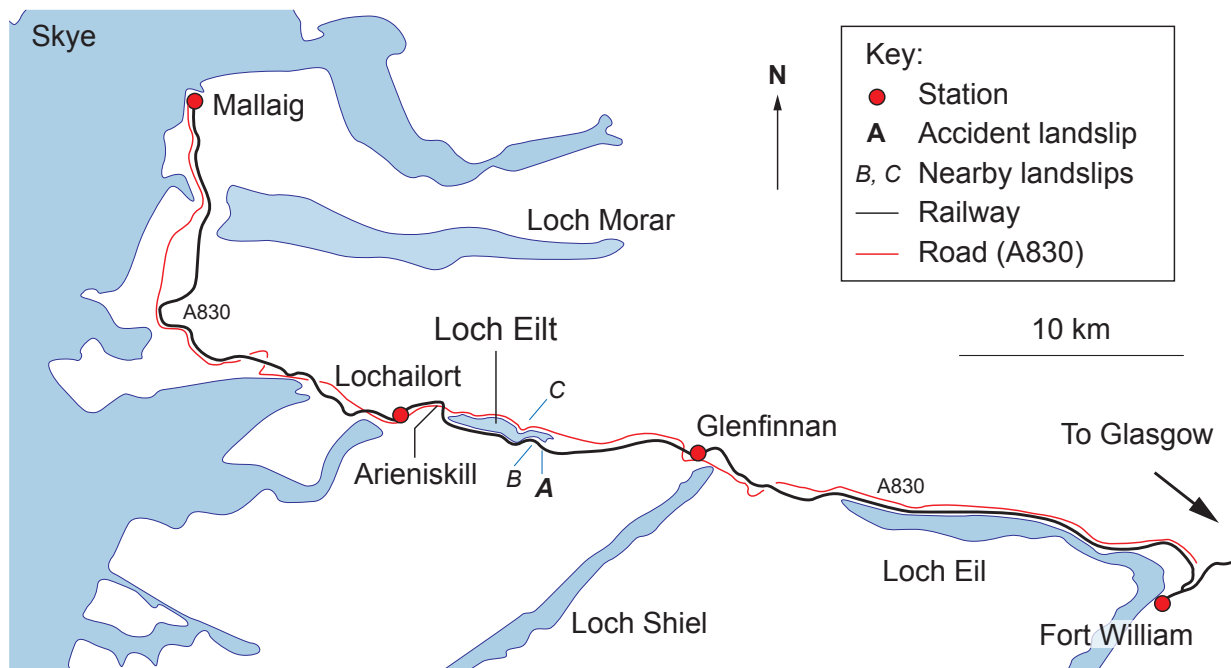
Figure 2: Map showing railway between Mallaig and Fort William and location of recent landslips. Sites marked 'B' and 'C' are referred to in paragraphs 54 and 41 respectively. Some intermediate stations have been omitted for clarity.

- 41 Network Rail geotechnical staff attending the accident site on 23 January observed that another landslide had occurred, 1 km to the north-west (marked 'C' in figure 2 and in background of figure 3), and believe this occurred at a similar time. This affected a natural hillside above the A830 on the opposite side of Loch Eilt. Although debris did not reach the road, two landslips in relatively close proximity demonstrates that slopes in this area were particularly vulnerable to the effect of the climatic conditions prevailing at that time.

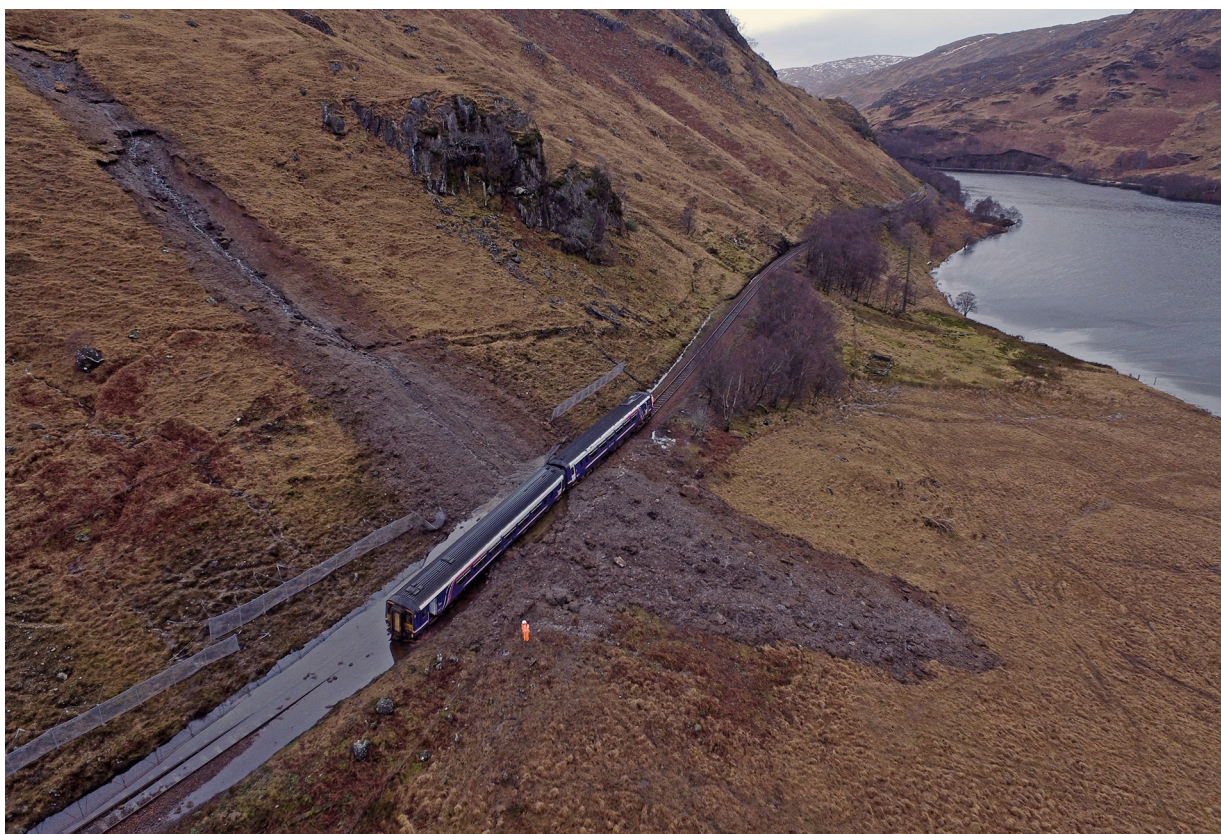
- 7 The accident occurred at about 19 miles 200 yards¹ on a right-hand bend on a remote section of single line about five miles west of Glenfinnan. The railway at this location is in a shallow cutting on sloping ground, and runs along the south shore of Loch Eilt at an elevation of approximately 50 metres above sea level (figure 5). The route forms part of the West Highland line between Glasgow and Mallaig in the Scottish Highlands.

Figure 5: Aerial view showing proximity of the accident site to Loch Eilt

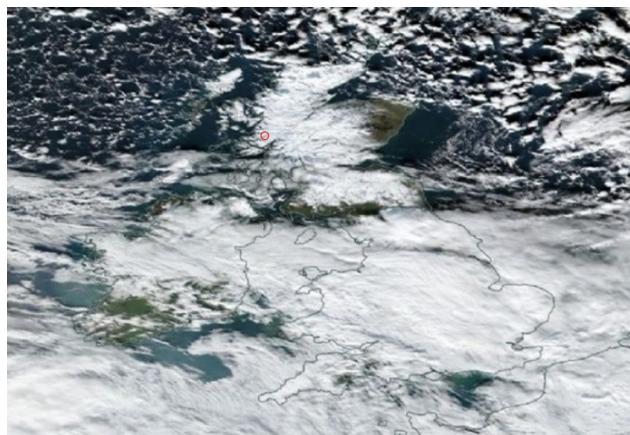
- 36 The RAIB has confirmed that snow cover extended over north-west Scotland by 20 January using satellite imagery (figure 7). Confirmation that this extended over the north slope of Sgùrr na Paite, to below track level, is provided by a witness report provided to the RAIB by a member of railway staff who arrived at the site a few hours after the accident.

Figure 7: Satellite photograph showing snow cover across north-west Scotland on 20 January 2018. Note that England and Wales are covered in cloud (image copyright NASA Worldview)
