Rail Accident Report

**Near miss with a track worker near Gatwick
Airport station
2 December 2018**

Report 12/2019
September 2019

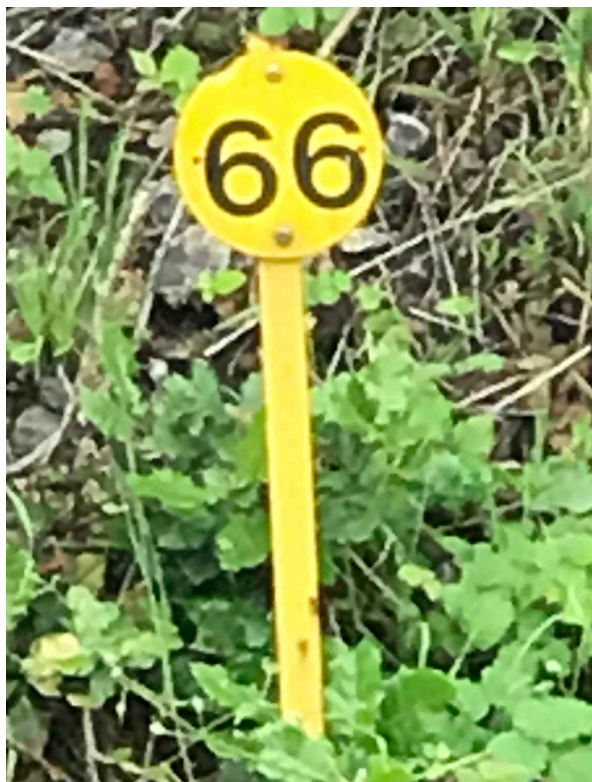
Figure 9: Typical chain marker, not at incident site

50 The SSOW pack for installing and removing short circuiting straps at 1703A and 1704A points was prepared by BAM Nuttall's SSOW planners based on information contained on a form (the B2 form) prepared by Network Rail's isolation planners. This form described the position of the straps as '26 miles 22 chains – 1703 points & 26 miles 30 chains – 1704 points'. It did not specify whether strapping at the A or B end points was required but the chainages correspond to 1703A and 1704A points on the down slow line. These positions could be identified at the site of work because there are lineside markers provided at almost every chain (figure 9). Although the 22 chain marker was missing, those for 21 chains and 23 chains were present.
