Rail Accident Investigation Branch

Rail Accident Report

Derailment of a freight train near Wanstead Park, London 23 January 2020

Report 12/2020
November 2020

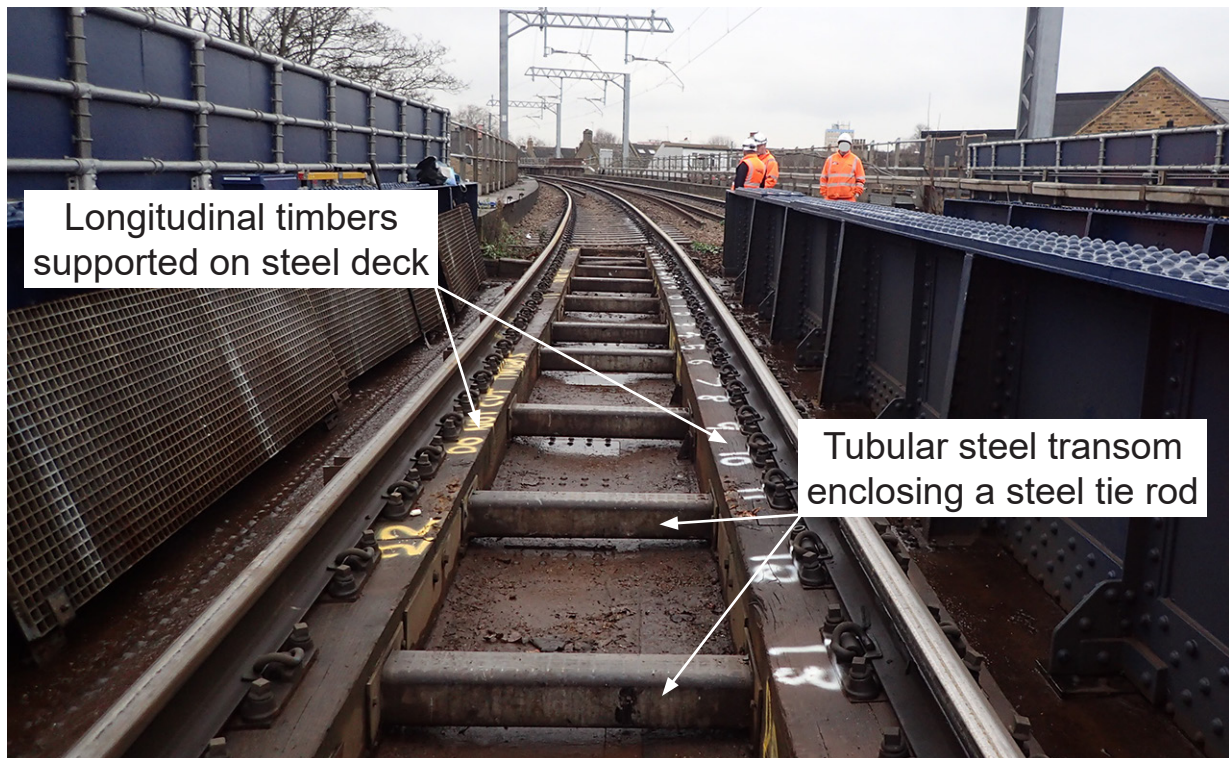
- 24 On bridge 456, the timbers are held at the correct distance apart by tubular steel transoms which enclose steel tie rods (figure 6). The timbers rest directly on the metal bridge deck and are held in position by metal brackets known as cleats.
- 25 Supporting running rails on longitudinal timbers, rather than using conventional sleepers and ballast, imposes less weight on the bridge and thereby permits a lighter and shallower bridge structure. This increases the clearance for high vehicles using the roads below. Although less expensive to construct, bridges with longitudinal timber systems (also known as waybeams, longitudinal wheel timbers, or longitudinal bearers) are vulnerable to developing track geometry faults and so have increased inspection and maintenance requirements.

Figure 6: Bridge 456 up deck after removal of the deck walkway

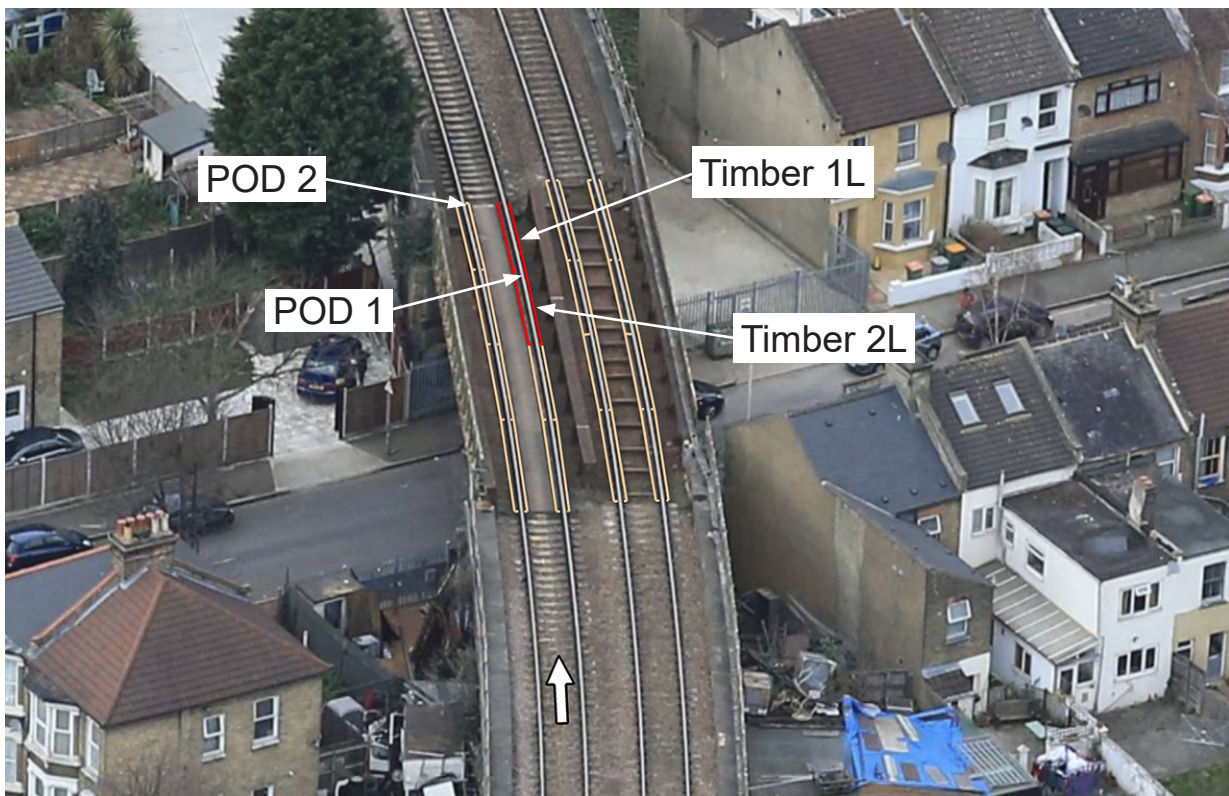
- 50 The up line across bridge 456 was supported by four longitudinal timbers under each rail, each about 6 metres long and laid end to end. The combined length of just over 24 metres was sufficient to cross the bridge and extend a few metres onto the embankment at each end, a feature known as a flying end. This was to provide a transition between the relatively stiff bridge deck and the more flexible ballasted embankment. In the direction of travel, the timbers were numbered R4 to R1 supporting the left-hand rail (cess rail) and 4L to 1L supporting the right-hand rail (six-foot rail). The initial derailment occurred close to the joint between timbers 2L and 1L at the location marked POD 1 on figure 12.

Figure 12: Bridge 456 showing the eight longitudinal timbers on each deck. The timbers associated with the derailment are numbered 2L and 1L.

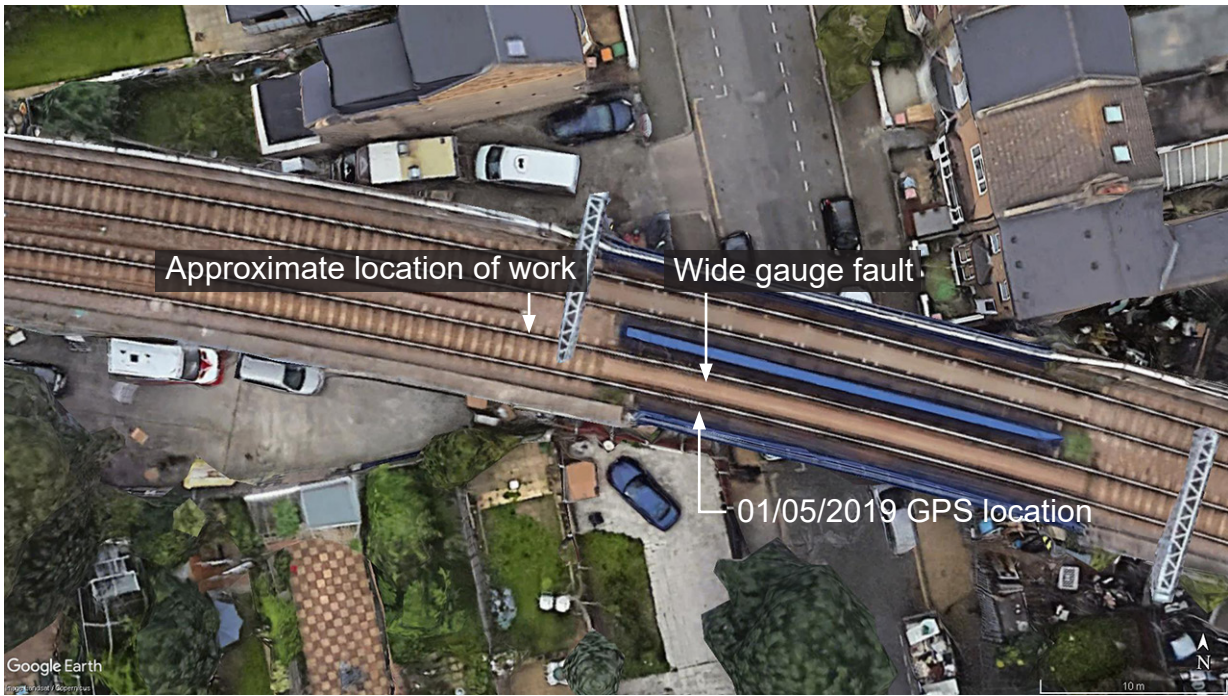
- 80 On 23 May 2019, track maintenance staff from Barking depot, led by the team leader [track maintenance], attended site during an overnight possession of the line. The team leader stated that they used an approved app on a Network Rail mobile phone to locate the fault. This app works by manually entering the GPS co-ordinates, and this causes the phone to vibrate when within five metres of the site, and the display to change colour when within three metres, giving staff a three to five metre radius around the reported site to locate and inspect the fault. The process is dependent on the mobile phone's accuracy when receiving the GPS signal. In this case, although the GPS co-ordinates put the fault on bridge 456 (figure 26), staff undertook work about eight metres west of the actual fault location and on a section of track with concrete sleepers.

Figure 26: Google Earth image showing location of track recording vehicle-generated GPS co-ordinates and the approximate location that re-gauging work was carried out.

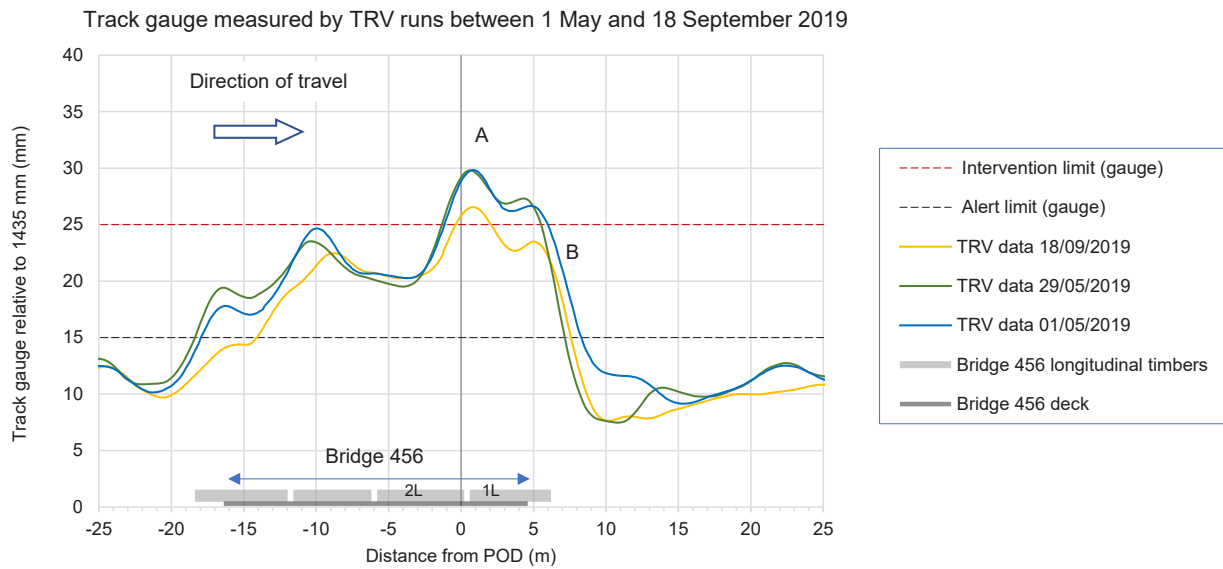
- 82 On 29 May 2019, the next scheduled track recording vehicle run identified and recorded a wide gauge fault in the same location and same magnitude as on 1 May (figure 27). The shape of the graph indicated a very similar pattern of gauge widening. On this occasion, the GPS co-ordinates on the fault report put the location of the wide gauge fault just off the bridge.

Figure 27: Track gauge data recorded by track recording vehicle runs on 1 May, 29 May and 18 September 2019. The graphs show that the gauge profile is a similar shape with a peak value (marked 'A'). Wide gauge exceeding the Alert limit is shown continuing off the bridge (marked 'B').

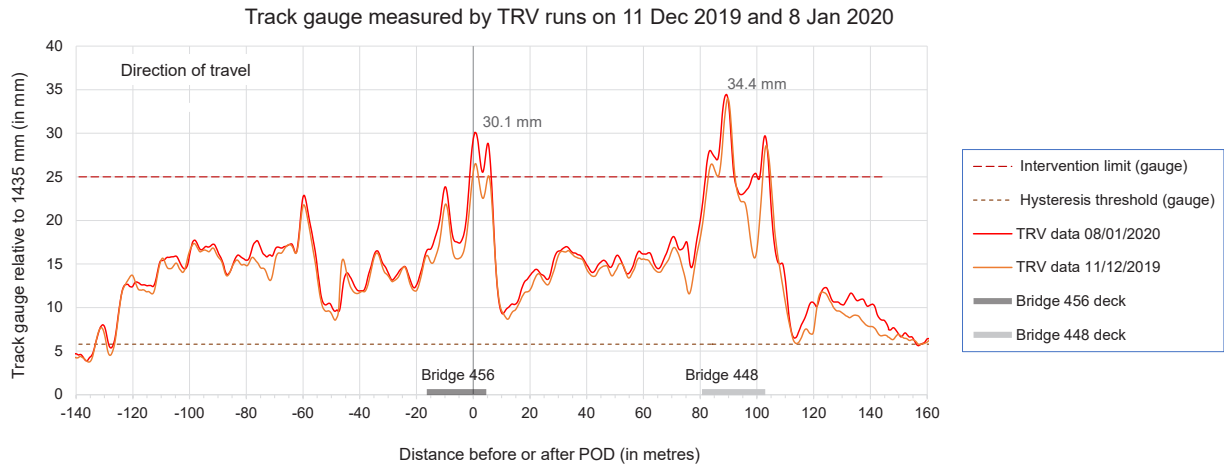
- 87 For the next two track recording vehicle runs on 11 December 2019 and 8 January 2020, wide gauge faults of 26.5 mm and 30.1 mm respectively were recorded on bridge 456. On both occasions, the fault exceeded the intervention limit (figure 29 and figure 30) but was missing from the associated fault report.
- 88 The same issue caused both omissions and is explained by an extract from the track recording vehicle trace for 8 Jan 2020 (figure 31). This shows wide gauge faults, automatically highlighted in red on the trace, corresponding with bridges 456 and 448 located within a section of continuous wide gauge. The wide gauge fault of 30.1 mm on bridge 456 is less severe than the wide gauge fault of 34.4 mm recorded on bridge 448.

Figure 30: Track gauge data recorded by track recording vehicle runs on 11 December 2019 and 8 January 2020, but extending over a longer distance than figure 29. The peak wide gauge faults at bridges 456 and 448 on 8 January 2020 are indicated together with the hysteresis threshold.

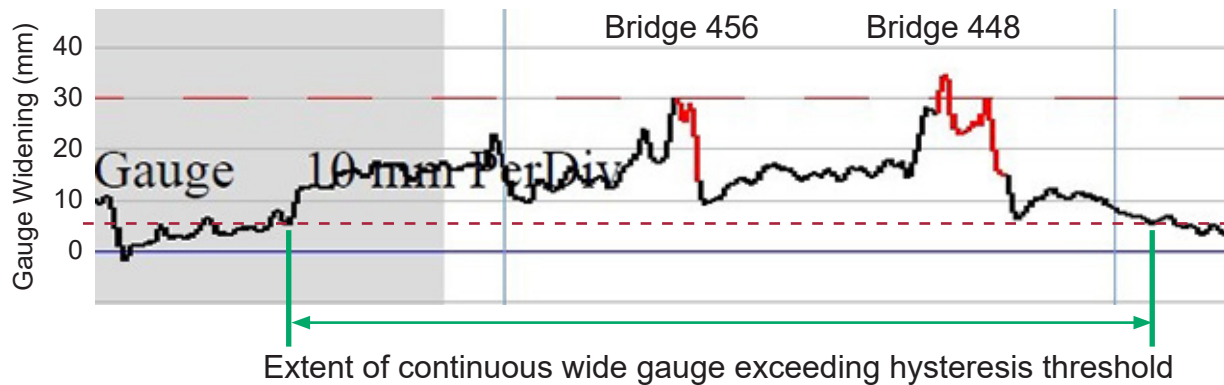
Figure 31: Extract from the track recording vehicle trace recorded on 8 January 2020 showing track gauge. Faults exceeding the intervention limit (25 mm) are automatically highlighted in red. The hysteresis threshold (5.8 mm) and the positions of bridges 456 and 448 have been added.

- 89 The TrueTrak recording system used by Network Rail's fleet of track recording vehicles incorporates a feature to provide a single GPS location for each track geometry fault. Fault sheets are produced following each run which show the type of fault detected, its magnitude and the GPS location where the fault is most severe. They do not show the distance over which the fault extends. To enable it to distinguish between consecutive faults, the processing software applies a pre-set quantity known as the hysteresis threshold value. The recorded magnitude of the fault must improve until it is better than this threshold for the system to register the end of one fault and the start of the next.

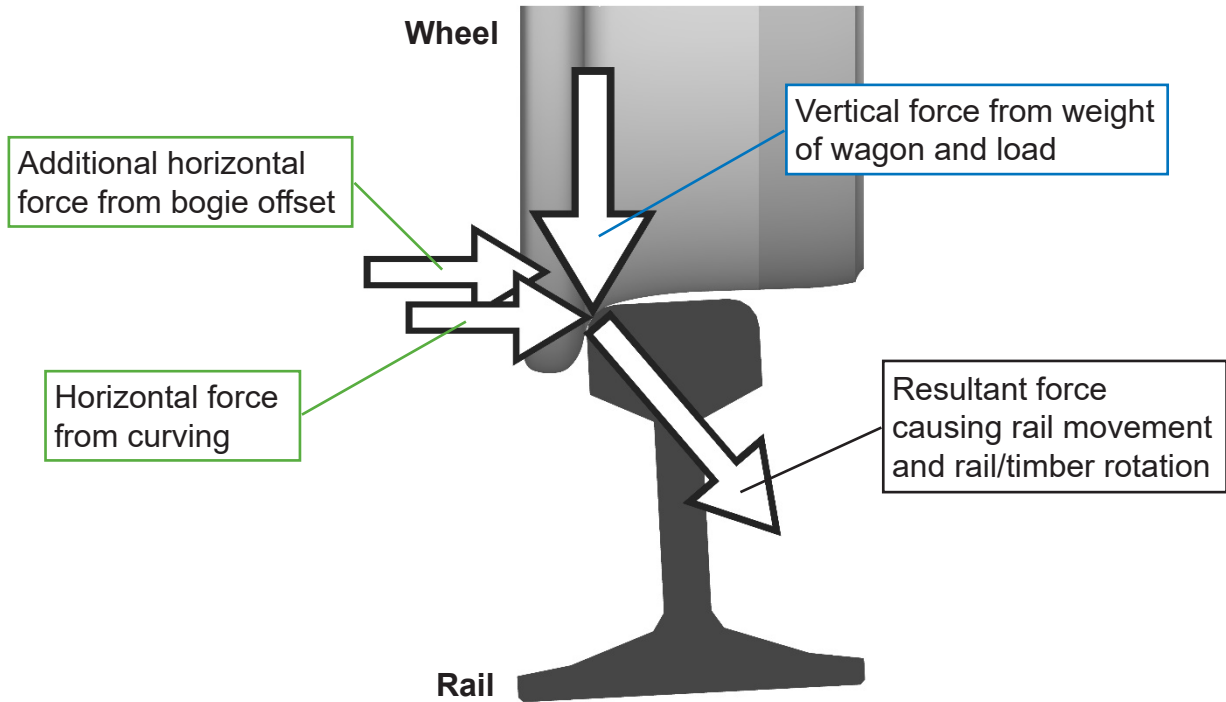
113 Evidence that wagon 3415's trailing bogie was imposing a high lateral force (figure 35) on the right-hand rail is provided in the following paragraphs by considering wheel flange wear over the previous three years. Curving behaviour under cant excess suggests that the right wheel flange of the trailing bogies of each wagon would have been close to, and probably in contact with, the outer (right-hand) rail (paragraph 46).

Figure 35: Simplified diagram showing forces acting from wheel to rail to cause rail movement and rotation

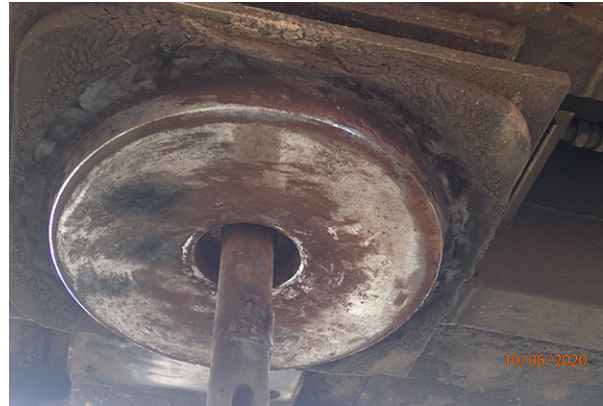
117 To permit bogie rotation, the top of each bogie is fitted with a bogie centre pivot with an internal diameter of 17 inches (432 mm) (figure 36). This encloses and supports a slightly smaller top centre pivot fitted to the underside of the wagon's underframe (figure 37). The two parts are designed to allow a radial clearance of approximately 6 mm between each of the vertical faces within the assembly. This is to allow the bogie to move laterally into the appropriate position relative to the wagon body. The large horizontal surfaces of these steel castings are designed to be in contact and support the weight of the wagon body in conjunction with side bearers.⁶

Figure 37: The 2-3 end top centre pivot with pin, located on the underside of the wagon's underframe

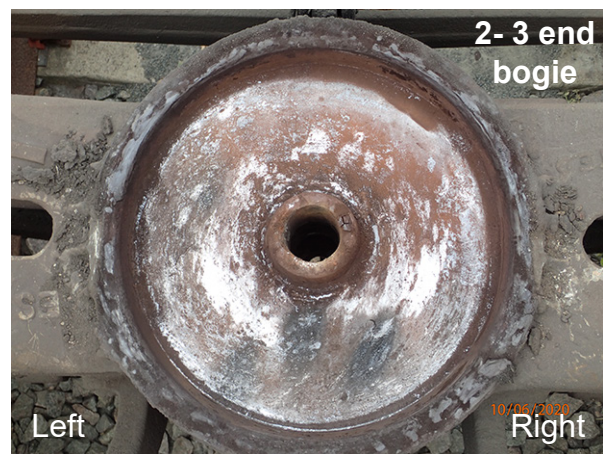
Figure 39: The 2-3 end bogie centre pivot

118 Examination of the bogie centre pivot attached to each bogie found a difference in the wear patterns, with uneven contact apparent on the 1-4 end, but relatively uniform contact on the 2-3 end (figure 38 and figure 39).
