## **Rail Accident Report**

Collision and derailment at Neville Hill 13 November 2019

Report 13/2020 November 2020 This investigation was carried out in accordance with:

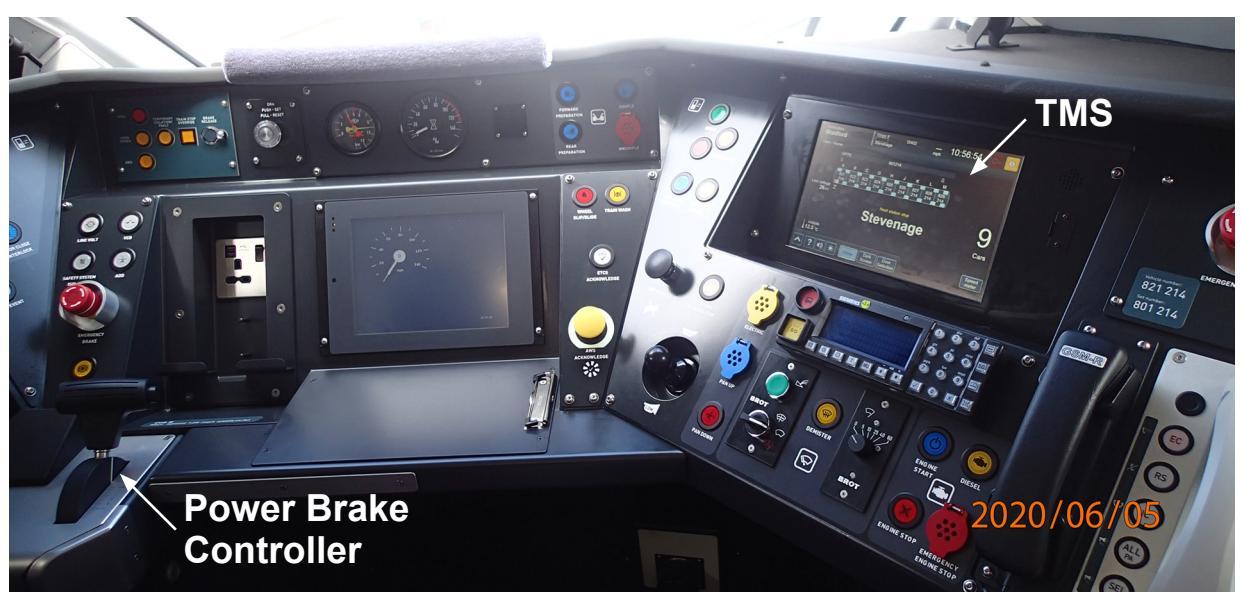
Figure 4: Class 800 cab layout showing TMS and power brake controller

- 19 In common with most modern trains, the IETs are fitted with a computerised Train Management System (TMS) to assist the driver (figure 4). The TMS is a system that provides information and enables a driver to configure the train for the journey ahead. Control over whether APCO is operational or not is achieved using the TMS. The default setting is for APCO to be operational.

- 21 Unlike older stock operated by LNER, but in common with most modern stock, the IETs are fitted with a combined power brake controller (figure 4) which gives a driver access to the full range of tractive and braking efforts.

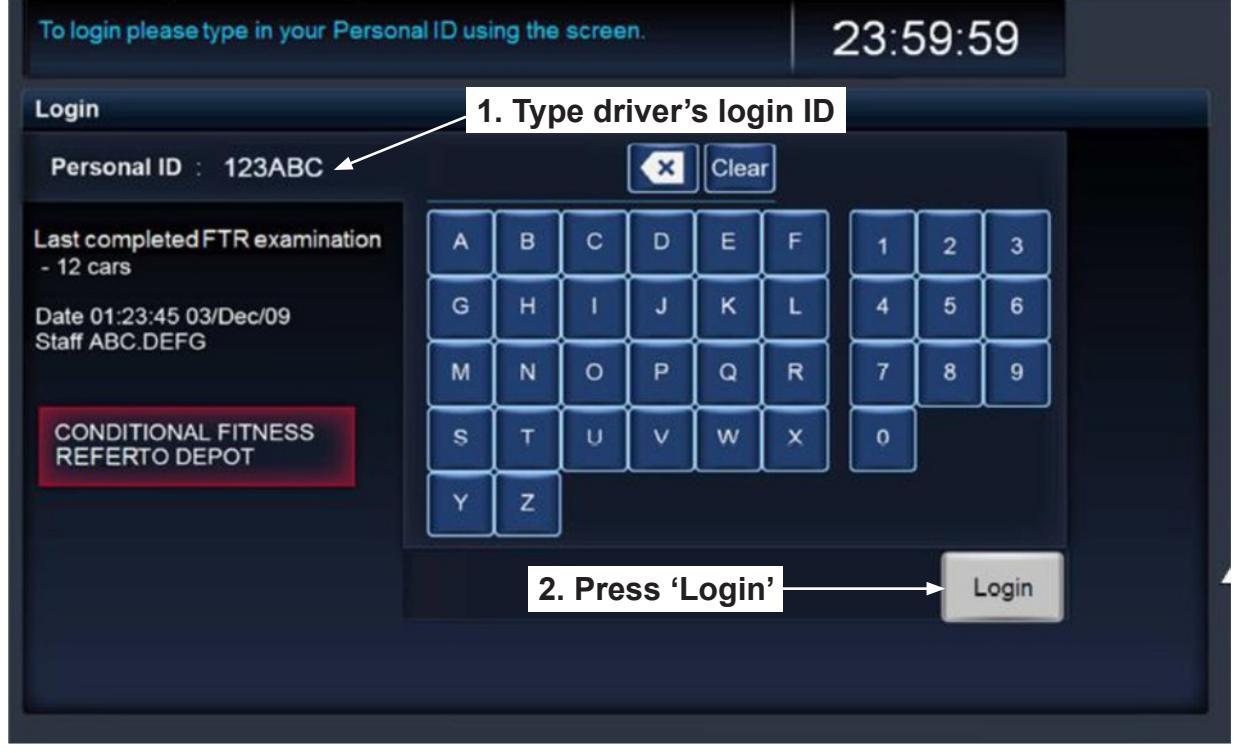
Figure 6: TMS login screen

- 64 When setting up a train for an upcoming journey in the TMS, a driver is presented with a series of screens. The driver enters their driver login ID on the first screen (figure 6) and then the train headcode on the second screen (figure 7). Upon pressing ENTER after typing the headcode, the TMS displays the journey's time, origin and destination stations for the driver to check.

- 65 When satisfied that the correct headcode has been entered, a driver has the choice between two buttons to take the TMS to the home screen, which is the default screen during a journey. The HOME button takes the TMS to the home screen but does not cause the TMS to accept the entered headcode. The CHECK STOPS button takes the TMS to a screen where the driver can check the stops for the intended journey, before reaching the home screen. It is the pressing of this CHECK STOPS button which causes the TMS to accept the entered headcode.
