Rail Accident Report

Fatal accident involving a train passenger at Twerton 1 December 2018

Report 14/2019
October 2019

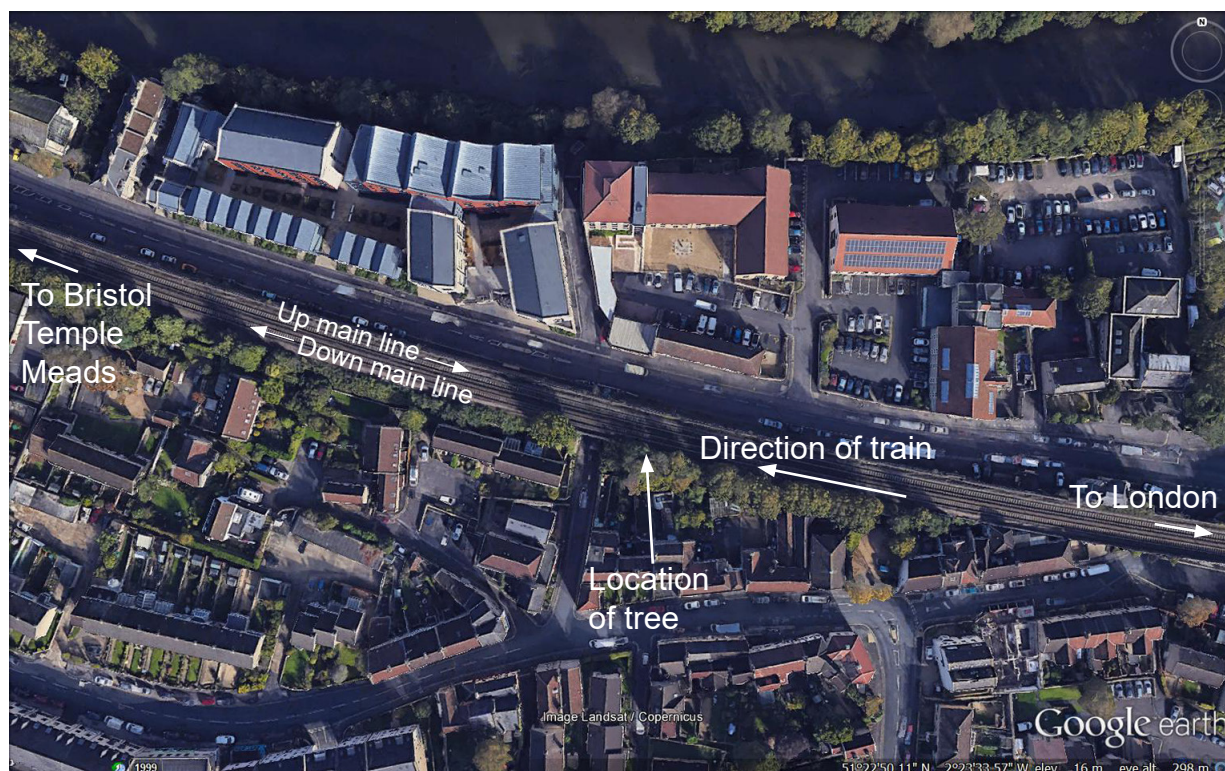
Figure 3: Satellite view of the accident location

- 15 The branch which the passenger came into contact with was attached to a stem that was growing from the stump of an ash tree.

- 16 After the accident, Network Rail commissioned an arboricultural consultant to investigate the history of the tree. The consultant's report identified that the tree involved was an ash tree which had been growing on the embankment approximately 5.5 m from the nearest running rail of the 'down' main line.

- 17 The report describes how the tree was either felled or coppiced² around 1998 and after that seven stems grew out from the stump. Eventually the stump became colonised by two or three types of wood decay fungi which ultimately led to the failure of the stems. The stem involved then fell towards the railway, coming to rest on a chain link fence at the top of the embankment.

- 18 From a review of historical aerial photographs and video footage, the RAIB has concluded that the stem involved did not fail before 18 April 2015. However, by 4 February 2017, it had fallen and was resting on the fence with some branches extending out towards the railway line. The photographs and video footage also show that the tree remained largely unmoved in this position until at least late on the afternoon of the day of the accident. Given that the tree had been in this position for at least 22 months without moving significantly, it was not a particularly windy day and the RAIB is not aware of any other events that could have affected its position, the RAIB believes it is likely that it was still in that position at the time of the accident.
