# Rail Accident Report

**Near miss between a passenger train and lorry  
at Mucking AHB level crossing, Essex  
13 March 2019**

# Near miss between a passenger train and lorry at Mucking AHB level crossing, Essex, 13 March 2019

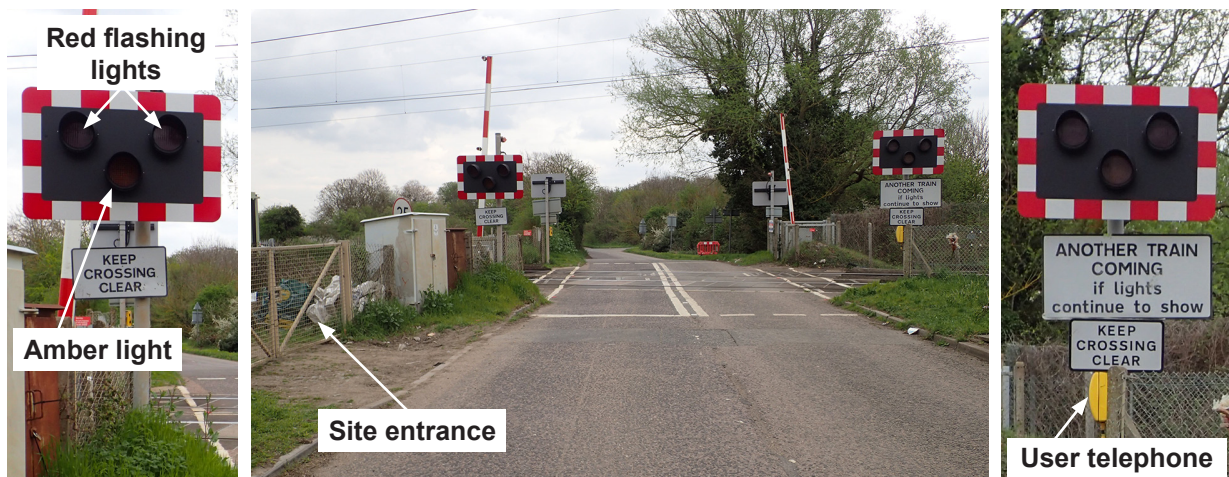
Figure 3: Mucking level crossing viewed from west side

- 17 Mucking level crossing is an automatic half barrier crossing equipped with one rising barrier on each side of the railway (figure 3 and figure 4). When lowered, each barrier extends across about half the width of the road and obstructs the side of the road from which vehicles normally approach the crossing. Exits from the crossing remain unobstructed at all times.

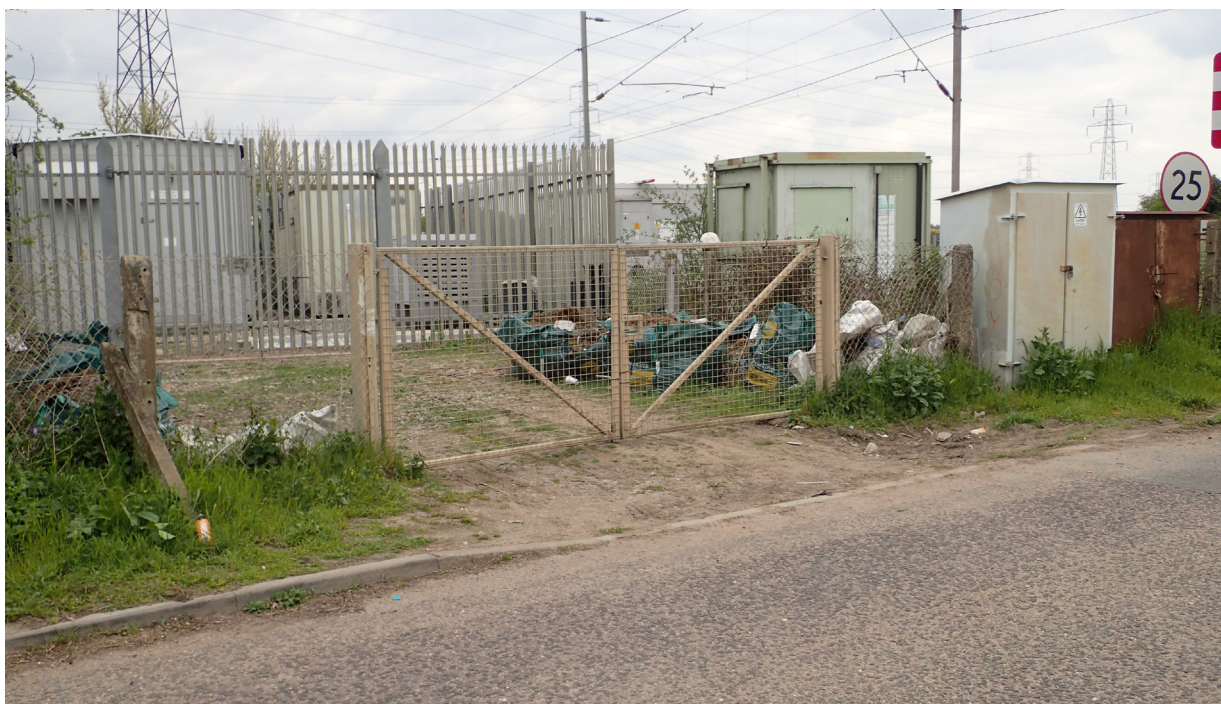
Figure 5: Mucking principal supply point compound

- 24 Construction work was being undertaken close to Mucking level crossing as part of a Network Rail project to upgrade the equipment supplying power to railway signalling equipment at 10 sites between London Fenchurch Street and Shoeburyness in Essex. The purpose of the project was to provide new uninterruptable power supply (UPS) equipment at existing electricity principal supply points to reduce the risk of signalling failures and train delays. The main office for the project was located at Grays, about 10 kilometres from Mucking.
- 25 The principal supply point at Mucking is located in the compound north-west of the level crossing and is within an inner compound surrounded by a substantial metal palisade fence. An outer compound, surrounded by a chain-link fence, provides space for storage of equipment and materials and is accessed by a double gate (figure 4 and figure 5).

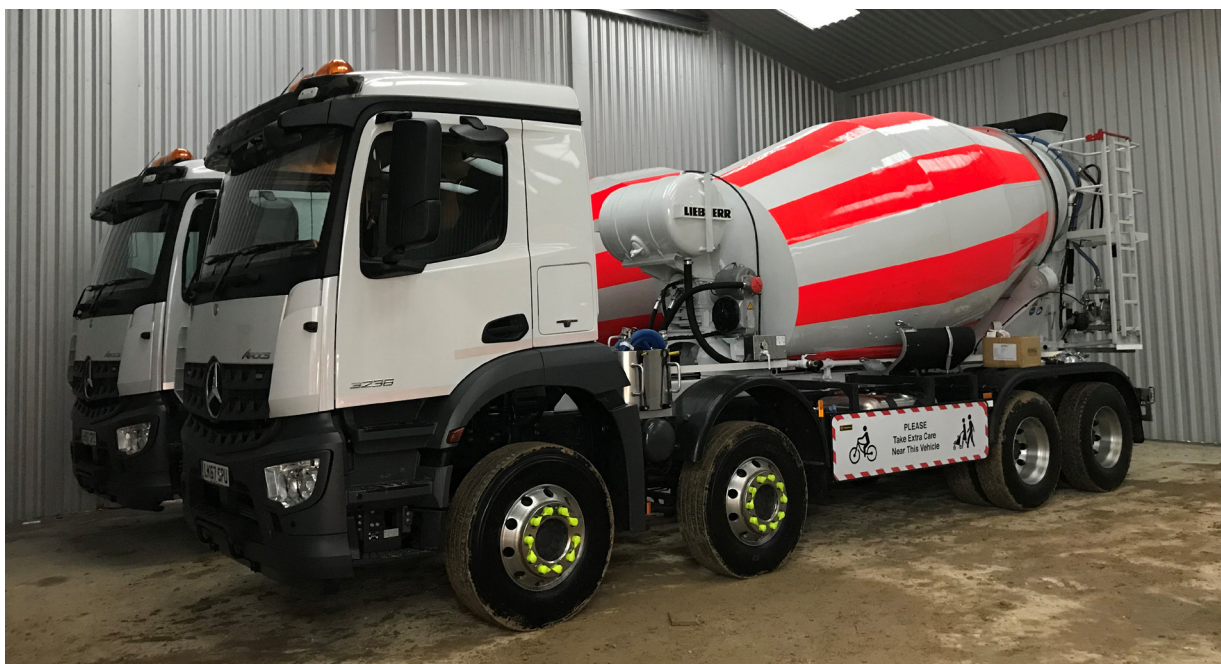
Figure 6: Concrete delivery vehicle of the type involved in the incident (courtesy of Euromix Concrete)

- 37 The supplier, Euromix Concrete, provided an 8m<sup>3</sup> capacity vehicle. The lorry was larger than required for this delivery and was approximately 9 metres long with a gross vehicle weight of about 21.5 tonnes at the time of the incident (figure 6). This was the first large goods vehicle (LGV) to deliver to the site at Mucking.
