# **Rail Accident Report**

Derailment at Santon near Foreign Ore Branch Junction, Scunthorpe 25 January 2008

Report 10/2009 April 2009 This investigation was carried out in accordance with:

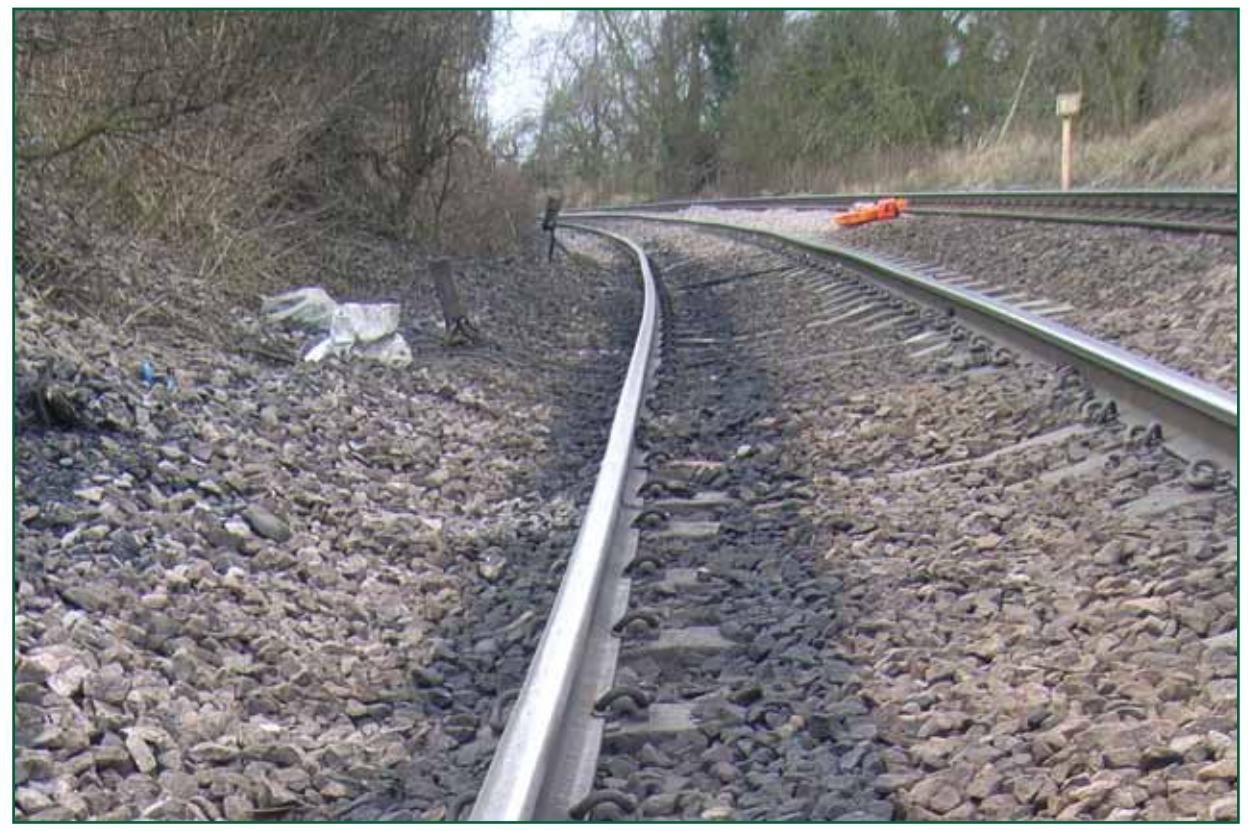
Figure 3: General view of the curve at Santon close to milepost 26

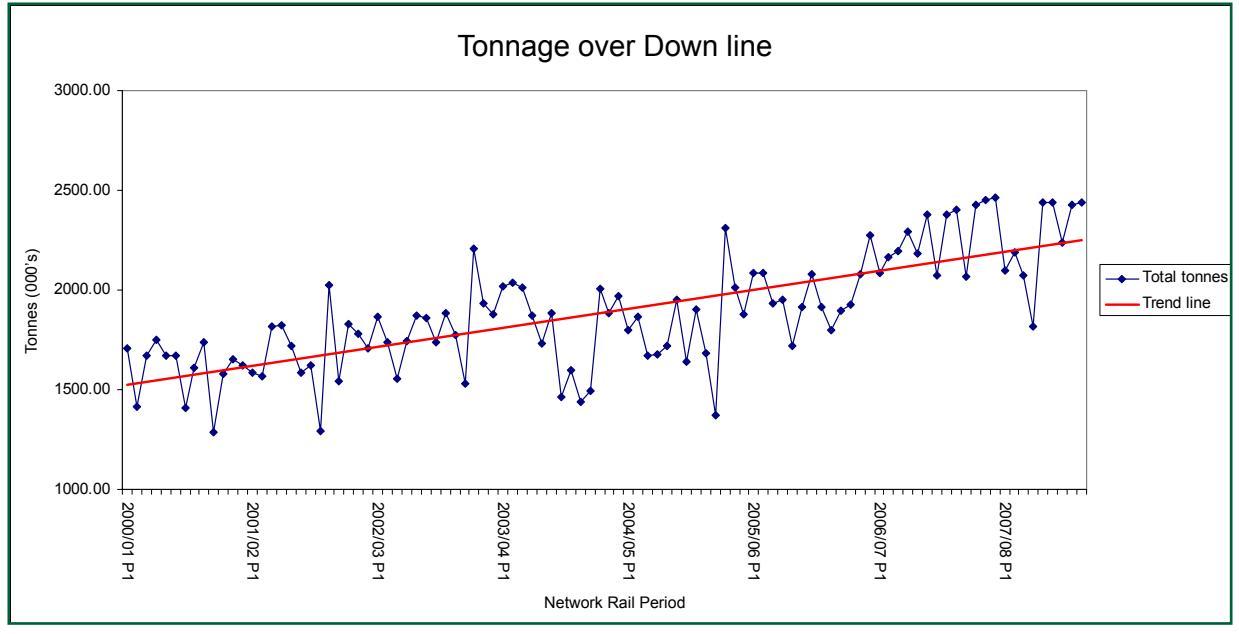
88 Over the past six years there has been a 38% increase in the annual tonnage carried over this line, see Figure 12.

Figure 12: Tonnage on the down line over the past 6 years

197 The high annual tonnage (Figure 12) carried over this line is due to the increase in the number of loaded freight trains originating from the Immingham area, so the annual tonnage on the down line is significantly higher than that of the up line. Not only was the high tonnage wearing out the down line's track components, it was also contributing towards the development of the track geometry faults. The high annual tonnage over the track at the point of derailment was a probable contributory factor to the derailment.

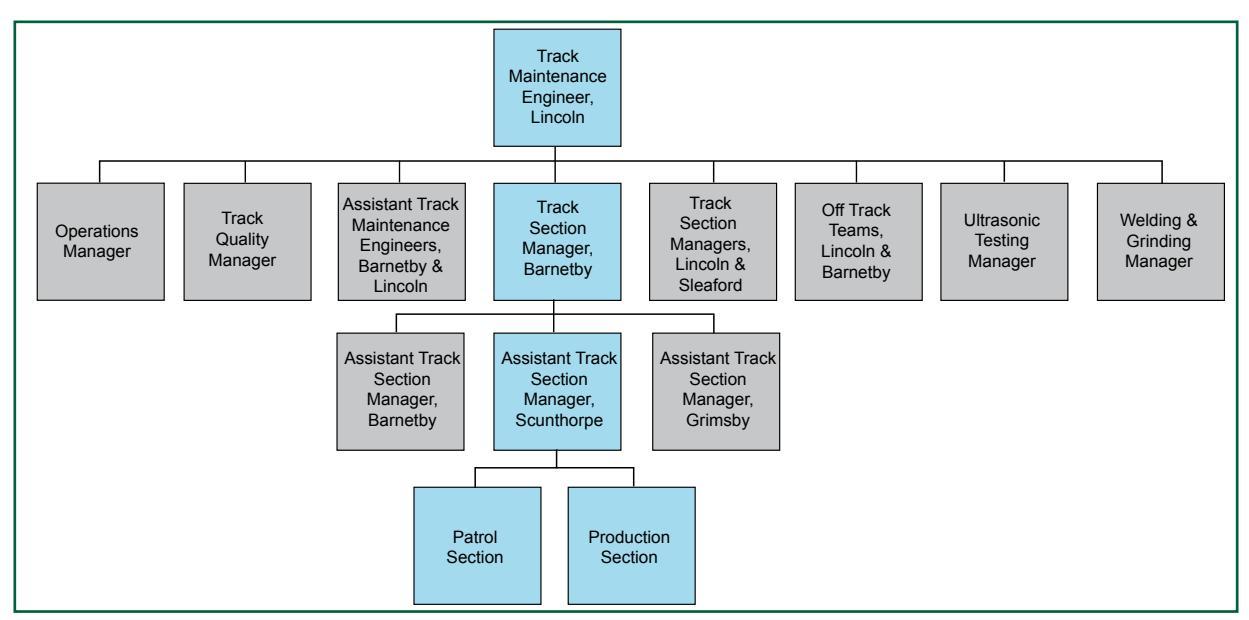
Figure 13: Local maintenance organisation diagram as at 25 January 2008

- 91 In the 18 months prior to the accident, there had been six personnel changes involving the Barnetby track section manager and the Scunthorpe assistant track section manager posts. These changes began after a near miss incident in August 2006, which Network Rail investigated and, as a result, dismissed the track section manager and demoted the assistant track section manager. Initially, Network Rail appointed local staff to deputise in these roles. Permanent appointments were then made but the new track section manager and the new assistant track section manager did not remain in post for more than two months due to long-term sickness. Consequently Network Rail appointed staff from the local team to deputise.

- 93 In January 2008, there were a number of vacancies within the Scunthorpe maintenance team, both in the patrol and production sections (Figure 13). The patrol section, responsible for inspection activities, should have included five staff but had just two permanent members and one of these was covering the vacant assistant track section manager role. Network Rail seconded staff from the production section into the patrol section to cover this shortfall. There were fewer vacancies in the production section, separately responsible for maintenance actions.

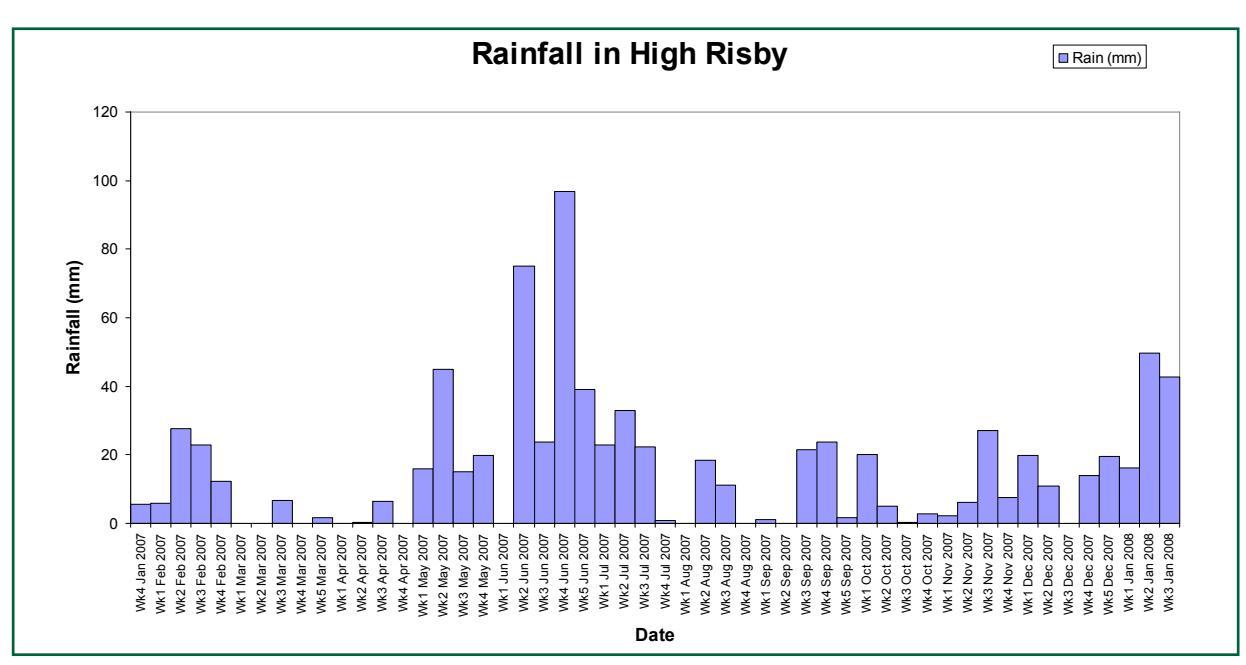
136 Rainfall data for the year prior to the derailment was obtained from the Environment Agency. It was recorded at a Met Office registered rainfall site at High Risby which is less than 1.5 miles from Santon. The data showed there had been short periods of intense rainfall during June 2007 and January 2008 (Figure 15).

Figure 15: Weekly rainfall recorded at High Risby over previous 12 months

137 The intense rainfall in June 2007 coincided with Network Rail closing the railway between Santon and Foreign Ore Branch Junction for four days due to flooding.

- 194 Rainfall data from a nearby weather station showed periods of intense rainfall during 2007 which correlated with the trend in deterioration shown in the track recording data. There were no immediately visible signs of water at the point of derailment, but there were many other indications that it was present in this area (see paragraphs 58, 59, 126, 132 and 135).
