JB Report: 2007/02

**REPORT ON SERIOUS RAILWAY INCIDENTS AT SLEPENDEN
BLOCK STATION DUE TO WRONG-SIDE SIGNALLING AT
SANDVIKA STATION ON THE DRAMMEN LINE 20 APRIL 2005**

Date
February 2007

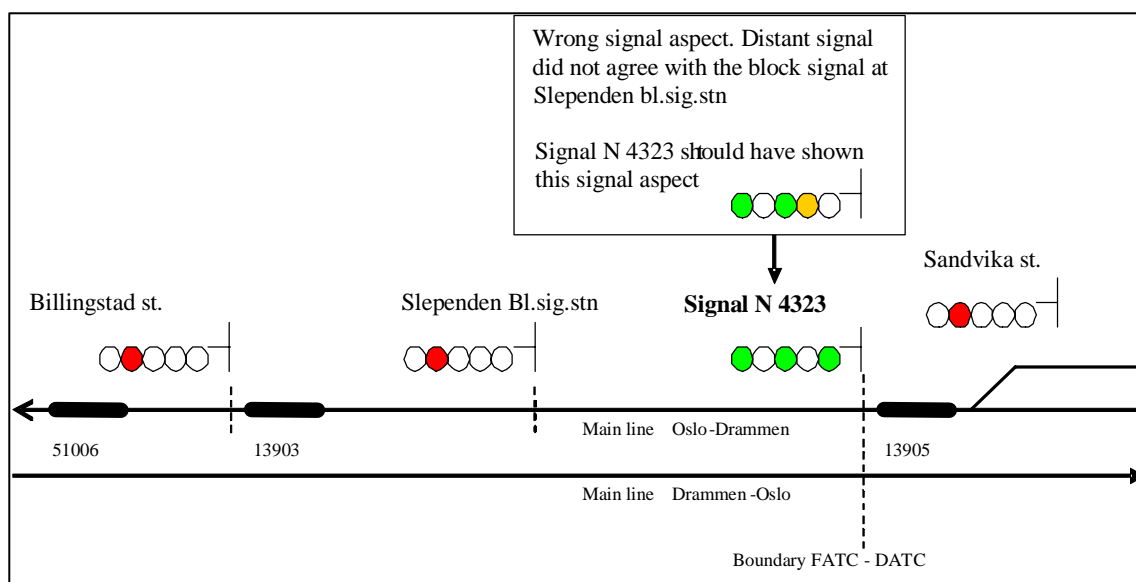
Figure 3: Airport express train 13905 departs at time 0417 from Sandvika station

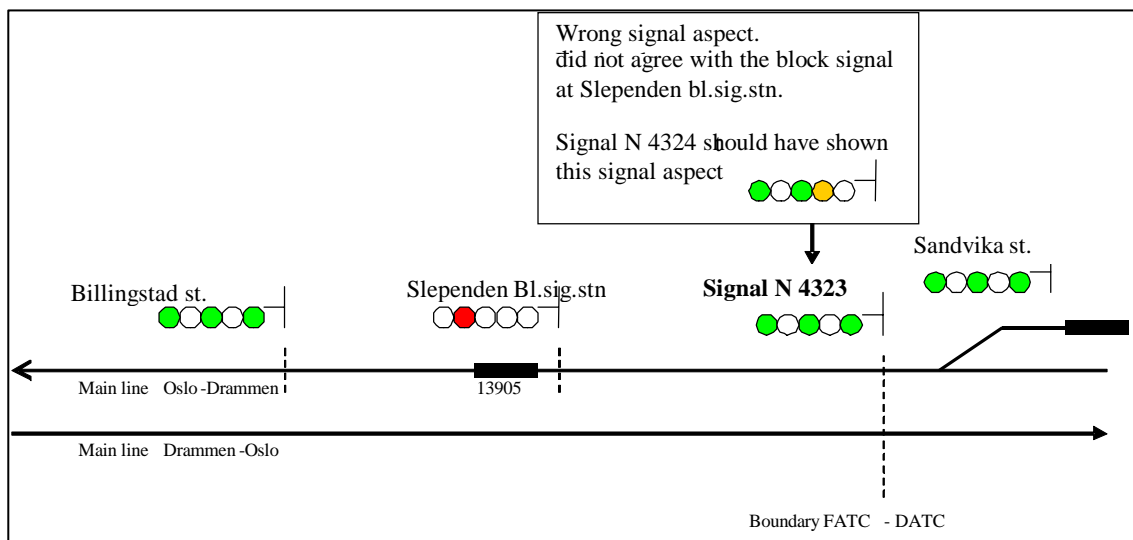
A route was set for the train to depart on line 1 at Sandvika station for train 12207, with main exit signal N 4323 showing a “proceed” signal for NSB train 12207. The train went past the main exit signal and the distant signal for Slependsen block signal station was showing the “expect to proceed” signal (see figure 5). The train’s ATC equipment received the same information and the train continued out onto the block section at a speed of almost 82 km/h.

Figure 5: The situation at time 04:42:46, immediately before the second serious incident occurred. Train 12207 started to depart on line 1 at Sandvika station.

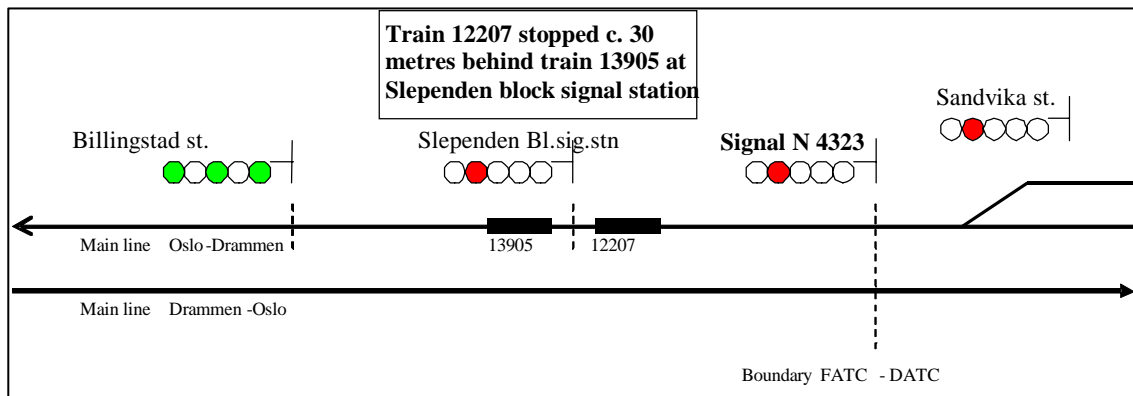
When the train approached the Slependsen holding point, the locomotive driver began to have doubts when he discovered 2 red lights on one of the lines. These were the rear lights on train 13905 which was standing on the block section after Slependsen block signal station. He was unable to ascertain which of the main lines the red lights were located on, but for safety's sake he immediately applied the emergency brake and gradually discovered that train 13905 was standing on the very main line on which he was travelling. Because the emergency brake had been applied, the locomotive driver was able to stop the train just in front of the signal at Slependsen block signal station. The person involved estimated that his distance from airport express train 13905 was approx. 30 metres. It was only the alertness and quick-thinking of the locomotive driver that prevented this becoming a collision.

Figure 6: At time 04:44:31, the scenario after the locomotive driver had applied the emergency brake and stopped train 12207 in front of the signal at Slependsen block signal station.

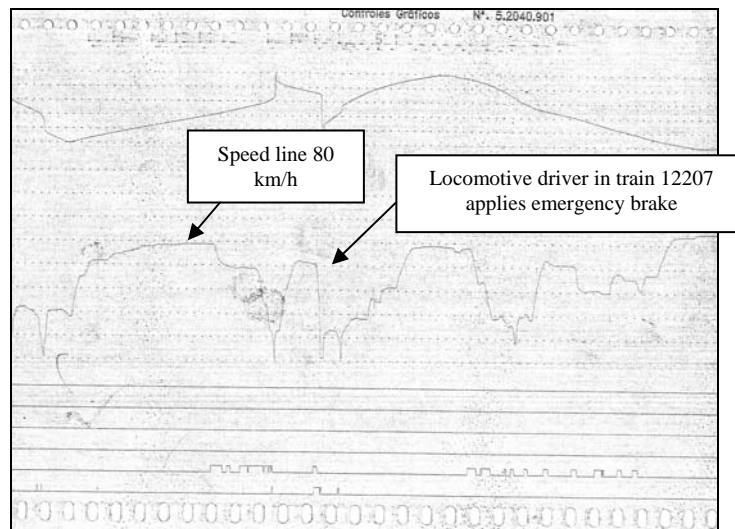
Figure 14: Speed printout (Hasler) for train 12207
