# Rail Accident Report

## **Passengers struck by a flying cable at Abergavenny (Y Fenni) station 28 July 2017**

# Passengers struck by a flying cable at Abergavenny (Y Fenni) station, 28 July 2017

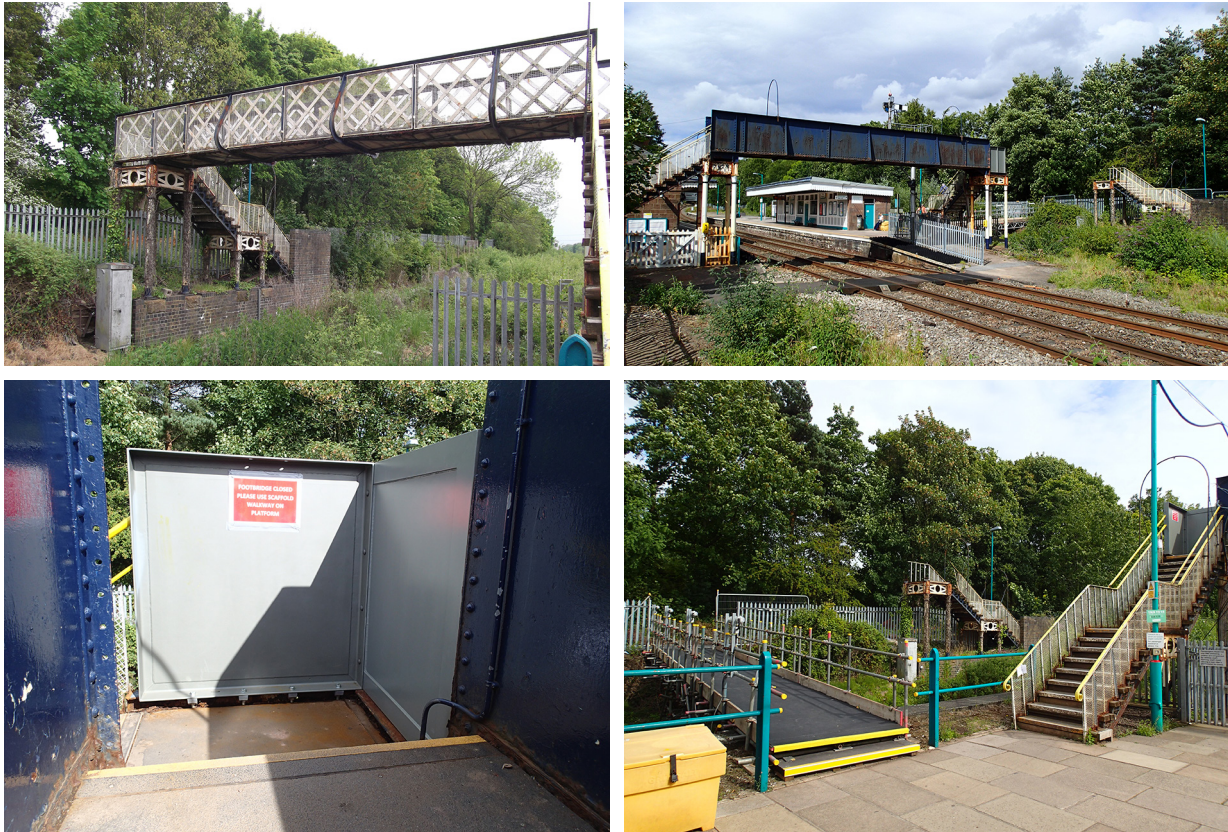
- 15 The footbridge comprised two spans: a girder span over the operational railway and a lattice span over a disused track bed (figure 8). Network Rail had identified that the lattice span was in a poor condition and required attention so it contracted Centregreat Engineering to remove the lattice span so it could be examined and refurbished. The contract also included installing a corner section at the top of the centre footbridge stairs and building a temporary walkway from platform 2 over the disused track bed to the bottom of the far set of footbridge stairs (figure 8), to maintain the public right of way. This work was scoped during December 2016 and planned to take place during the first half of 2017.

- 16 The lattice span was lifted out during the night of 15-16 July. Photographs of the footbridge taken before and after this work show that the cable's position had not changed (figure 7). Further work took place during the night of 27-28 July to correct minor issues that had been reported. The only work carried out on the footbridge was to extend the handrails at the top of the central flight of stairs so that they could be attached to the new corner section. The RAIB found no evidence that this work affected the cable tray or the cables attached to it.

Figure 8: From top left clockwise: The footbridge lattice span, the footbridge after the lattice span had been removed, the temporary walkway to platform 2 over the disused lines and the footbridge corner section (top left image courtesy of Network Rail)

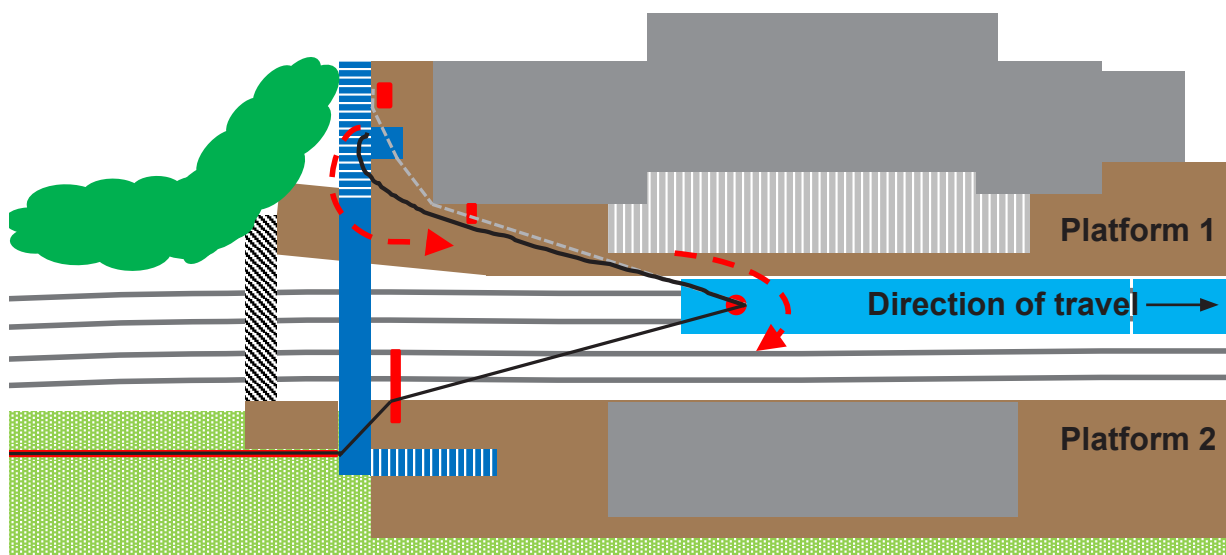
- 20 The electrical supply cable was pulled until no further movement was possible, at which point the end of the cable that was terminated within a distribution cabinet at the foot of the footbridge stairs broke free. Once loose, the free end of this cable whipped round and struck a group of passengers on the footbridge stairs (figure 11) causing minor injuries to three of the group. There were no injuries to anyone on the platforms although a member of station staff was nearly struck (paragraph 4). The cable came to rest on the Down Main line next to the train, with its end resting on platform 2 (figure 12). The telecommunications cable snapped during the accident, with a length of it also coming to rest on the Down Main line. This cable is not reported to have injured anyone.

Figure 11: Diagram showing the position of the electrical supply cable once it broke free

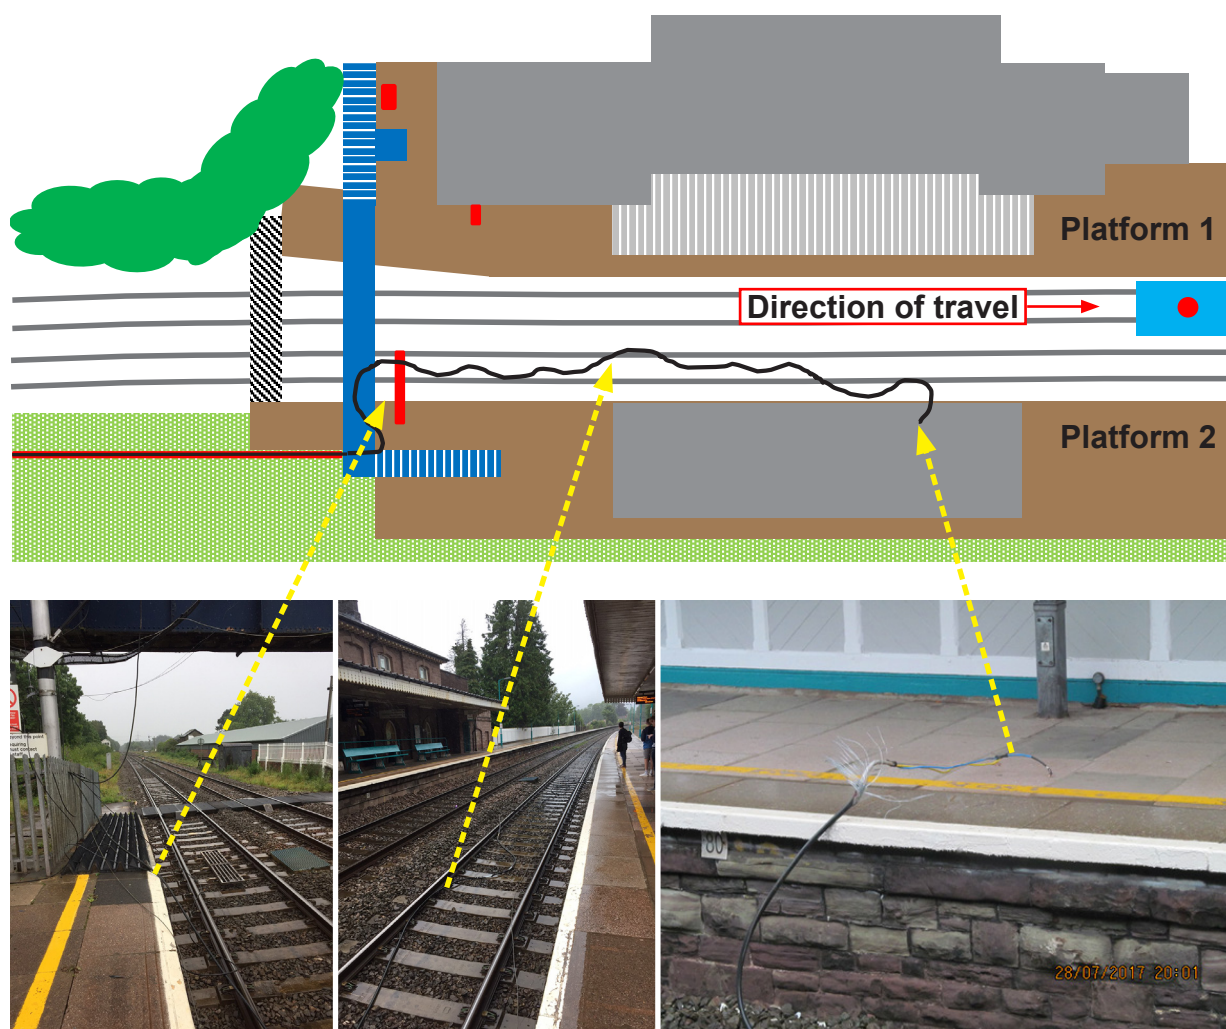
Figure 12: Diagram and photographs showing the position of the electrical supply cable after it came to rest (left and middle images courtesy of Network Rail, right image courtesy of British Transport Police)

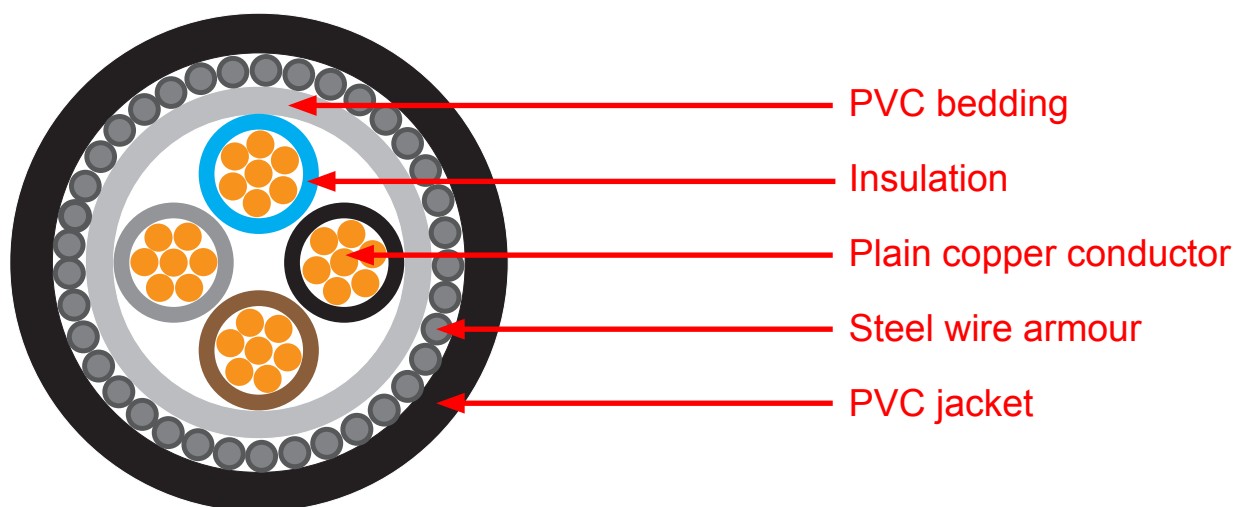
- 30 The electrical supply cable ran from the distribution cabinet at the station, over the footbridge, to the signal box. It was a four core steel wire armoured cable (figure 13), rated for 600/1000 V, with a diameter of about 25 mm. A cable of this construction and diameter typically weighs about 1.3 kg per metre length. Its manufacturer estimates it has a breaking load of about 30 kN (about 3 tonnes), which made it more likely that the cable would break at its termination point rather than breaking along its length, when it was pulled.

Figure 13: Diagram showing the construction of a steel wired armour cable

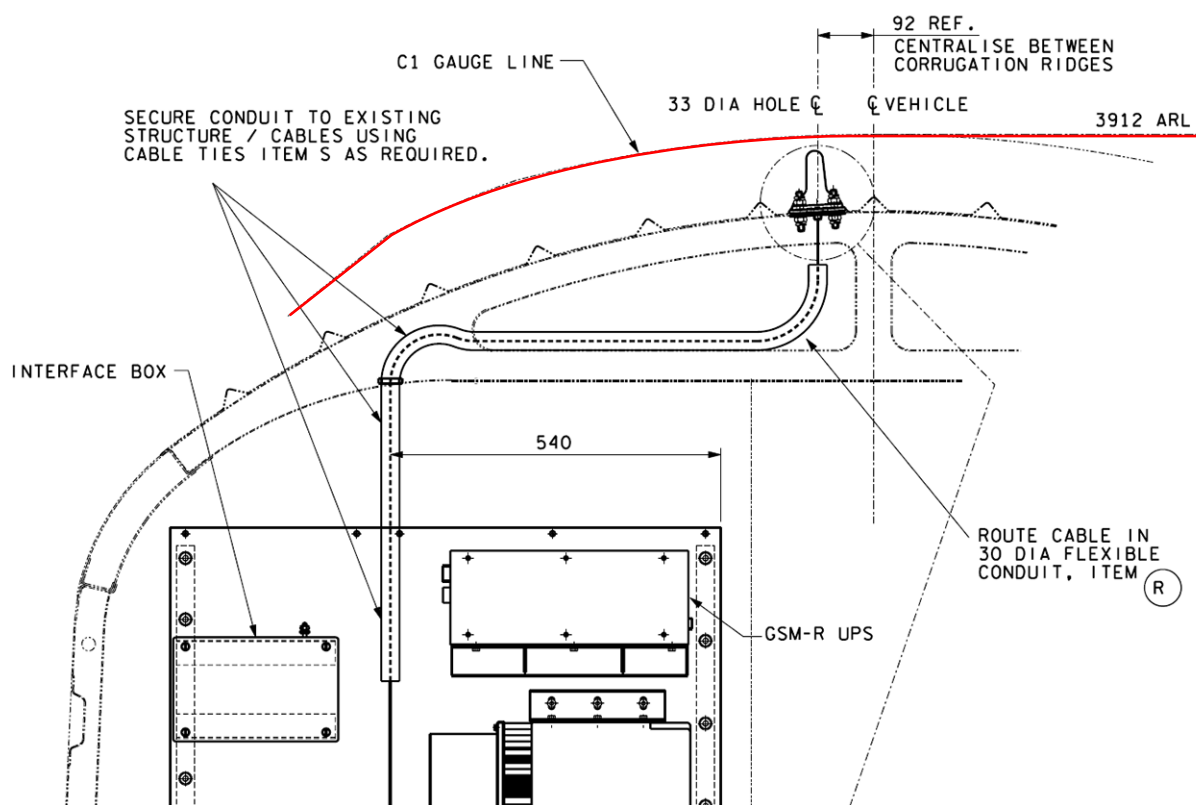
- 35 The installation drawing for the modifications made to the DVT when its radio equipment was installed shows the top of the antenna is within the limits of the relevant profile by about 25 mm (figure 15). The height of the antenna was assumed by the designer of the installation to be at the maximum ride height for the vehicle, ie when in tare condition and with new wheels (ie maximum wheel diameter). Therefore the height of the radio antenna was compliant with the requirements of GE/RT8073 and in a normal position relative to the railway's infrastructure.

Figure 15: Extract from the drawing for installing the radio antenna to the DVT (drawing courtesy of Network Rail)
