Rail Accident Report

**Fatal accident at Trenos footpath crossing near
Llanharan, Rhondda Cynon Taf, South Wales,
1 June 2017**

Report 07/2018
May 2018

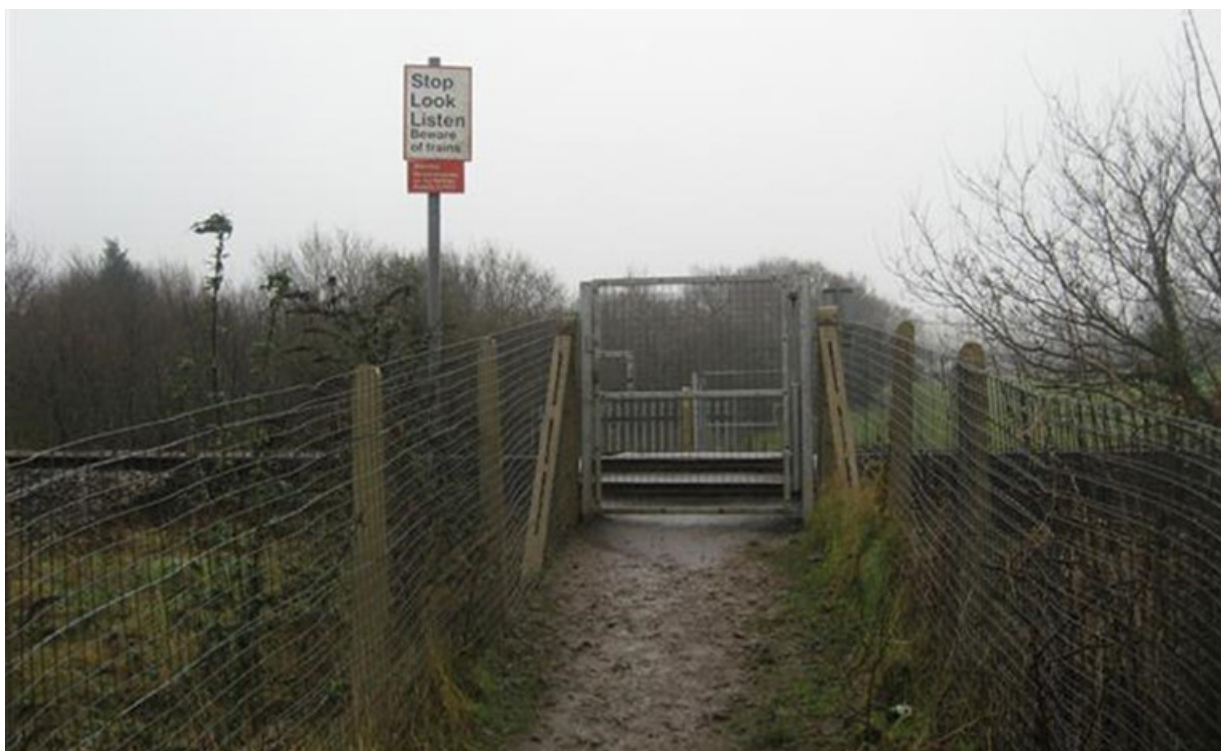
Figure 3: approach to Trenos crossing from the south

- 13 The approach from the south side is up a sloping path (figure 3 and figure 4). A pedestrian's view from this side of the railway looking towards trains approaching on the down line, the line used by the train which struck the pedestrian, is shown in figure 5.

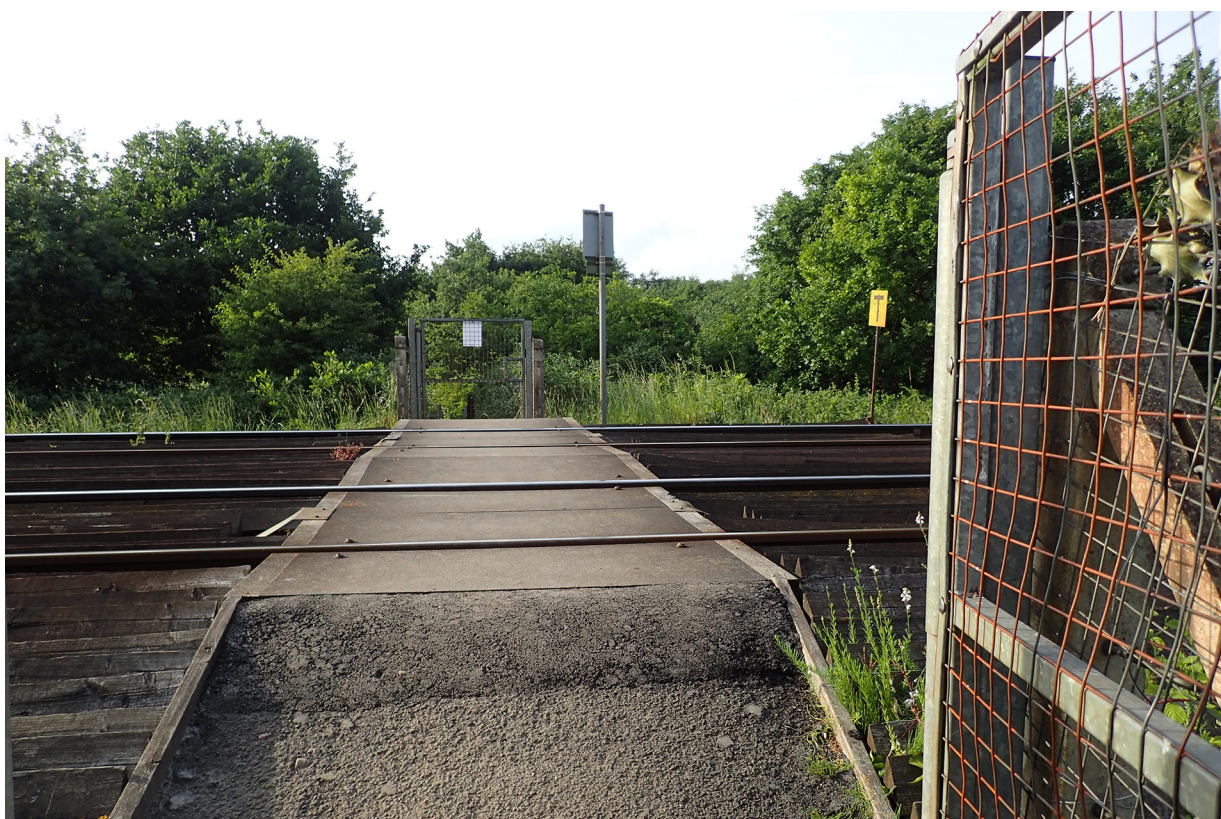
Figure 4: Trenos crossing from the south with pedestrian gate open

- 16 Trenos crossing was inspected by Network Rail operations staff while responding to the accident on 1 June 2017. These staff found no evidence that the condition of the crossing was a factor in the accident and the RAIB concurs with this view.

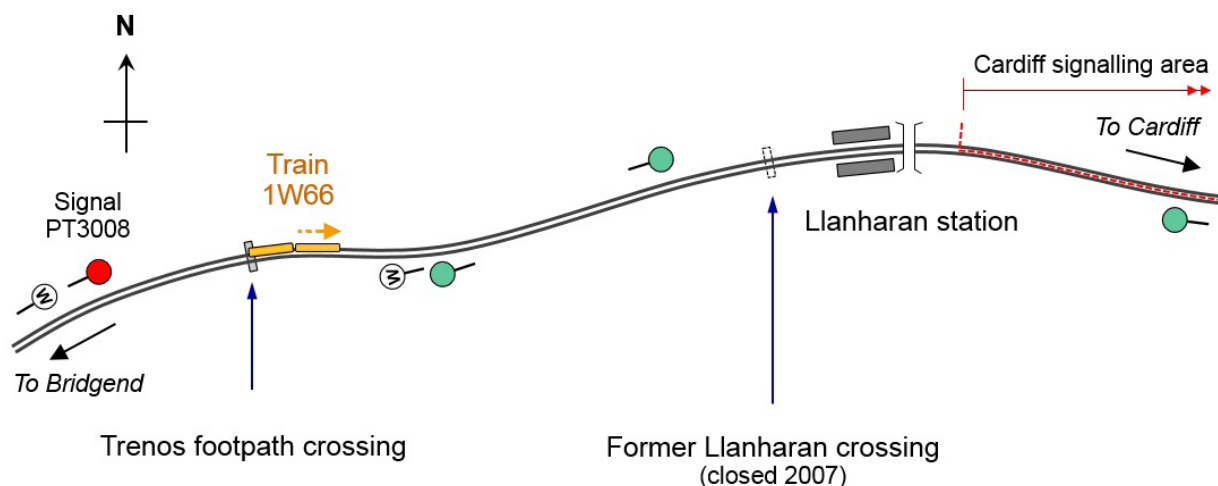
Figure 8: diagram at 15:32 hrs

- 27 The driver sounded the train's horn again, nine seconds before the crossing, and applied the brake. The on-train data recorder confirms that the driver did not use the train's emergency brake. At 15:32 hrs, the train stopped with its rear cab over the crossing (figure 8).

- 28 The driver looked out of the leading cab's right-hand window and saw the train's guard, who was travelling in the rear cab, speaking to the pedestrian. The guard believed the pedestrian was at immediate risk and shouted that she should get off the crossing. The driver then observed the pedestrian move off the crossing, and resumed the journey. He did not immediately report the incident despite the out of course stop. He attempted to contact the guard by the train's cab-to-cab telephone system, but this was not working.

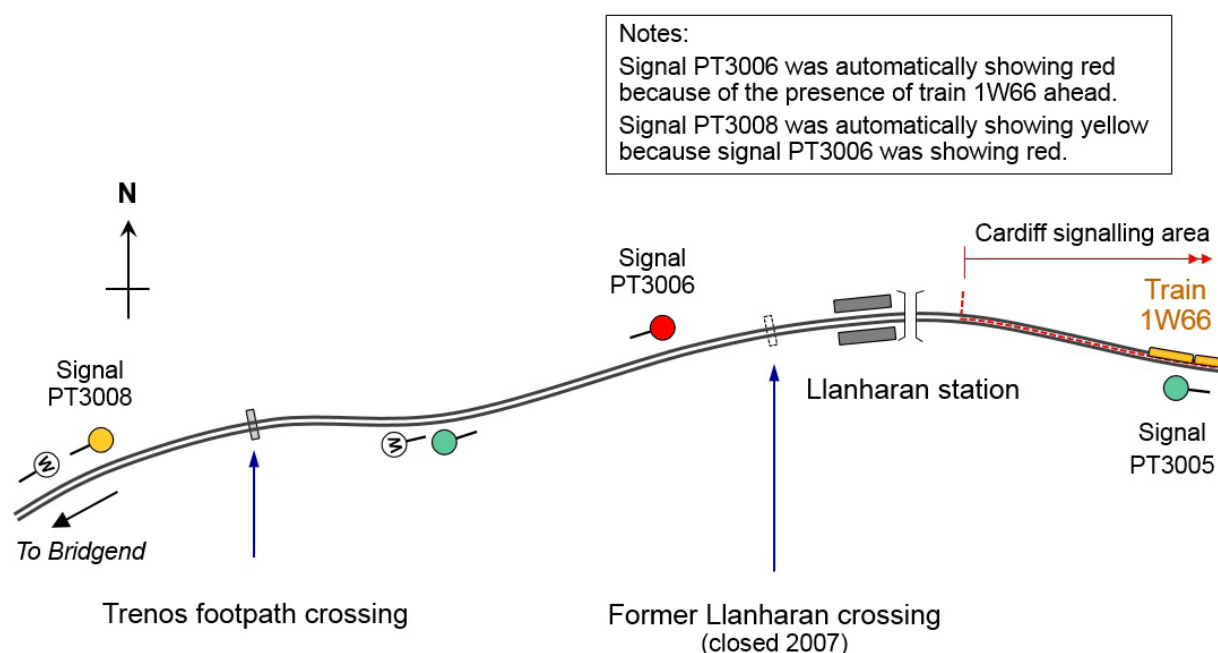
Figure 9: diagram at 15:35 hrs

- 29 The guard also used the train's cab-to-cab telephone but was unable to contact the driver. The guard ran through the 2-carriage train and entered the driver's cab. He informed the driver that he was concerned about the pedestrian's state of mind and advised the driver to report the incident to the signaller. The driver applied the brake and stopped the train for a second time east of Llanharan station at 15:35 hrs (figure 9).

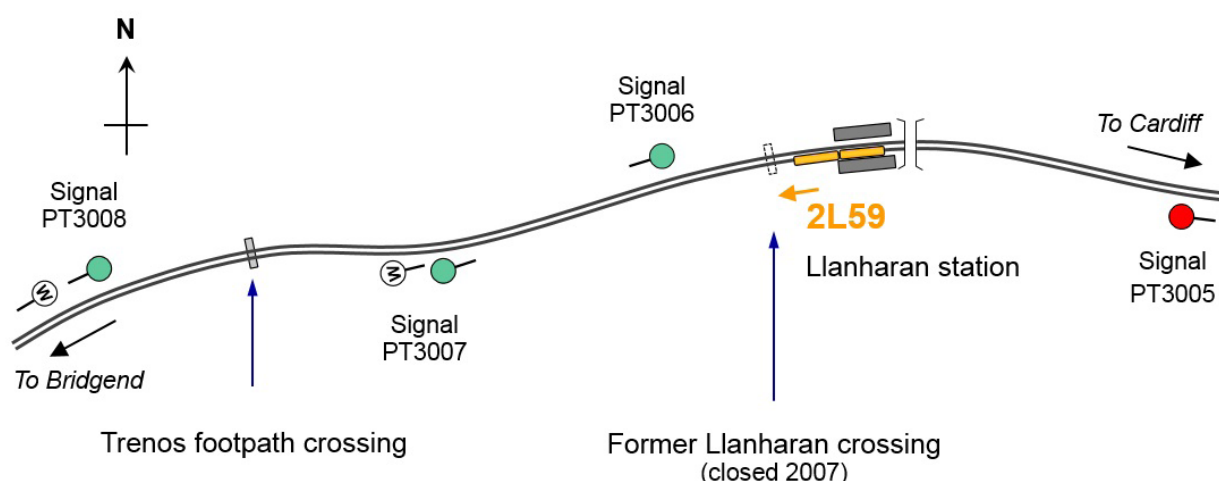
Figure 11: diagram at 15:48 hrs

- 38 At 15:48 hrs (figure 11), train 2L59 departed from its booked stop at Llanharan station and accelerated towards its next stop at Pencoed station. This service was due to depart Llanharan at 15:36 hrs, but had been delayed at Cardiff and was running about 12 minutes late.

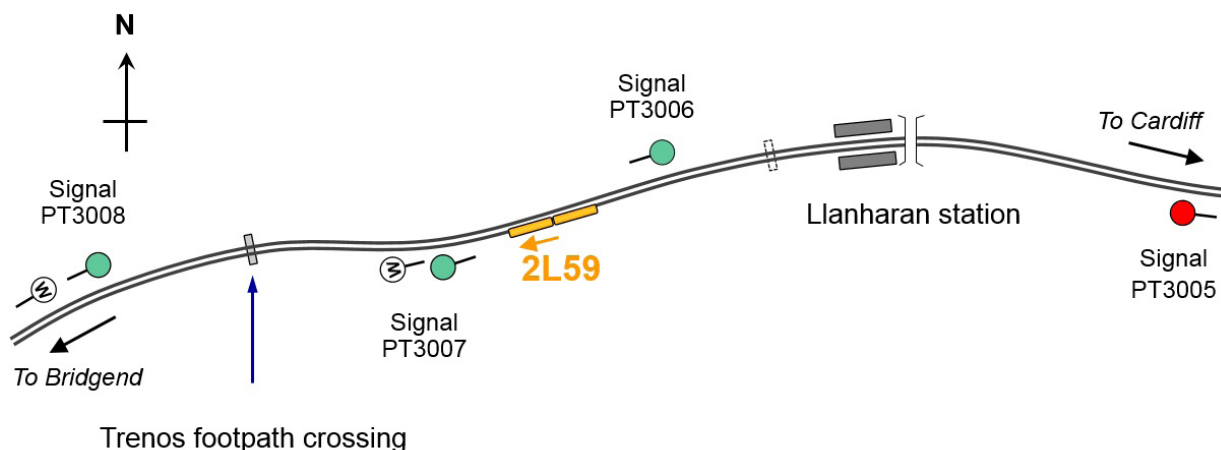
Figure 12: diagram at 15:49:30 hrs

- 39 Train 2L59's on-train data recorder⁵ indicates that signal PT3007 was displaying a green aspect as the train approached (figure 12). It also indicates that the driver then sounded the train's warning horn about 380 metres (16 seconds) from the crossing as it passed the whistle board located just beyond the signal.

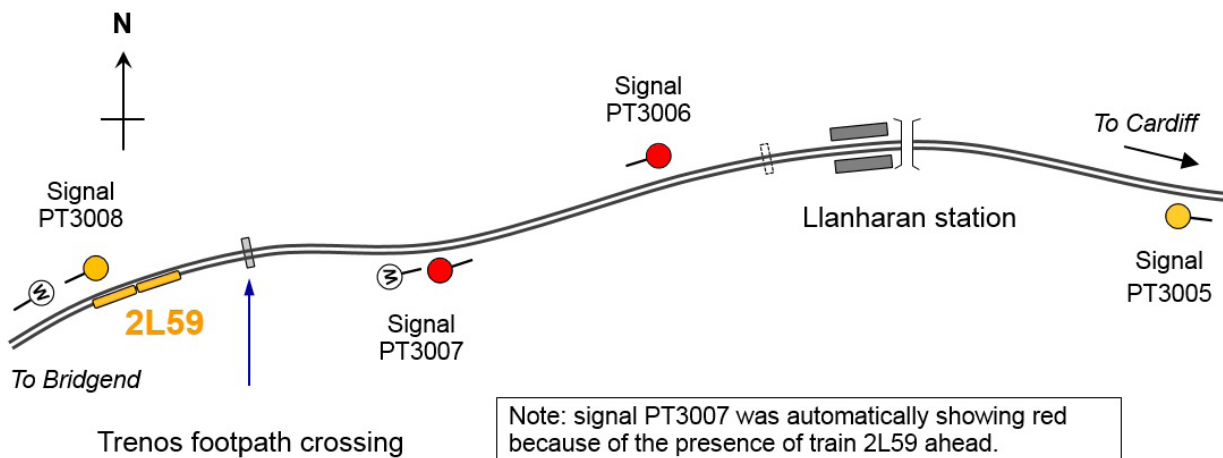
Figure 15: diagram at 15:51 hrs

- 43 The driver of train 2L59 contacted the Port Talbot signaller using the in-cab radio's emergency button. He informed the signaller that his train had struck a pedestrian on the level crossing just after Llanharan station. In response, the Port Talbot signaller put signal PT3006 to red (figure 15). This would have prevented a train approaching Llanharan crossing on the up line but would not have prevented a train approaching Trenos crossing. At 15:58 hrs, the signaller put signals PT3005 and PT3008 to red. Although the signaller still believed the accident had occurred at Llanharan crossing, this action also prevented trains approaching Trenos crossing.
