Rail Accident Report

Freight train collision near Logan, East Ayrshire 1 August 2015

Report 13/2016
July 2016

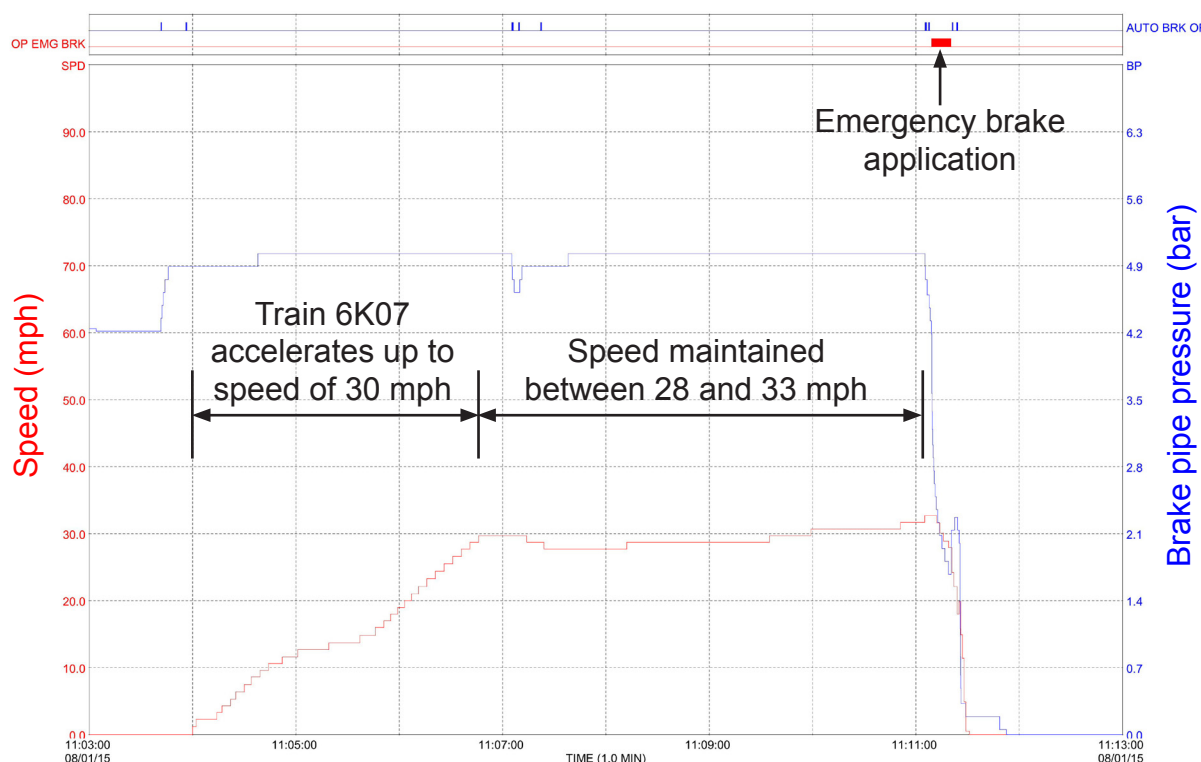
Figure 6: Data recorded by the locomotive's on-train data recorder

- 29 The locomotive's *on-train data recorder* shows that from 11:04 to 11:07 hrs, train 6K07 slowly accelerated until it reached a speed of 30 mph (48 km/h) within the work site (figure 6). For the next four minutes, train 6K07 maintained a speed between 28 mph (45 km/h) and 33 mph (53 km/h).

- 30 At 11:11:05 hrs, the driver made a brake application and the *brake pipe* pressure recorded by the on-train data recorder fell from 5.0 bar to 4.3 bar. This was 210 metres from the point of collision. Four seconds later the driver made an *emergency brake* application while travelling at 33 mph (53 km/h). This was 156 metres from the point of collision. Shortly after this the driver got out the driver's seat and braced himself behind the seat on the right-hand side of the cab as he realised a collision was unavoidable.

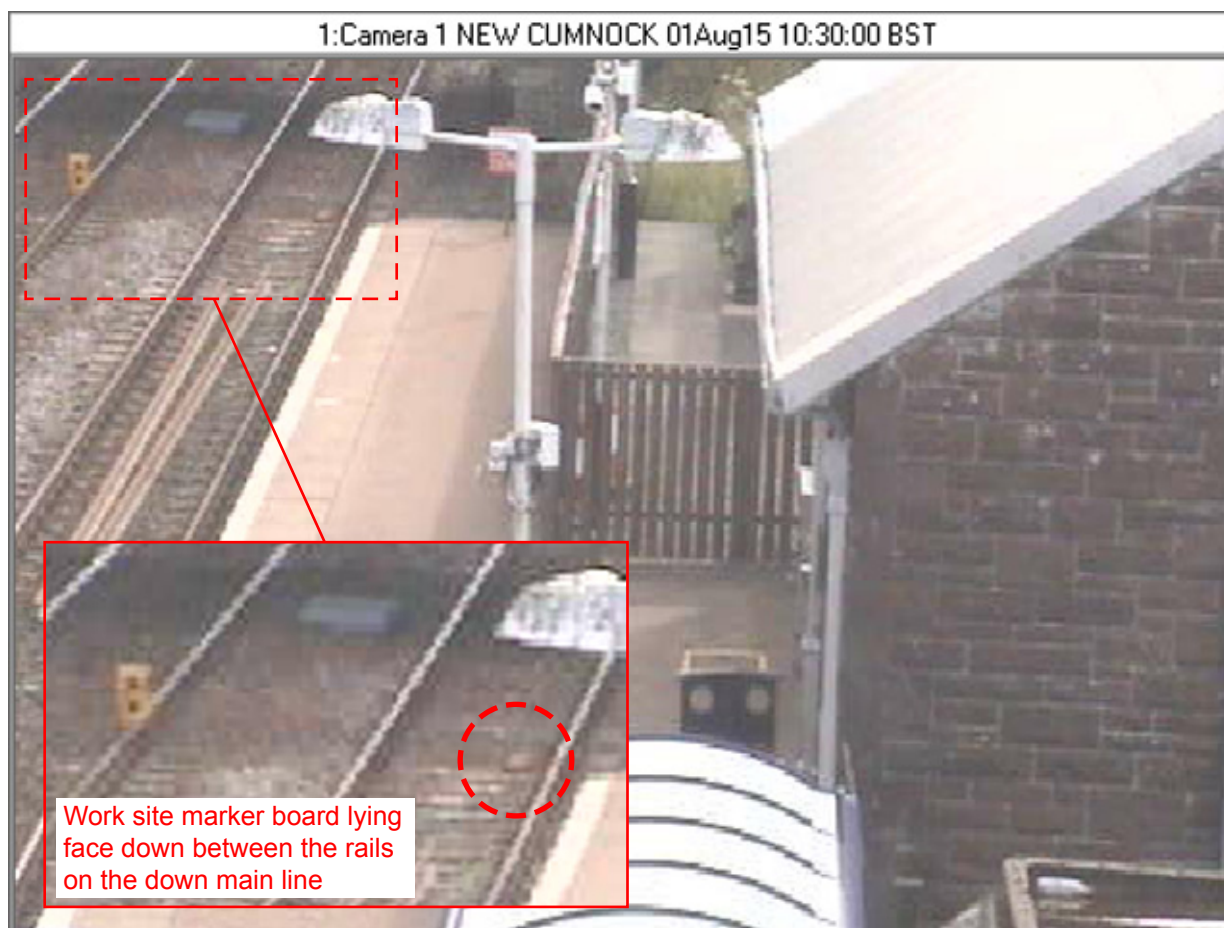
Figure 12: CCTV image from New Cumnock station (courtesy of ScotRail)

- 63 After the accident, the driver of train 6K07 stated that he might have thought he was driving in a possession rather than a work site while travelling from New Cumnock to site of the track renewal, and so could proceed at a speed of up to 40 mph (65 km/h). The protection arrangements in place at the entrance to the possession and work site may have led to the driver's uncertainty. At New Cumnock, the possession limit boards and the work site marker boards were located together at the possession detonator protection (figure 11). However, when train 6K07 approached, the work site marker board was not visible to the driver as it was lying face down between the rails (figure 12). It is not known when it was placed in this position but the RAIB obtained CCTV footage from New Cumnock station, which began at 10:30 hrs, that showed it was already lying face down by this time.

⁶ This photograph was taken in the days after the accident so may not show the exact positions of the boards as seen by the driver of train 6K07 on the day of the accident.

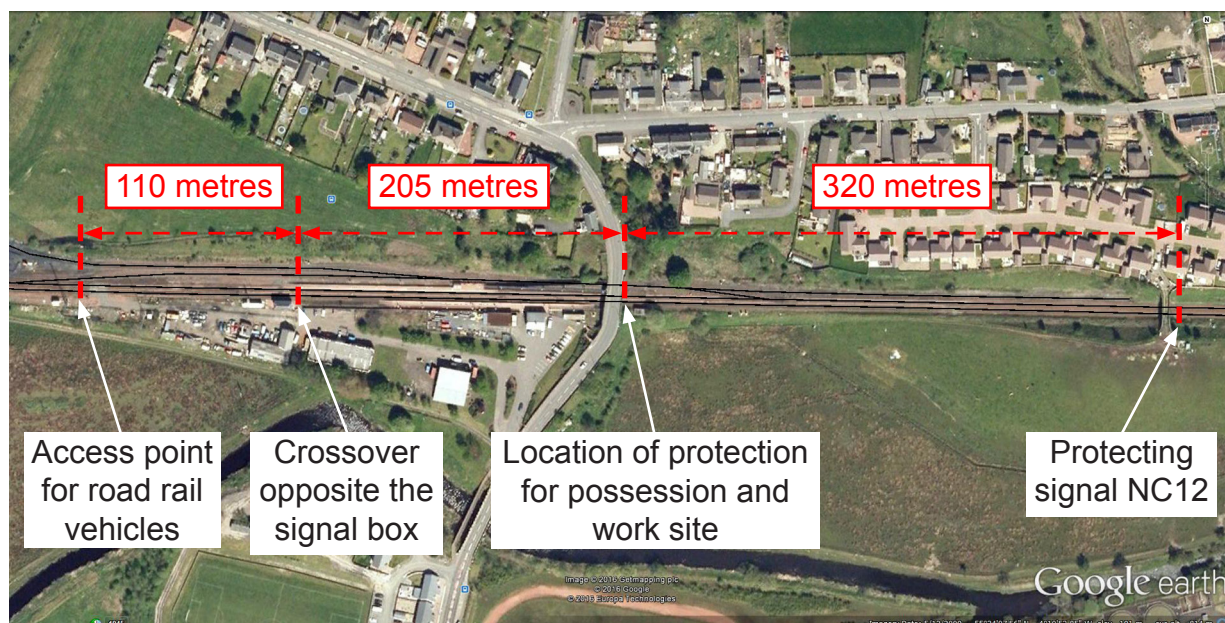
Figure 13: Overview of possession and work site arrangements at New Cumnock

- 67 The location of the protection boards at New Cumnock was driven by the operational requirements for the work site. Babcock Rail wanted to include the road rail access point at New Cumnock within the work site (figure 13). Babcock Rail also wanted sufficient space to hold a train at the exit to the work site while its rear was still clear of this access point. Locating the protection boards at the end of the platform ramp was also convenient for staff to get to when trains were coming into or going out of the work site and possession.

- 68 By co-locating the possession limit and work site marker boards, it meant each train that entered the possession and work site was required to pass both boards in one movement. When a train arrived at protecting signal NC12, its driver contacted the signaller. The signaller then obtained permission from the PICOP for that train to move up to the detonator protection by the possession limit board. The signaller then authorised the driver to pass signal NC12 at danger and move up as far as the possession limit board.

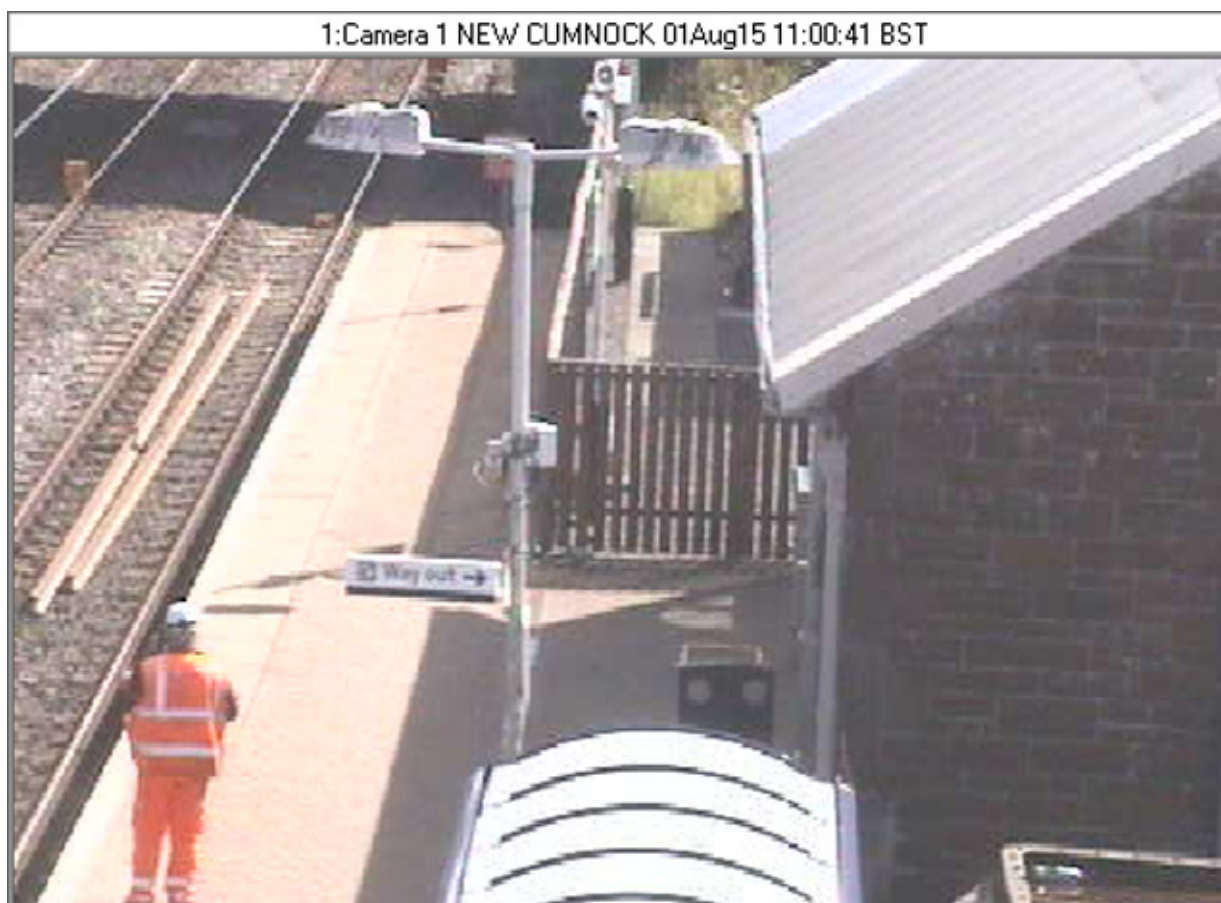
Figure 15: CCTV image of ES on platform at New Cumnock while briefing the driver of train 6K07 (courtesy of ScotRail)

- 87 At the same time as the ES arrived at New Cumnock station, the ESA, who was standing by the possession limit board, called the ES to say that train 6K07 had just arrived. The ES asked the ESA to pass his mobile phone to the driver and the ES then proceeded to brief his instructions to the driver for the movement into the possession and work site. While the ES gave his brief, he moved from his van to the platform at New Cumnock station. By this time the ES was only about 60 metres away from the train (figure 15).

- 88 There was no time pressure on the ES to carry out the briefing straight away as the train had arrived 13 minutes early at New Cumnock and was not needed at the track renewal site for another two hours. The ES could have walked down the platform to the train within a few minutes to give a face to face briefing. However, it was normal practice for the ES to brief drivers by mobile phone so he chose to do it this way. By giving his instructions in this way, the ES did not need to go onto the railway, but the risk in doing so was minimal as train 6K07 was already at a stand at the possession limit board and there were no other trains in the area.

- 89 Giving instructions by mobile phone rather than face to face can increase the potential for misunderstanding. A face to face conversation helps the person giving out the information to determine if the recipient has understood the instructions, by non-verbal means such as the recipient's body language or facial expressions. Technical issues such as a poor mobile phone signal can also cause distortion or a loss of sound during a conversation. This can result in incorrect information being received. To identify these inaccuracies, drivers and engineering staff (including PICOPs and ESs) are trained to repeat back the safety critical information passed during a conversation. Witness evidence is contradictory as to whether information was repeated back. As the conversation between the driver and ES was by mobile phone, there was no recording and so the quality of the communication between the two parties and their use of repeating back could not be checked.
