Rail Accident Report

**Partial collapse of a bridge onto open railway
lines at Barrow upon Soar, Leicestershire
1 August 2016**

Report 10/2017
June 2017

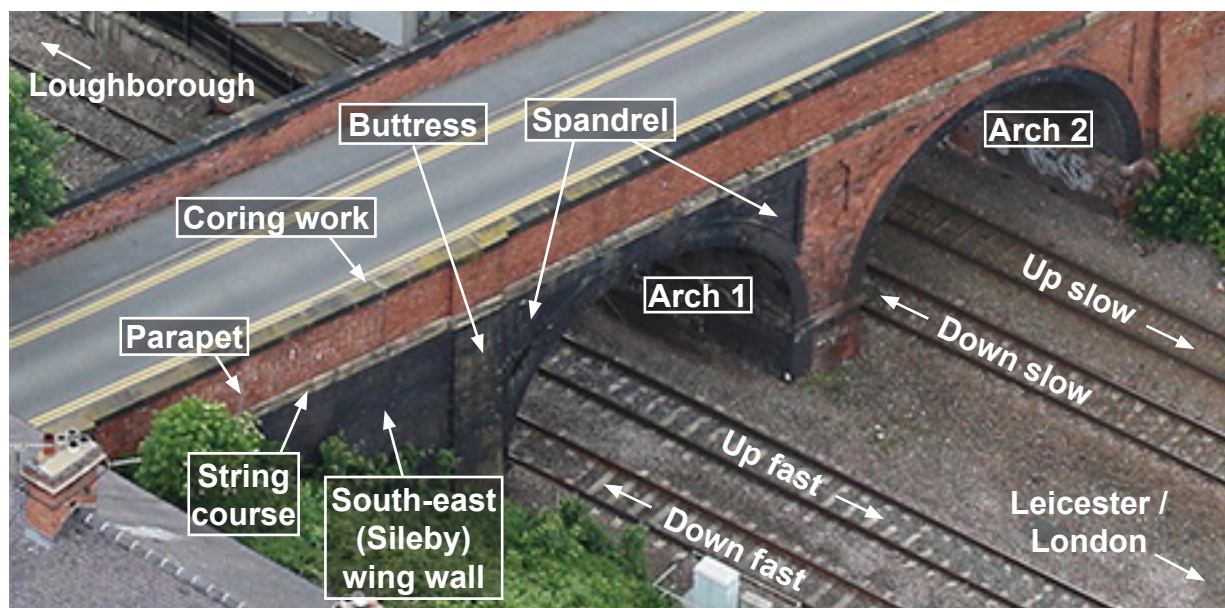
- 4 At the time of the collapse, a core sampling rig on the bridge was taking soil samples to investigate the cause of subsidence in the footpath adjacent to the Sileby wing wall (figure 2). The bridge was closed to the public but the railway lines below were open to traffic.
- 5 Shortly after the coring works commenced, water unexpectedly rose to the surface. A minute or so later, cracks appeared in the footpath, and the adjacent wall, footpath and the sampling rig fell from the bridge. Workers engaged in the coring work ran to safety and no-one was injured. Approximately 57 cubic metres of masonry rubble fell onto the railway below, completely obstructing two lines and fouling another (figures 3 and 4).

Figure 2: Location of incident and key features of Grove Lane bridge (image courtesy of Network Rail)

- 39 The bridge carrying Grove Lane was originally built with a single arch during the construction of the Midland Counties Railway in about 1840. It was later extended to a two-arch structure around 1868 when the railway was widened to four tracks. The collapsed wing wall is believed to be part of the original construction. The original construction was in blue brick while the newer parts of the bridge are mostly in red brick (figure 2).

- 67 The wing wall was built with a uniform thickness which was insufficient to carry the relatively large loads often found behind retaining walls of similar height. Network Rail reported that, after the incident, the wing wall was found to be 540 mm thick all the way up to the string course (figure 2). Brick walls intended to carry significant lateral loads are generally built thicker at the bottom than at the top to provide greater resistance to overturning.
- 68 The design of the wing wall was reported to be unlike any other on the Midland Main Line and not within the experience of Network Rail's asset engineers. As a consequence, they had not realised that the design of the structure gave it a latent susceptibility to overturning.

- 81 It is not clear where the fill material was migrating to; normally there would be indications of *leachate* emerging through nearby brickwork and it might be expected to appear through the vertical crack, but there was little evidence of this. It is possible that the material was being washed into voided areas at the back of the wing wall and into any gaps created by movement of the wing wall. It is also possible that it was washed elsewhere as there was evidence of leachate appearing through cracks in the adjacent buttress, spandrel and around arch 1 (figure 2).

- 87 In March 2015 Network Rail commissioned CML to carry out an excavation in the area of subsidence and a hole was hand-dug down to the string course (figure 2). This work was undertaken by the site manager. He reported that the fill was wet but no voids were found within the depth excavated to explain the subsidence. The water main, which was below the string course, was not identified by a pre-work survey, it was not uncovered by the excavation and its presence was not reported on. The area was made good and a report submitted to Network Rail which suggested that subsidence of the wing wall may have been a possible cause. This was considered to be improbable by Network Rail who took no follow-up action on the report.

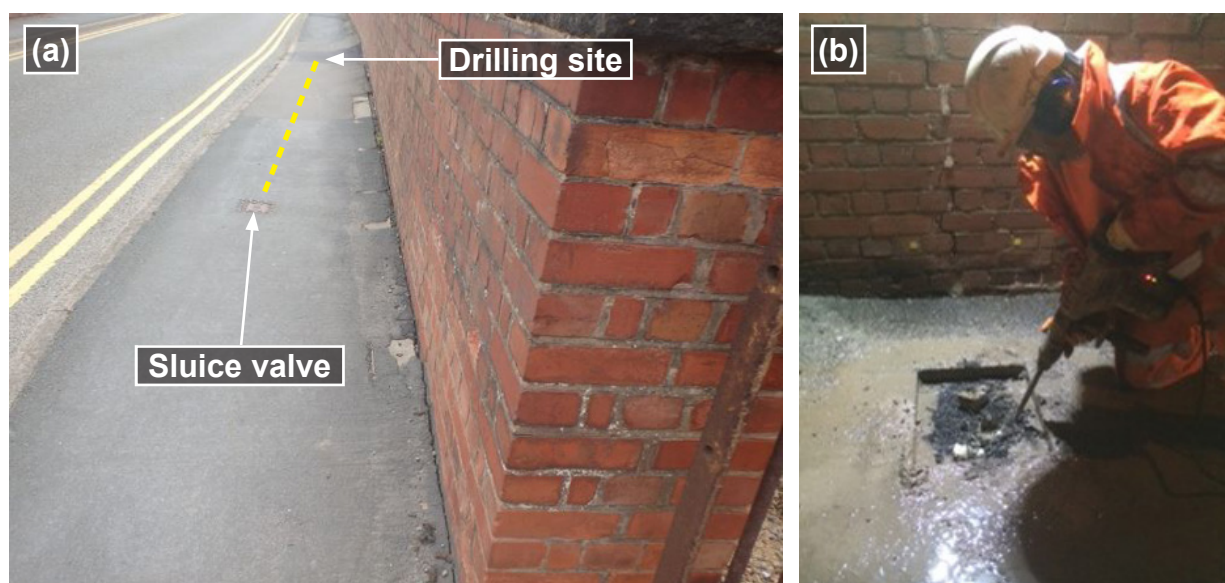
Figure 8: (a) trial hole site in relation to sluice valve (image courtesy of Network rail); and (b) trial hole on line of water main (image courtesy of CML)

- 93 The Network Rail standard for the examination of bridge structures NR/L3/CIV/006/2A 'Handbook for the examination of structures Part 2A: Bridges', issue 2, June 2010) includes a requirement for bridge examiners to record evidence of services below the road of overline bridges and any changes since the previous examination. Although there were repeated references in examination reports to subsidence in the footpath, the contractors who undertook bridge examinations on behalf of Network Rail did not record any observation of the presence of a water main in their reports. A buried water main in Grove Lane bridge is, however, listed in Network Rail's *National Hazard Directory* and there was an access chamber for a water main sluice valve in the footpath, approximately 7.5 metres from the area of subsidence (figure 8(a)).
