Rail Accident Report

**Train travelling with doors open on the Jubilee
line
1 September 2018**

Report 06/2019
July 2019

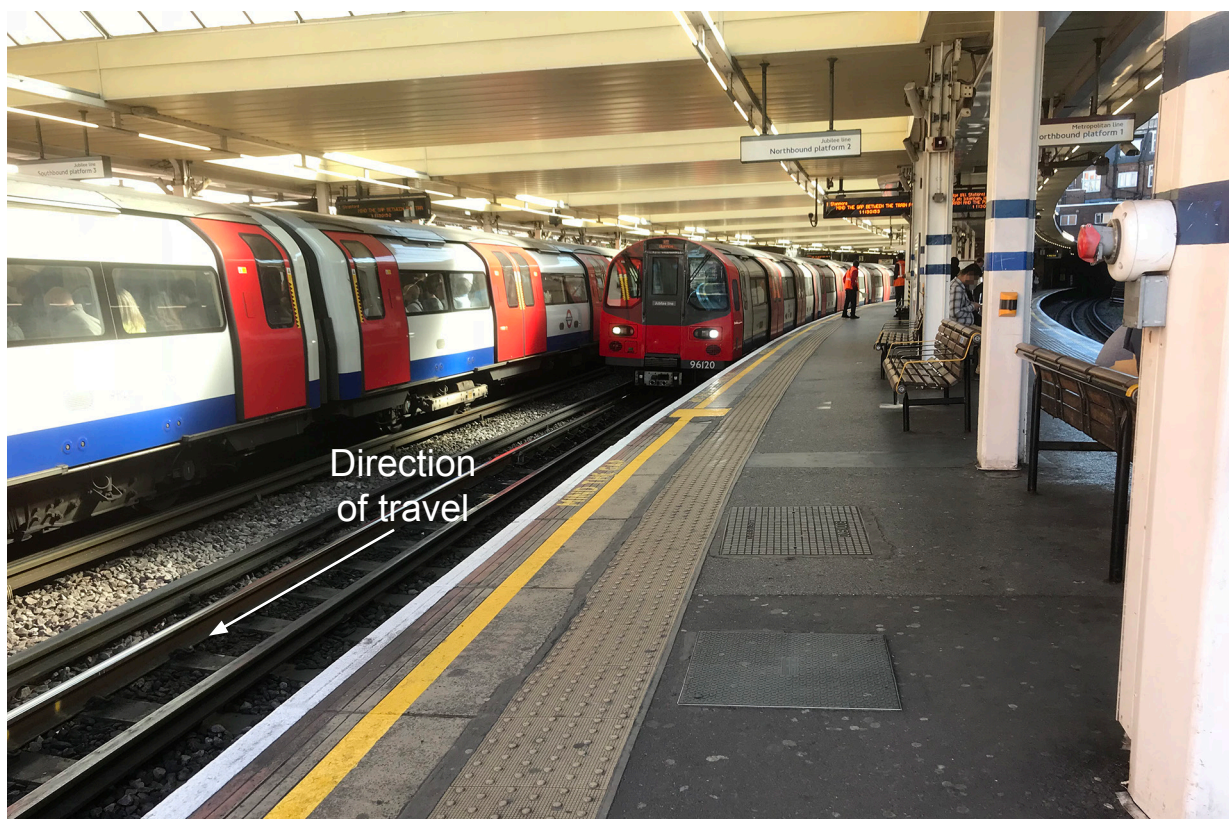
Figure 3: Platform 2 at Finchley Road

- 6 The incident happened on London Underground's Jubilee line which runs from Stratford in east London to Stanmore in north-west London (figure 2). Finchley Road station, West Hampstead station and the 600 metres of track between them are all on a surface section of the Jubilee line. London Underground's Metropolitan line runs adjacent to the Jubilee line between Finchley Road and West Hampstead stations (figure 2 inset). At Finchley Road station, northbound Jubilee line trains such as the train involved in the incident use platform 2, which was on the left-hand side of the train (figure 3). When stopping at West Hampstead station, the platform was on the right-hand side of the train.

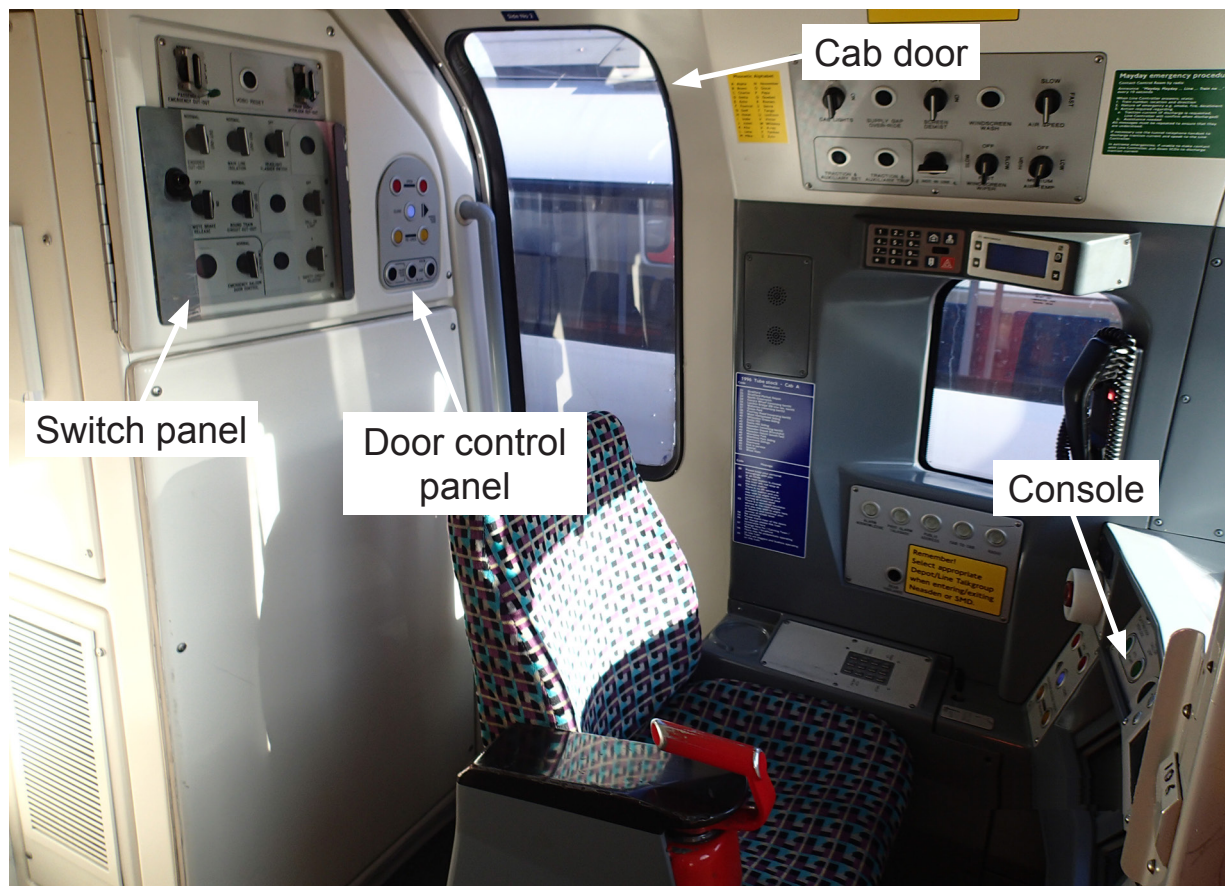
Figure 5: Driving cab

- 11 The train operator sits in the driving cab at the front of the train with a control console in front of them. This console includes the buttons normally used to operate the passenger doors, CCTV monitors and other train controls. A cab door is provided on both sides of the driving cab behind the driver. On the back wall of the driving cab, beside each cab door, are buttons for opening and closing the cab door and buttons sometimes used to operate the passenger doors. Adjacent to these buttons is a bank of bypass switches only used when responding to train faults (figures 4 and 5).

- 61 Both the ESDC and TDIC switches are part of the cut-out switch bank on the back wall of the driving cab, near the cab door which was adjacent to the platform (figures 5 and 10). However, there are significant differences between these switches; the TDIC switch is at a higher level and nearer the cab door than the ESDC switch. The TDIC switch is fitted with a flap and a seal in the form of a plastic tag which must be broken before the switch can be operated. The flap covers only the TDIC switch and must be lifted before the switch can be turned. The ESDC has no seal or individual flap. However, it can only be operated after opening a plastic door which covers most of the switch bank, but not the TDIC switch. This plastic door opens towards the driving cab door, which makes operating the ESDC switch from the doorway difficult.

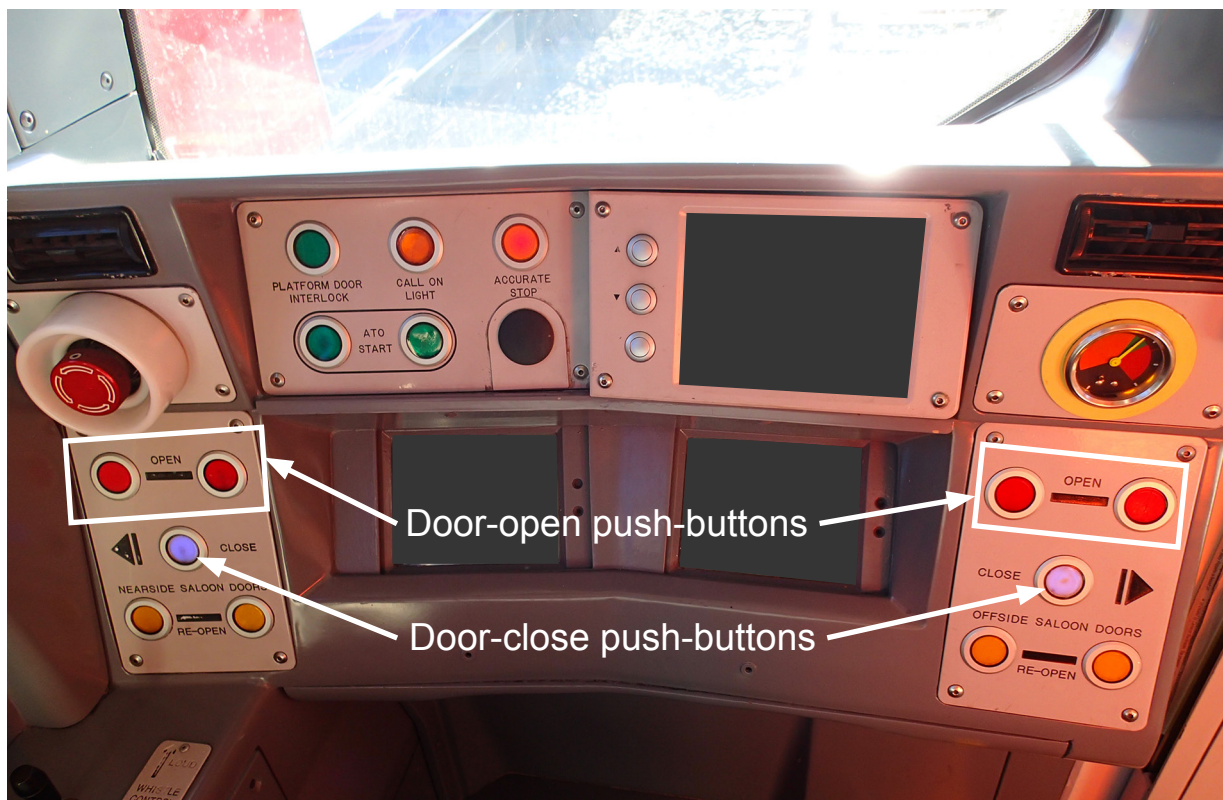
Figure 6: Train operator's passenger door-open and close buttons

- 12 The passenger doors are normally controlled by the train operator using two sets of buttons on the driving cab console (figure 6). The set on the left-hand side of the console operates doors on the left-hand side of the train, and the set on the right-hand side of the console operates the right-hand side doors. Each set includes two door-open buttons which must be pressed simultaneously before the doors open on the appropriate side of the train (this normally opens all doors immediately, but did not do so during the incident). The push buttons illuminate red as soon as they are pressed and remain illuminated until the door-close button is pressed.

- 13 Passenger doors are normally closed by the train operator pressing the door-close button on the console on the side for which door closure is required (figure 6). This normally closes all doors on that side of the train. Full closure of all doors completes the door interlock circuit, which causes the door-close buttons to illuminate blue; this indication is known as the doors closed visual (DCV). If any of the doors are not detected as fully closed, the DCV lights stay unlit. When the door-open buttons are pressed at a station the DCV blue lights go out.

- 68 Before starting a train, train operators are required to check the DCV lights are illuminated as confirmation that all doors are fully closed (figure 6 and paragraph 41). The train operator could not recall whether he checked the DCV lights before departing from Finchley Road, but stated that if he had seen they were not illuminated he would not have started the train. He also stated that he would have stopped the train if had he noticed that the DCV lights were not lit during the journey to West Hampstead.

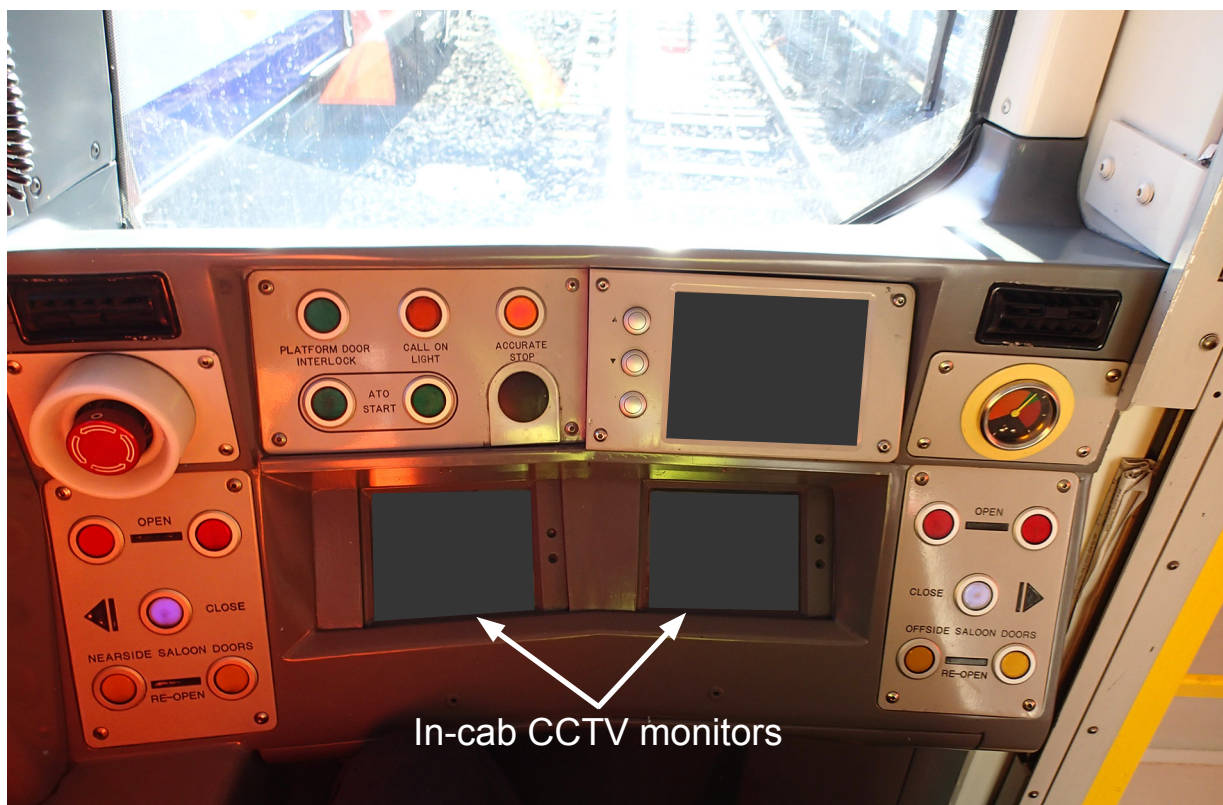
Figure 7: CCTV monitors on console

- 14 To assist train operators when deciding if it is safe to close the doors and when monitoring the platform edge as the train departs from a station, the console includes two CCTV monitors (figure 7). These monitors receive live images from CCTV cameras positioned along the platform. Each monitor shows two images such that the whole length of the side of the train alongside the platform is displayed over four images across the two monitors (figure 8).

72 The train operator recalled having to use his hands to shield the in-cab CCTV monitors from sunlight when checking if it was safe to start the train, and during the time the train was leaving the platform (paragraph 14). Post-incident observations by the RAIB at a similar time of day to that of the incident showed that sun glare made it difficult to see the side of the train on the CCTV monitors (figure 15).

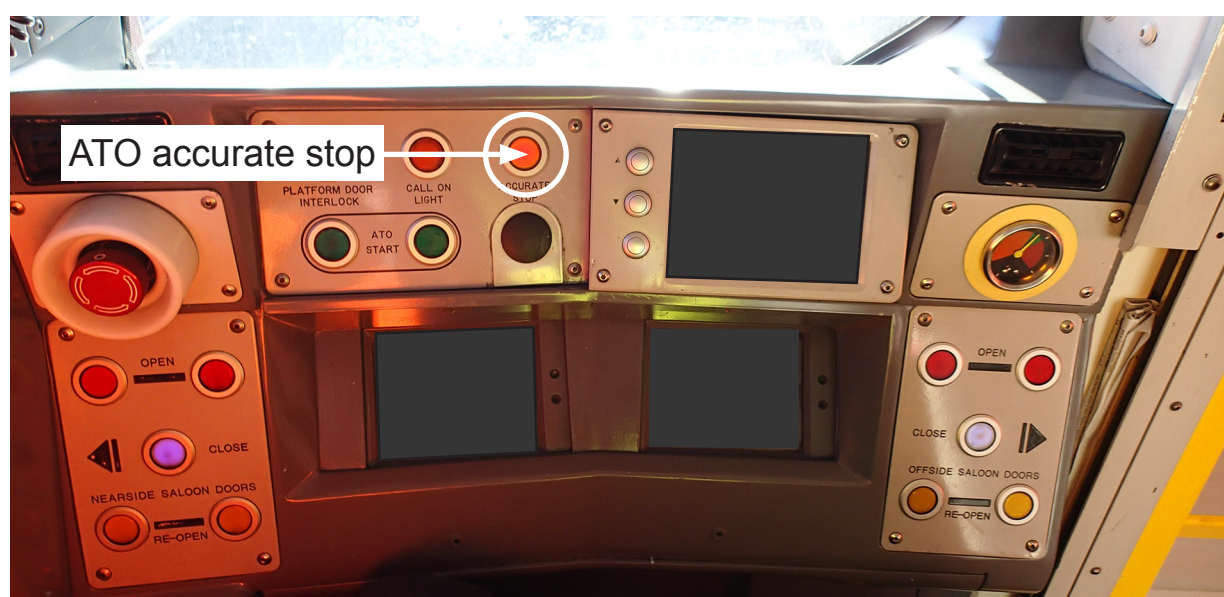
Figure 13: ATO accurate stop indicator

- 37 In normal ATO operation, the train stops automatically at the correct location, and this is confirmed by an accurate stop detection system, consisting of equipment fitted to the train and on the track, which causes a yellow 'accurate stop' light to illuminate on the train operator's console (figure 13). The train operator then opens the passenger doors on the appropriate side of the train.

- 39 In some instances trains do not stop accurately and the yellow light will not illuminate. LUL stated that this happens at about 0.017% of station stops. In these circumstances train operators are trained to open the cab door to check whether the train has stopped with all passenger doors alongside a part of the platform where they can be used safely by passengers.

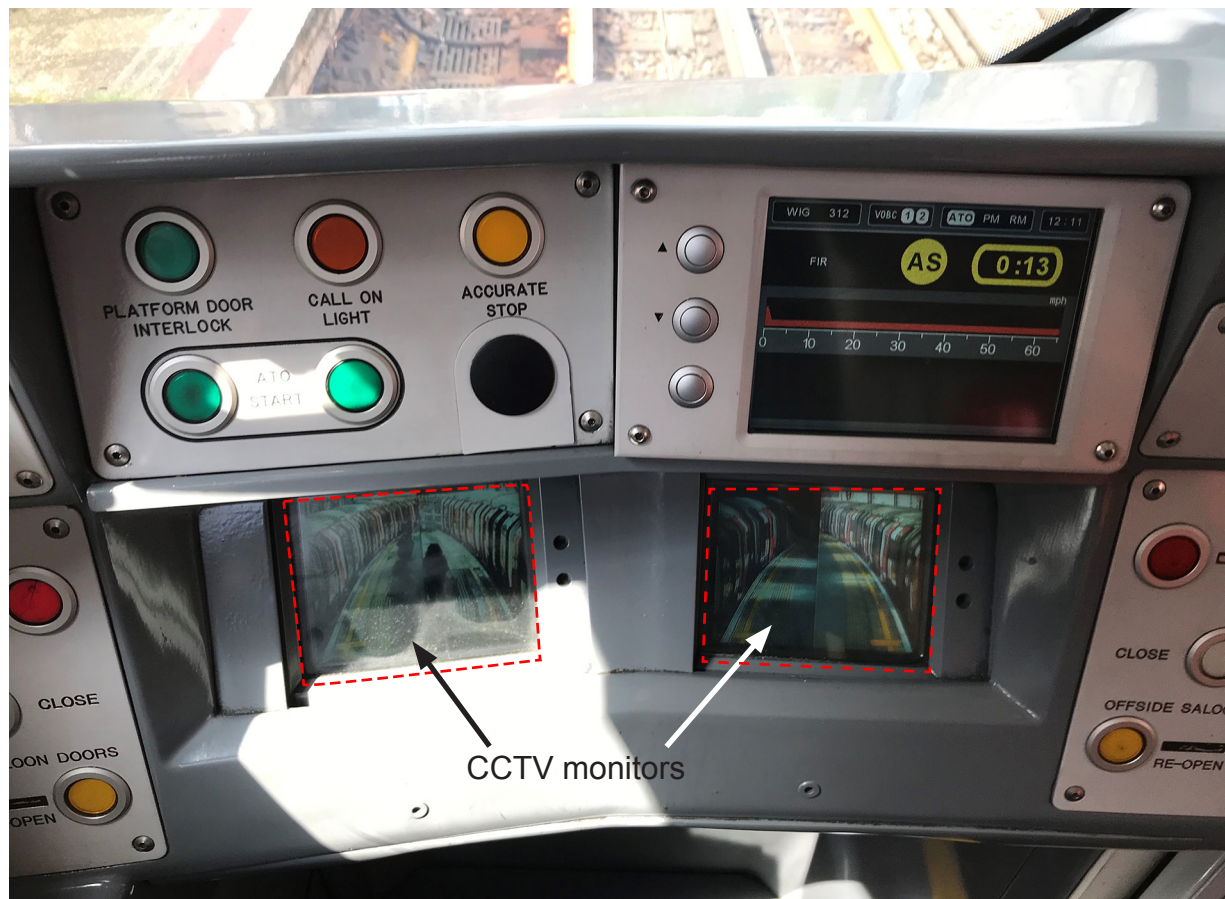
Figure 16: In-cab CCTV monitors showing longitudinal images of the side of a train

- 73 The CCTV cameras are positioned to provide the best view along the side of the train (figure 16) so that the train operator can see if anyone is trapped in a door or in an unsafe position relative to the side of the train. There is no requirement for CCTV cameras to be aligned to directly facilitate seeing whether train doors are open.

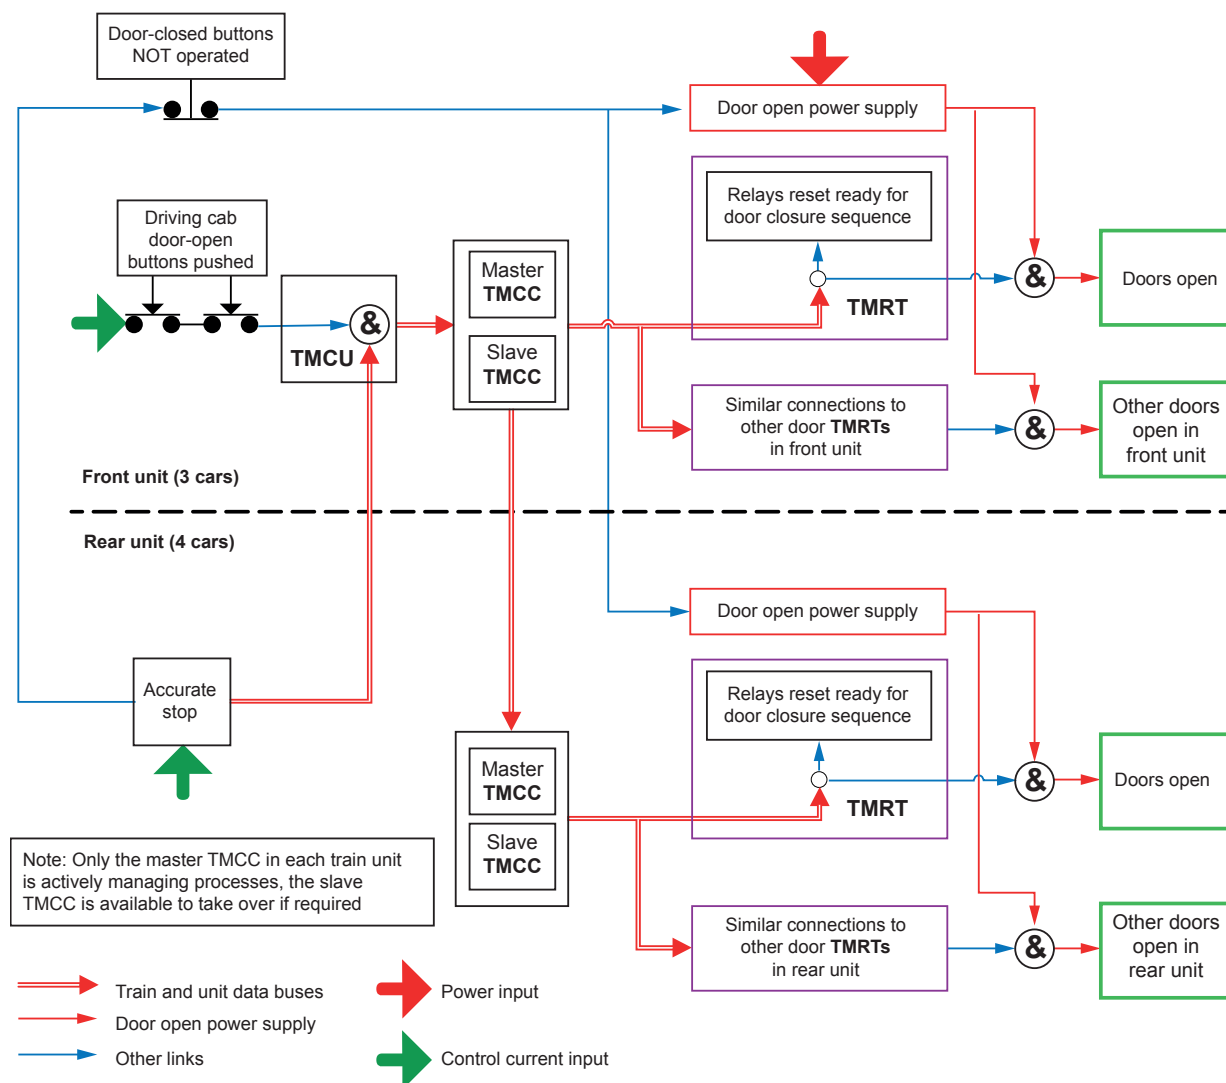
Figure C1: Door opening system, normal operation with train stopped accurately (simplified)

- C24 LUL has been unable to recreate the exact status of the control equipment during the Finchley Road incident, and so was unable to establish with certainty the effect of correctly following the procedures, including operation of the ESDC switch, intended to be applied by train operators dealing with doors not opening and closing when expected.

- C25 Post incident testing by LUL found that some local door-open buttons were defective. Some button defects had the same effect as keeping a button permanently pushed. Other faults meant that the intended effect of pushing a button was not achieved. In default passenger mode, the first of these defects would cause the associated doors to open as soon as power was available to open them. The second type of defect meant that passengers pressing a button would not open the associated doors.
