# Rail Accident Report

**Runaway of ‘ironmen’ trolleys and subsequent  
near miss at Raven level crossing, Garnant,  
Carmarthenshire  
1 November 2014**

Report 13/2015  
August 2015

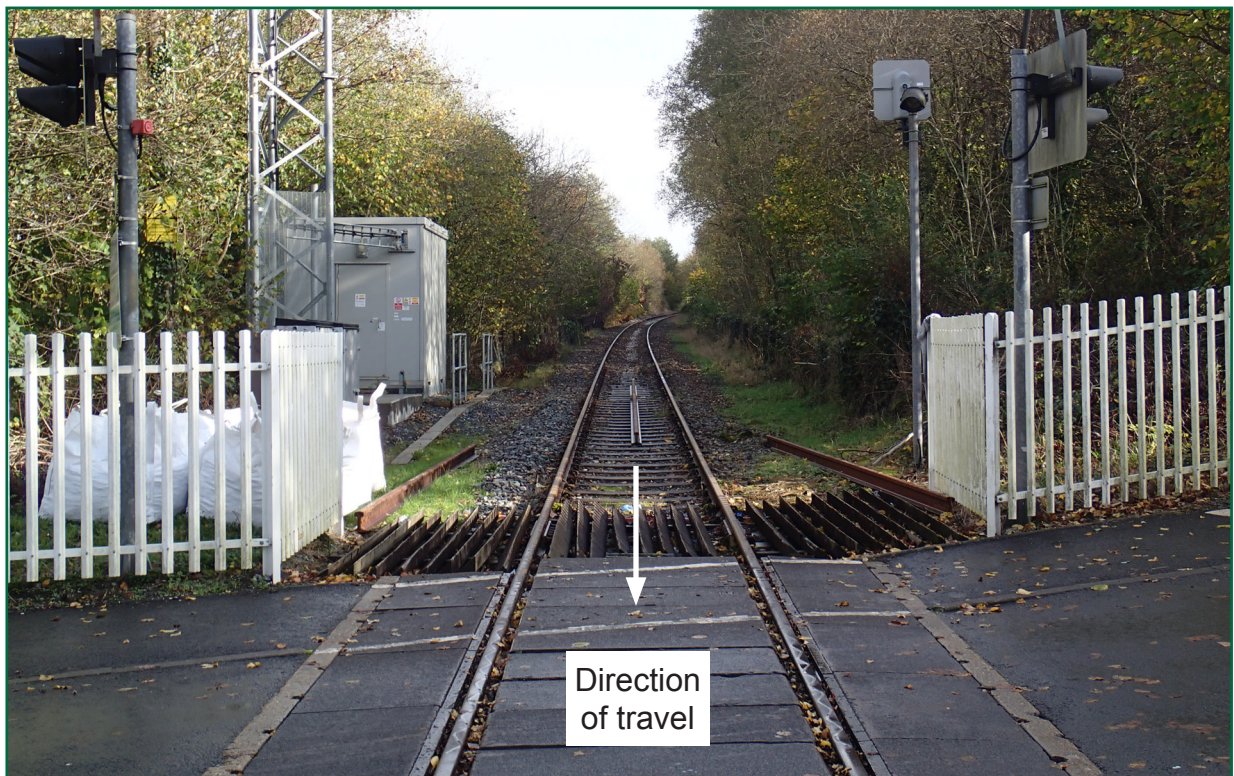
- 5 Following the loss of control of the rig, the two track workers rode on the ironmen in order to shout a warning to colleagues who were working in the *four foot* at Raven level crossing (figure 3). The warning provided just enough time for their colleagues to get clear of the line. The two track workers then jumped off the ironmen just before the crossing, receiving minor injuries; one was taken to hospital and was later discharged.

Figure 3: Raven level crossing looking towards GCG

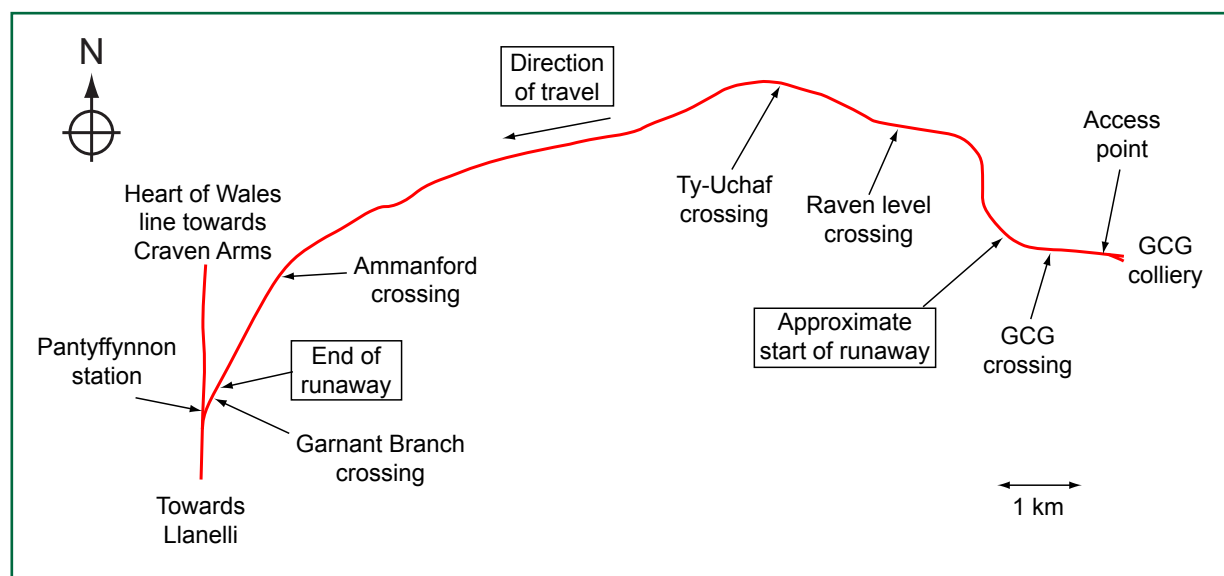
- 4 There were two Network Rail track workers with the pair of ironmen and the length of rail (figure 2), subsequently referred to as the rig. The track workers lost control of the rig shortly after passing GCG level crossing; it then ran along the Garnant Branch line for approximately 5.4 miles (8.7 km) before it was stopped by a Network Rail manager near Garnant Branch level crossing. In addition to Raven level crossing, the rig ran over three road crossings, two of which were open to road traffic, three *user worked crossings* and four footpath crossings. The RAIB estimates that it reached a maximum speed of 19 mph (30 km/h) and that it ran over the four road crossings at speeds of between 15 and 17 mph (24 and 28 km/h)<sup>1</sup>.

Figure 4: Garnant Branch, showing path of the runaway ironmen on 1 November 2014

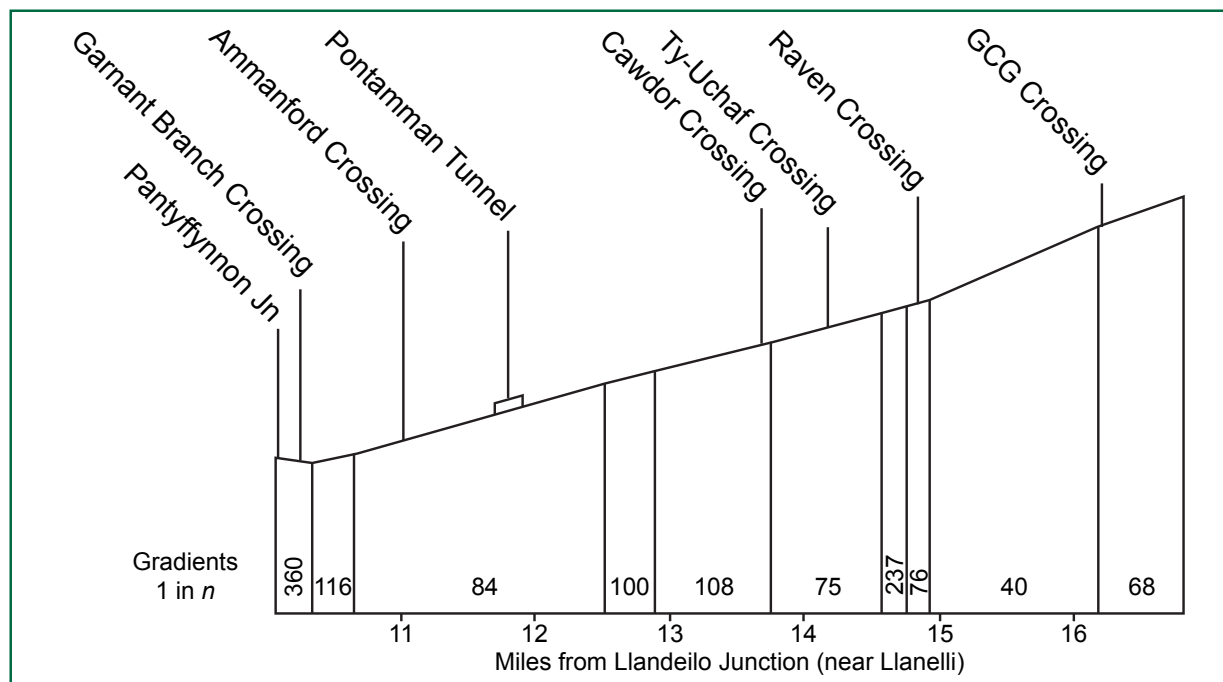
- 7 The line descends through a height of 150 metres from GCG to Pantyffynnon, which is equivalent to an average gradient of 1 in 69. The gradient for the 1.3 miles (2.1 km) between GCG and Raven level crossings averages 1 in 40 (figure 5)<sup>2</sup>; this is the section on which the track workers lost control of the ironmen.

<sup>2</sup> Note: the RAIB has measured the average gradient over 1.9 km of this section as 1 in 39, rather than the 1 in 40 shown in figure 5.

Figure 5: Gradient map of Garnant Branch line (source: Network Rail)

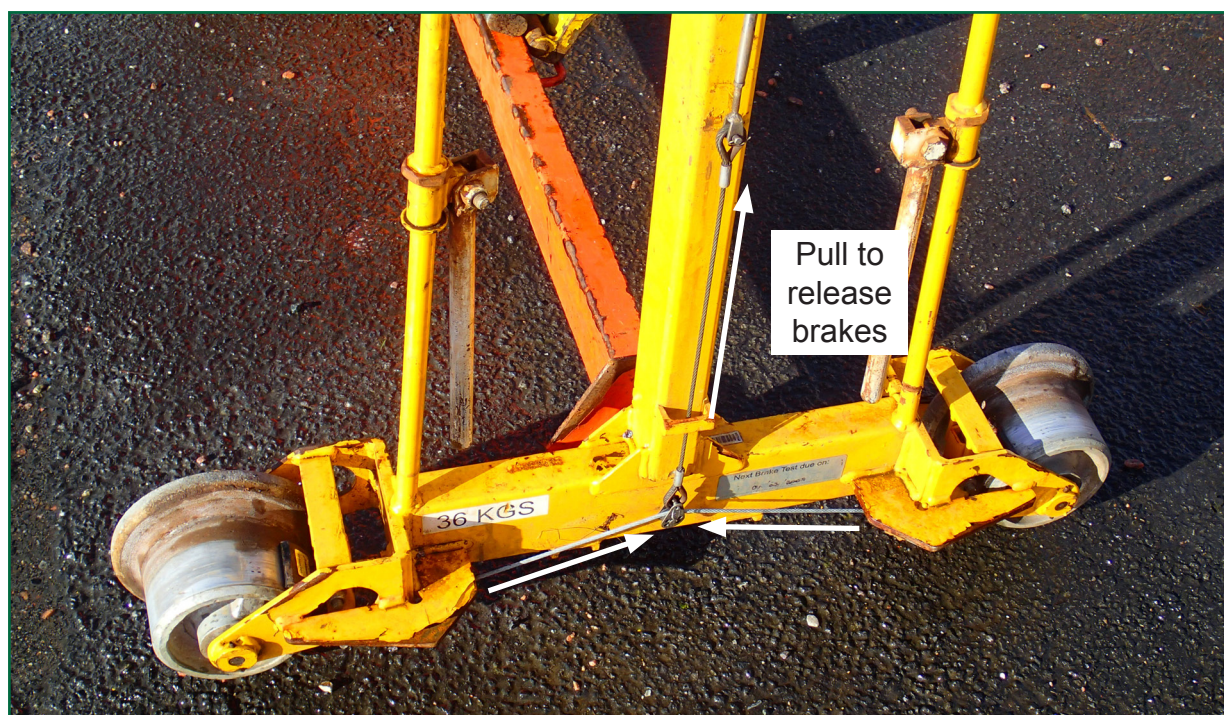
G1 Both wheels on one side of an ironman are braked. Permaquip's user guide MAN/M/O/105 describes the ironman brake as 'fail safe'. The brake force is provided by a spring that holds a brake pad against the tread of each braked wheel, resulting in a torque that resists rotation of the wheel. When the operator depresses the brake handle, it pulls a vertical cable upwards, increasing the tension in a horizontal cable (figure G1). In turn, this pulls the brake pads away from the wheel treads (figure G2). The effective length of the vertical cable can be altered by adjusting a turnbuckle, which has locknuts top and bottom.

Figure G1: Braked wheels of ironman, showing vertical and horizontal cables; tension in these cables releases the brakes

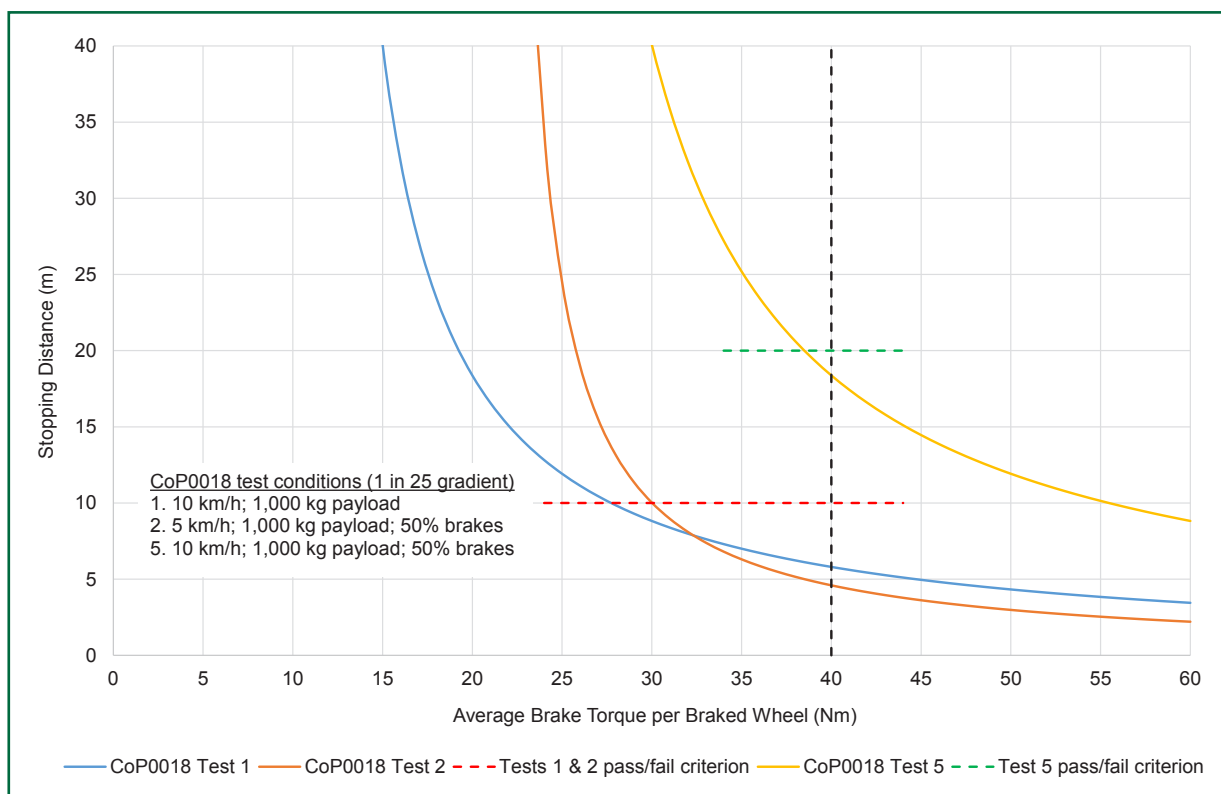
The stopping distance is dependent on the brake torque. This is affected by a number of factors, including the cable adjustment, the coefficient of friction between the brake pad and the wheel tread (which is a function of the roughness of both surfaces) and the spring rate. The RAIB has estimated the relationship between torque and stopping distance for the Permaquip ironman using the conditions defined in CoP0018 (figure G3). This demonstrates that reductions in brake torque result in disproportionate increases in the stopping distance. Network Rail observed this effect when it carried out testing of ironmen brake performance following the runaway on 1 November 2014.

Figure G3: Relationship between torque and stopping distance

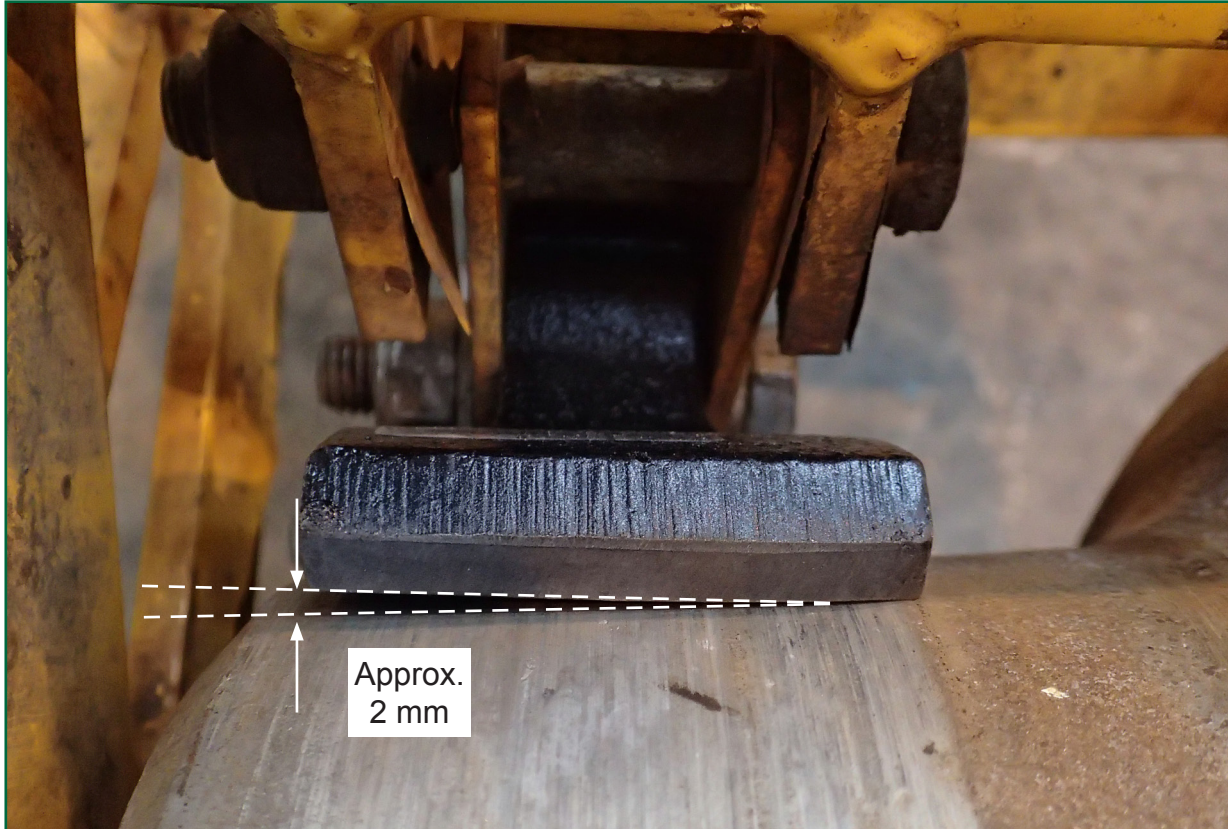
- G3 Permaquip's user guide MAN/M/O/105 sets out the requirements for maintenance of the braking system. These include a requirement that the brake pads should be completely clear of the wheels when the brake handle is held fully down, and in full contact with the wheels when the brake handle is released. However, with new brake pads fitted, there is a gap of typically 2 mm at the outside edge of the brake pad (figure G4) because the wheel is tapered and the brake pad is not. Permaquip has been unable to explain why the pad is not designed to sit flush against the wheel tread.

Figure G4: Alignment of new brake pad with wheel tread
