Rail Accident Report

Derailment at Porthkerry, South Wales 2 October 2014

> Report 10/2015 August 2015

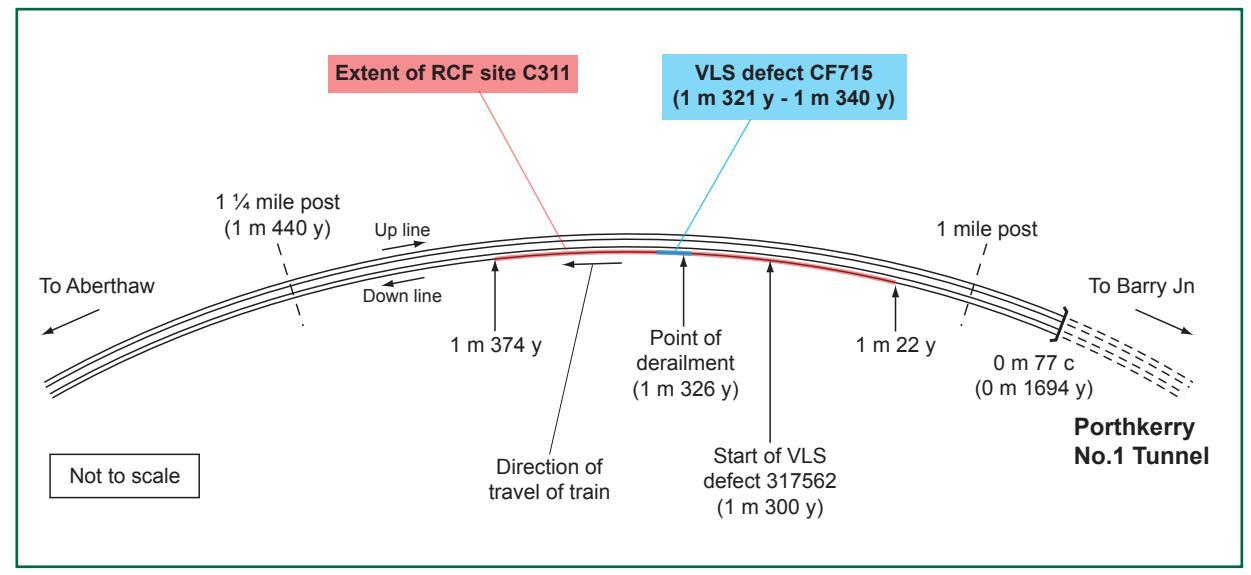
Figure 3: The layout of the key features at the derailment site (see text for meaning of features)

7 The derailment occurred as the train was travelling on the down line round a left-hand curve on a rising gradient. The point of derailment was at mileage 1 mile 326 yards, measured from a zero datum at Barry Junction. The maximum permitted speed at this location is 50 mph (80 km/h).

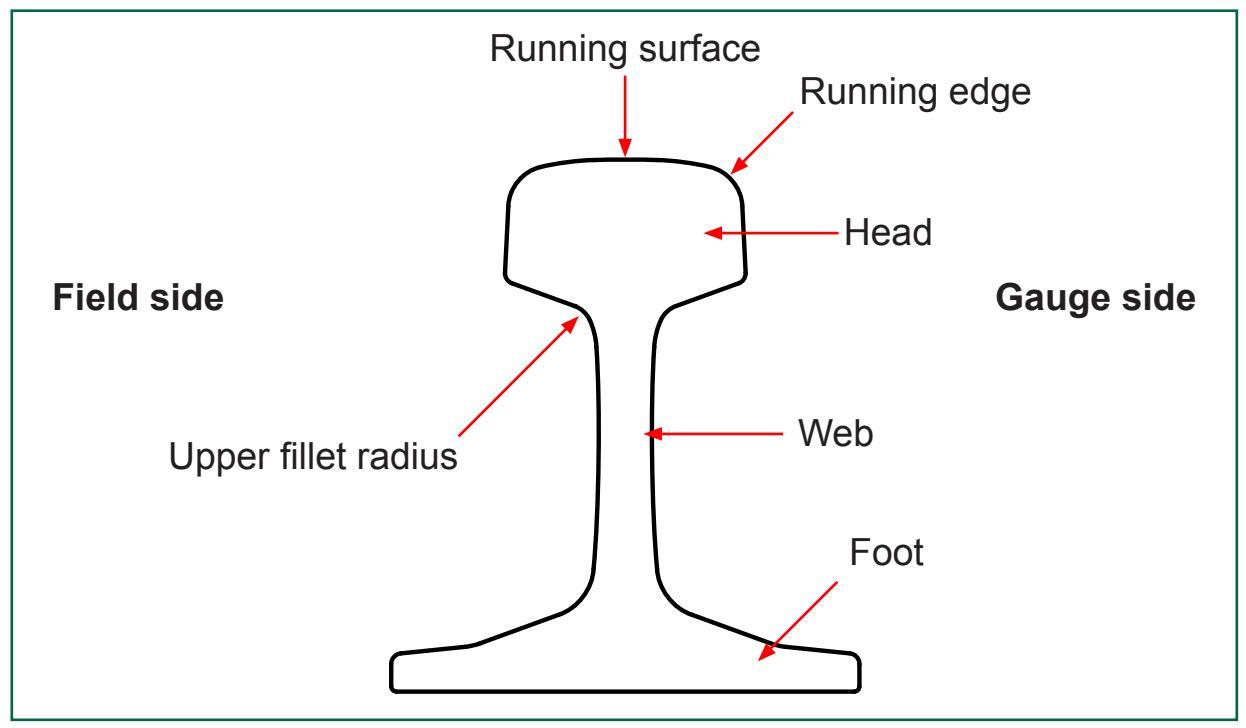
Figure 5: Nomenclature of rail

- 24 The front of the train passed the site of the derailment travelling at 16.5 mph (26.5 km/h) and the locomotive and the first 19 wagons passed over the defective rail without incident.
- 25 As the 20th wagon ran onto the defective left rail, the *field side* of the rail head (figure 5) broke away from the rest of the rail. The weight of the wheels pressed the *gauge side* of the head down so that the wheels ran on the web of the rail. When examined by the RAIB after the derailment, the wheels on the left side of the 20th wagon (rear bogie) and 21st wagon (leading bogie) had marks on the tread consistent with them having run on a sharp edge, such as would be presented by the broken top surface of the rail web.

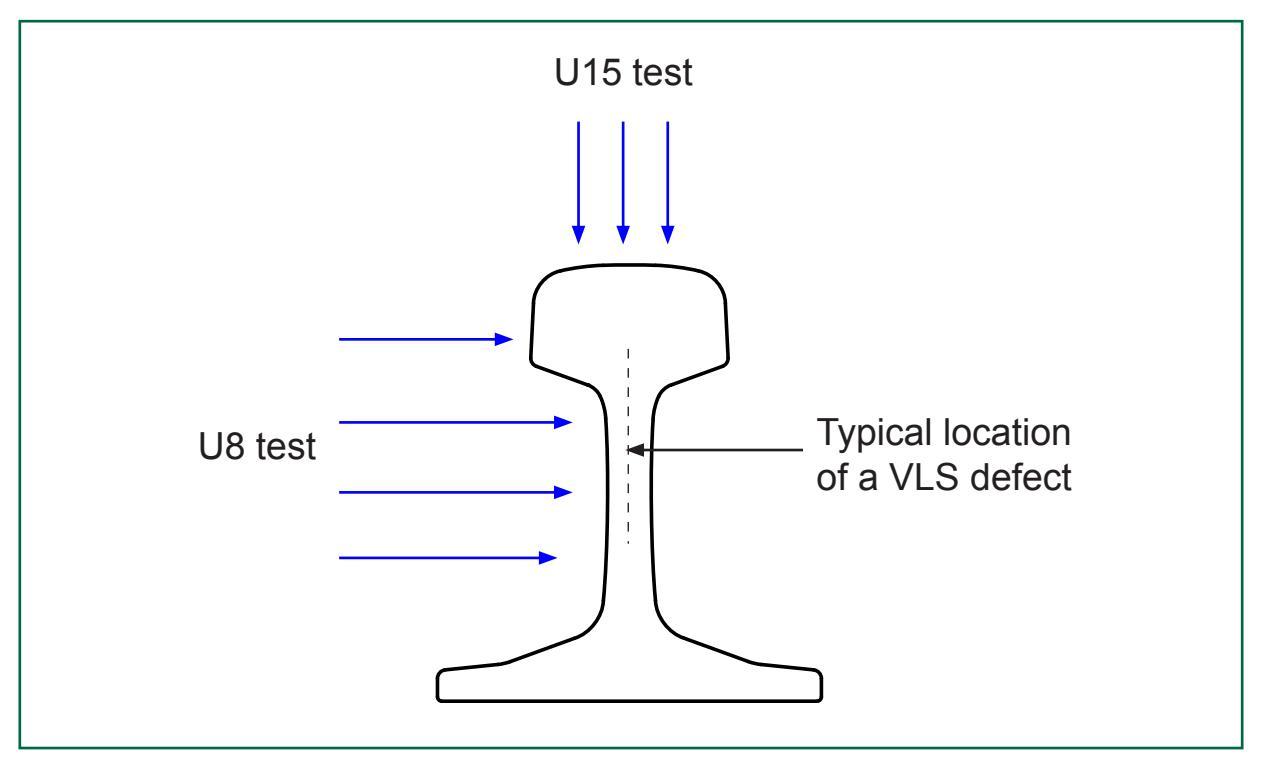
Figure 7: Direction of ultrasound in U8 and U15 tests

48 The standard ultrasonic test for rails is known as U15¹, and is carried out with a set of ultrasonic probes on top of the rail looking at various angles down into the rail (figure 7). This test can be done from the UTU or by pedestrian testing. As the U15 test looks down from the top of the rail, VLS defects can be difficult to spot as they are aligned with their smallest dimension, their width, facing the ultrasonic beams. If a VLS defect is suspected, another test can be performed, U8, from the side of the rail. This test uses a hand-held probe to look sideways through the rail head and web. Any VLS defect would be perpendicular to this direction making it easy to spot in the ultrasonic response. As it requires a probe on the side of the rail, U8 testing cannot be performed from a UTU.

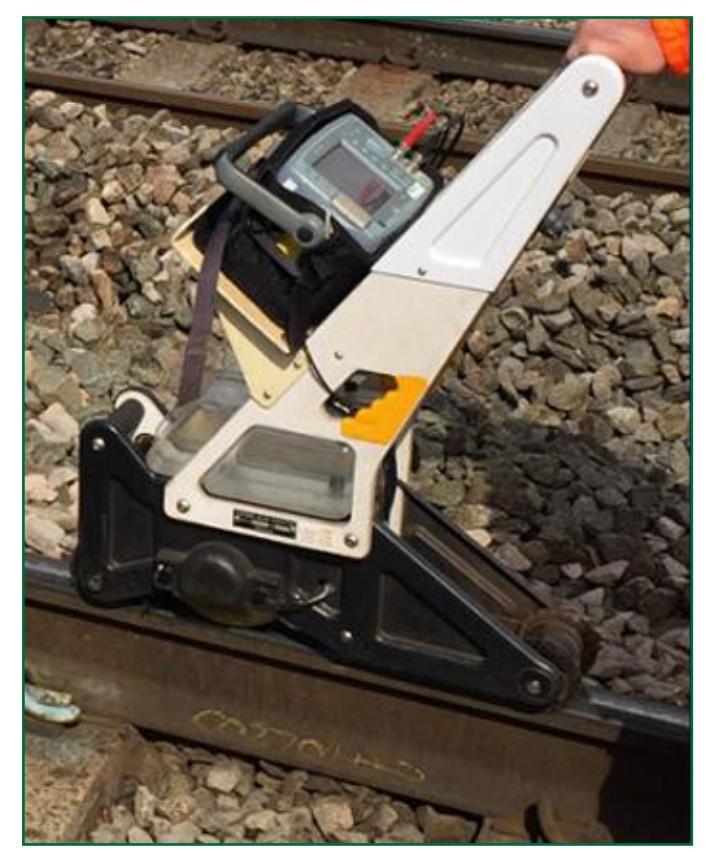
Figure 8: Sperry ultrasonic 'walking stick'

- 58 The RCF inspections involved the use of pedestrian ultrasonic test equipment, known as the Sperry 'walking stick' (figure 8). This is fitted with double flanged wheels to guide the ultrasonic test wheel along the head of the rail.

- 59 During some of the RCF inspections the rail was found to be deformed such that a lip had developed on the field side. This lip made the rail head wider and, in some locations, prevented the walking stick from being pushed over it, as the flanges on each side of its wheels were not far enough apart to cope with the width of the lipped rail. When this was found to be the case the tester reported on the test report sheet that the rail was ultrasonically untestable due to head profile. The rail defects standard, NR/L2/TRK/001 mod07 defines the action that must be taken in these circumstances, which is to replace the rail or reprofile the rail head (by grinding) and retest it within 4 weeks.

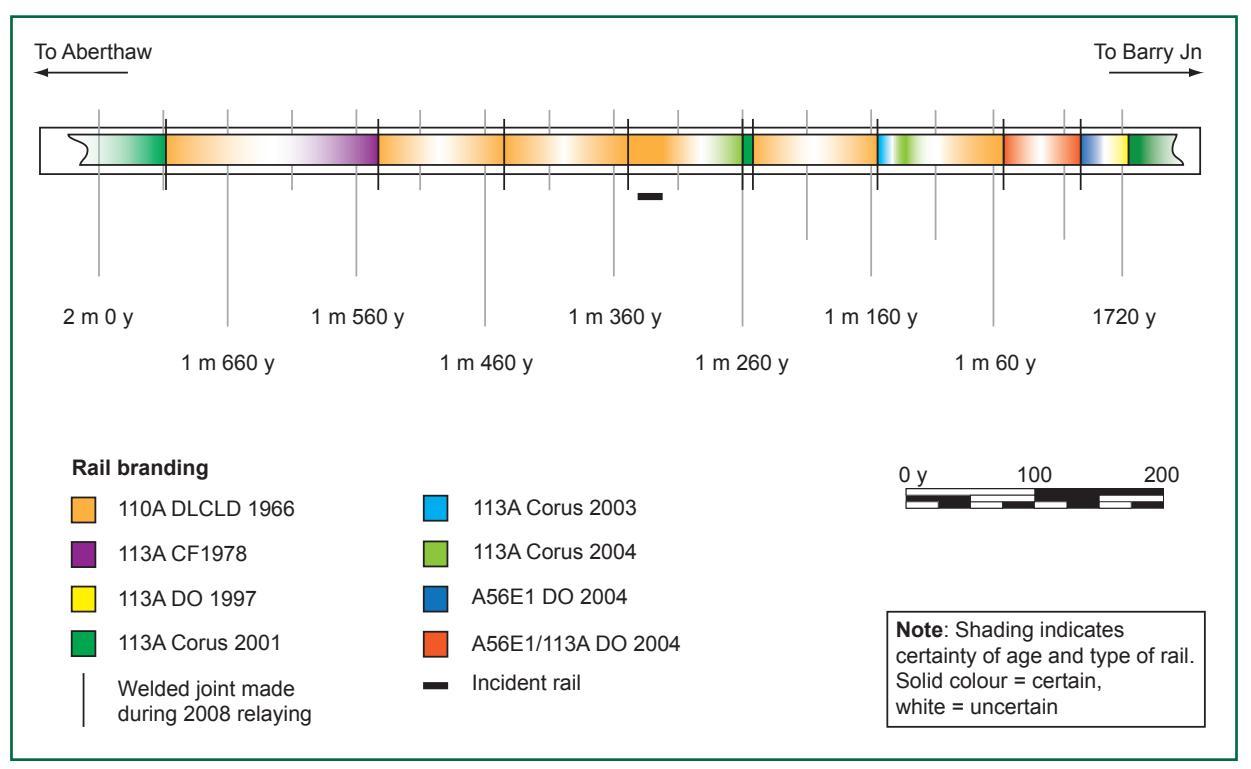
Figure 14: Plan of left-hand rail at Porthkerry showing rail type and age

77 The health and safety file also contained copies of weld inspection certificates for the rail welds made during the relaying work. These gave details of the type and profile of the rails joined along with the position of the weld along the track. The RAIB used the information on these certificates to produce a graphical representation of the age and profile of the left (low) rail (figure 14). This showed that the predominant rail type was normal grade BS110A rolled in 1966. There was only one grade of rail specified in the British Standard for rail (BS11:1959, 'Flat Bottom Railway Rails') in 1966, and this corresponded to the modern 'normal' grade, but amendment 2 to that standard in January 1964 stated that the chemical composition and properties required from the steel should be agreed between the manufacturer and customer. It is possible that British Railways agreed improved properties with Dorman Long for these rails because, when tested by the metallurgist, the chemical composition was found to be close to the modern *'wear resisting A' grade*.

- 78 In addition to the BS110A rail, the weld certificates also recorded lengths of newer rail of normal grade BS113A section. Contrary to what was declared on the plain line GEOGIS/Construction details form (paragraph 76), no lengths of 1977 rail were recorded on the welding certificates.
- 79 The health and safety file did not record where any of the rail had been used before its installation at Porthkerry in 2008. Network Rail has been unable to provide the RAIB with any indication of the rail's previous use. However, given the age of the rail when it was installed at Porthkerry and its subsequent relatively rapid collapse, the RAIB has concluded that it is likely to have been used on a relatively lightly loaded line.

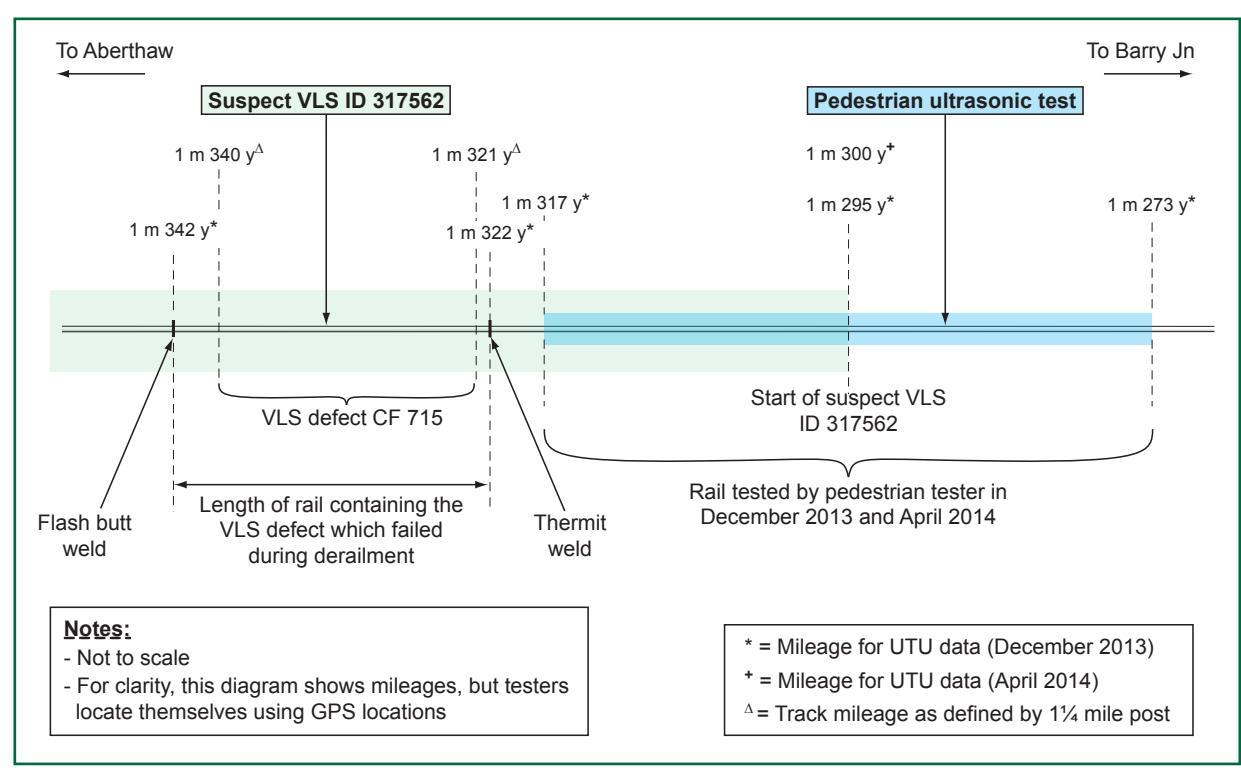
Figure 15: Diagram showing relative position of features on left-hand rail of down line

105 The process which Network Rail usually employs to identify VLS defects in rail is by dedicated visual inspection (paragraph 91). However, when the down line at Porthkerry was declared an RCF site in August 2012 (paragraph 57), an additional series of regular inspections was begun with the aim of monitoring the progression of the RCF. These included both visual and ultrasonic inspection of the rail. They were carried out by the ultrasonic inspection team, who reported via the section manager (rail testing and lubrication) to the rail management engineer until May 2014, and the Newport track maintenance engineer from then on.

- 106 The RCF inspection on 30 July 2014 found the VLS defect (paragraph 62) and assigned it identity 'CF715'. Details of it were input to the rail defect management system. Standard NR/L2/TRK/001 mod07 specifies the minimum action to be taken on discovery of rail defects. The action for a VLS in the head or web of the rail depends on whether the rail shows signs of the split widening; if there are signs, defined as the head spreading by 2 mm or more or there being visible cracking on the surface of the rail, the minimum action is '1B'. Action 1B means that an immediate 20 mph emergency speed restriction should be imposed and the rail should be replaced within 7 days. If there are no signs of the split widening, the action is less urgent and depends on the track category; for the track at Porthkerry the minimum action was '3M', which, for category 4 track, is to retest the rail at 104 week intervals. However, Wales Route had a policy of not leaving defects in track indefinitely (paragraph 51) and, where the minimum action was '3M', applied the next highest action, '3L', which is to remove the defect within 52 weeks.

- 107 The RCF inspection on 30 July 2014 did not identify any spreading of the head or cracking of the rail due to the VLS, so the action assigned was '3L'. The poor condition of the rail head due to the RCF and the lipping on the field side of the rail head would have obscured visual evidence of head widening. The metallurgical examination of the rail (paragraph 68) revealed that the VLS crack had not reached the rail head, but had broken through to the surface at the upper fillet radius (figure 5). The inspector stated that he used calipers to measure the head width below the lipping and he did not find it was spread by as much as 2 mm. The inspector also stated that he looked for cracking beneath the head of the rail and did not see any evidence of this. The cracking at this position was difficult to identify without conducting non-destructive testing (paragraph 113).
