Rail Accident Investigation Branch

Rail Accident Report

Derailment of a passenger train at Ealing Broadway 2 March 2016

Report 24/2016
December 2016

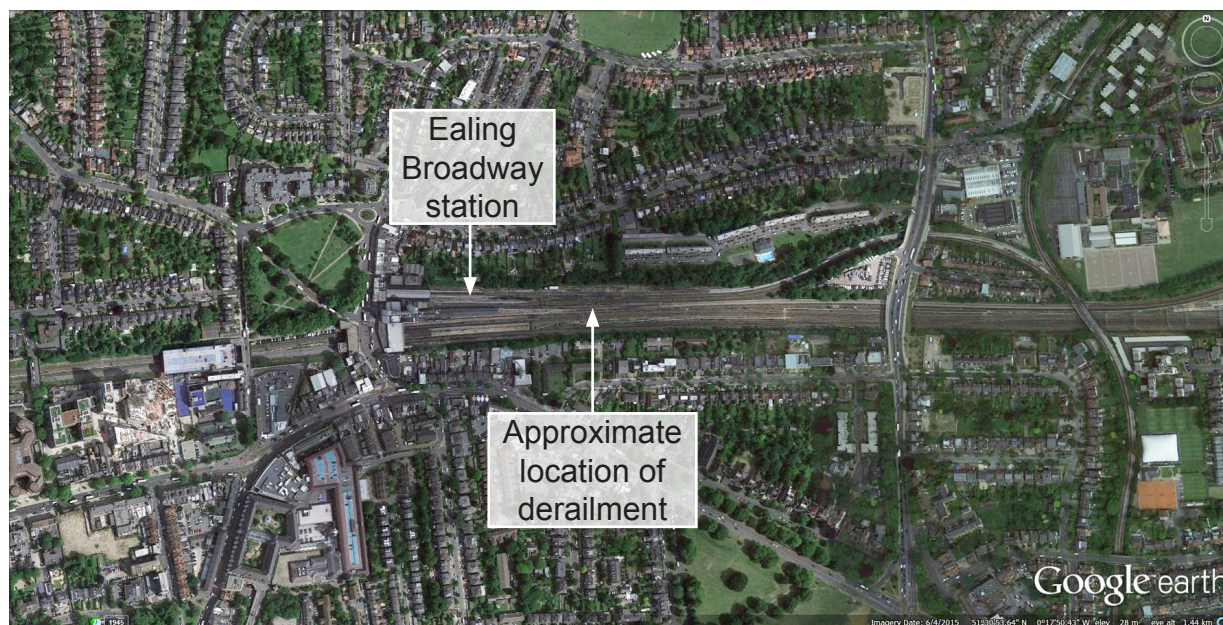
- 3 At 01:29 hrs on 2 March 2016, all wheels of the leading *bogie* of a London Underground District line train became derailed on *points* just outside Ealing Broadway station, London (figure 1). The train was travelling at less than 5 mph (8 km/h) at the time of the derailment.

Figure 1: Image from Google Earth showing Ealing Broadway station and the approximate location of the point of derailment

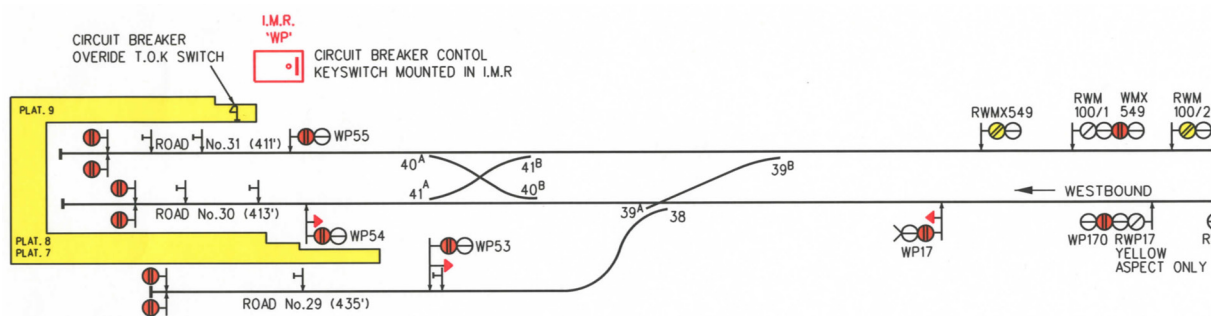
Figure 3: Extract from the Traffic Controller's Diagram showing the track layout at Ealing Broadway

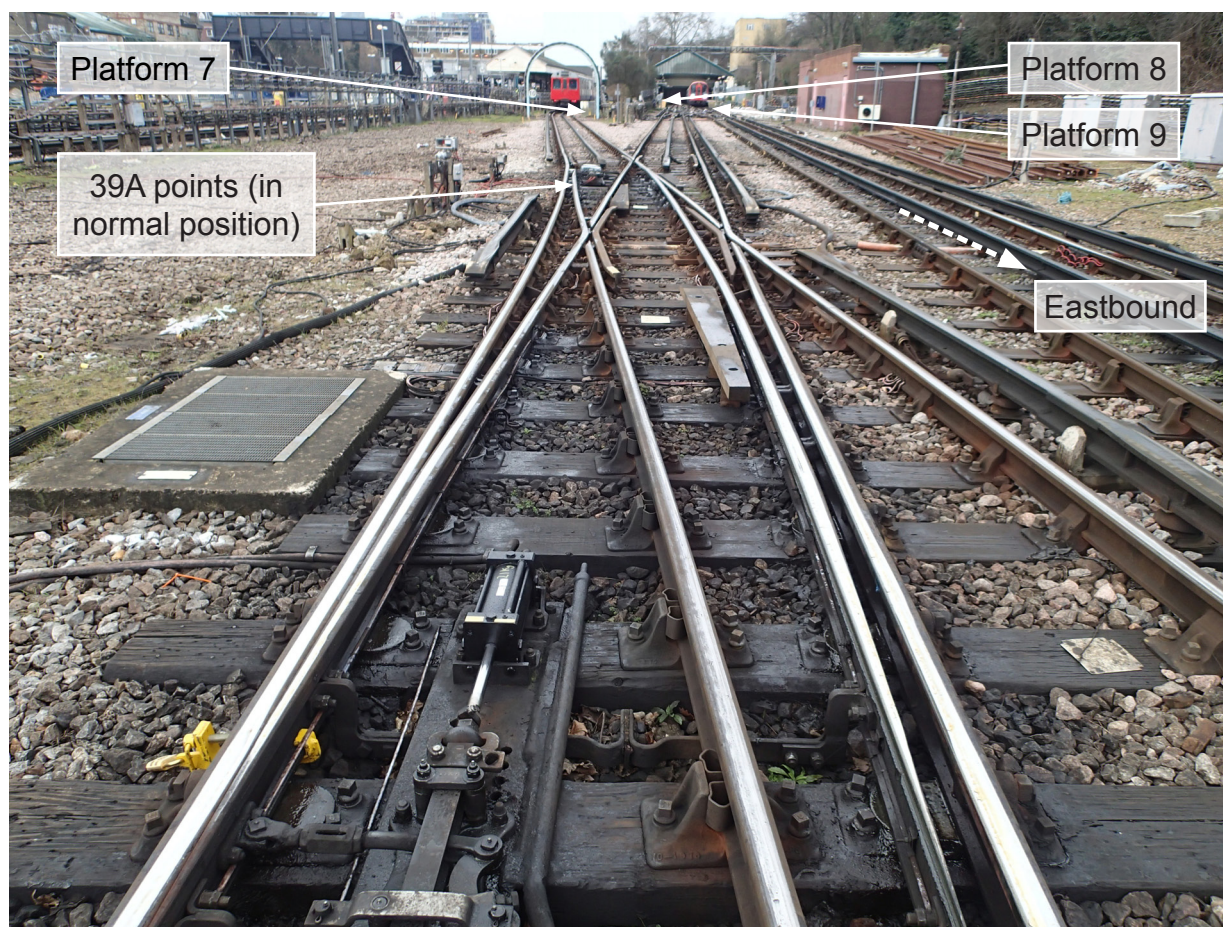
- The derailment occurred at 39A points, about 74 metres east of platform 7 at Ealing Broadway station, which is an above-ground station, and is the western terminus of the District line.

Figure 4: Showing the track layout from the east end of 38 points looking towards Ealing Broadway station. The train to the left is at platform 7 and the one to the right is at platform 9.

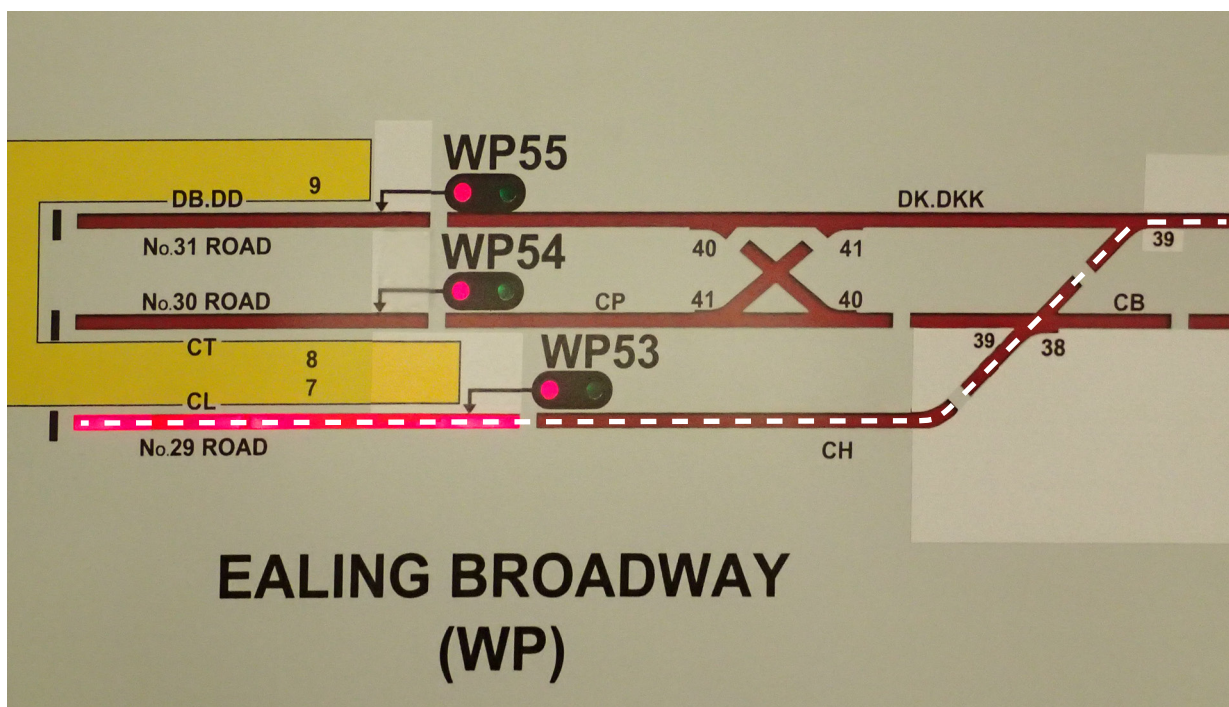
- 38 On 1 March 2016, the District line train service ran normally through the day until soon after midnight. At 00:31 hrs on 2 March, track circuit CB failed to revert to unoccupied after the passage of train 064 from platform 7 at Ealing Broadway to the eastbound line (figure 7). This movement required 39A and 39B points to be in the reverse position, and the failure of the track circuit meant that the points remained in this position.
- 39 The train operator of train 010 brought the signaller's attention to the failure when he reported the fact that the *platform starter* signal WP54 was not cleared for his train to depart from platform 8.

Figure 7: The signaller's overview panel showing the route train 064 took from platform 7 to eastbound line, the location of CB track circuit and signal WP54
