# Rail Accident Report

**Self-detrainment of passengers onto lines that were still open to traffic and electrically live at Lewisham, south-east London  
2 March 2018**

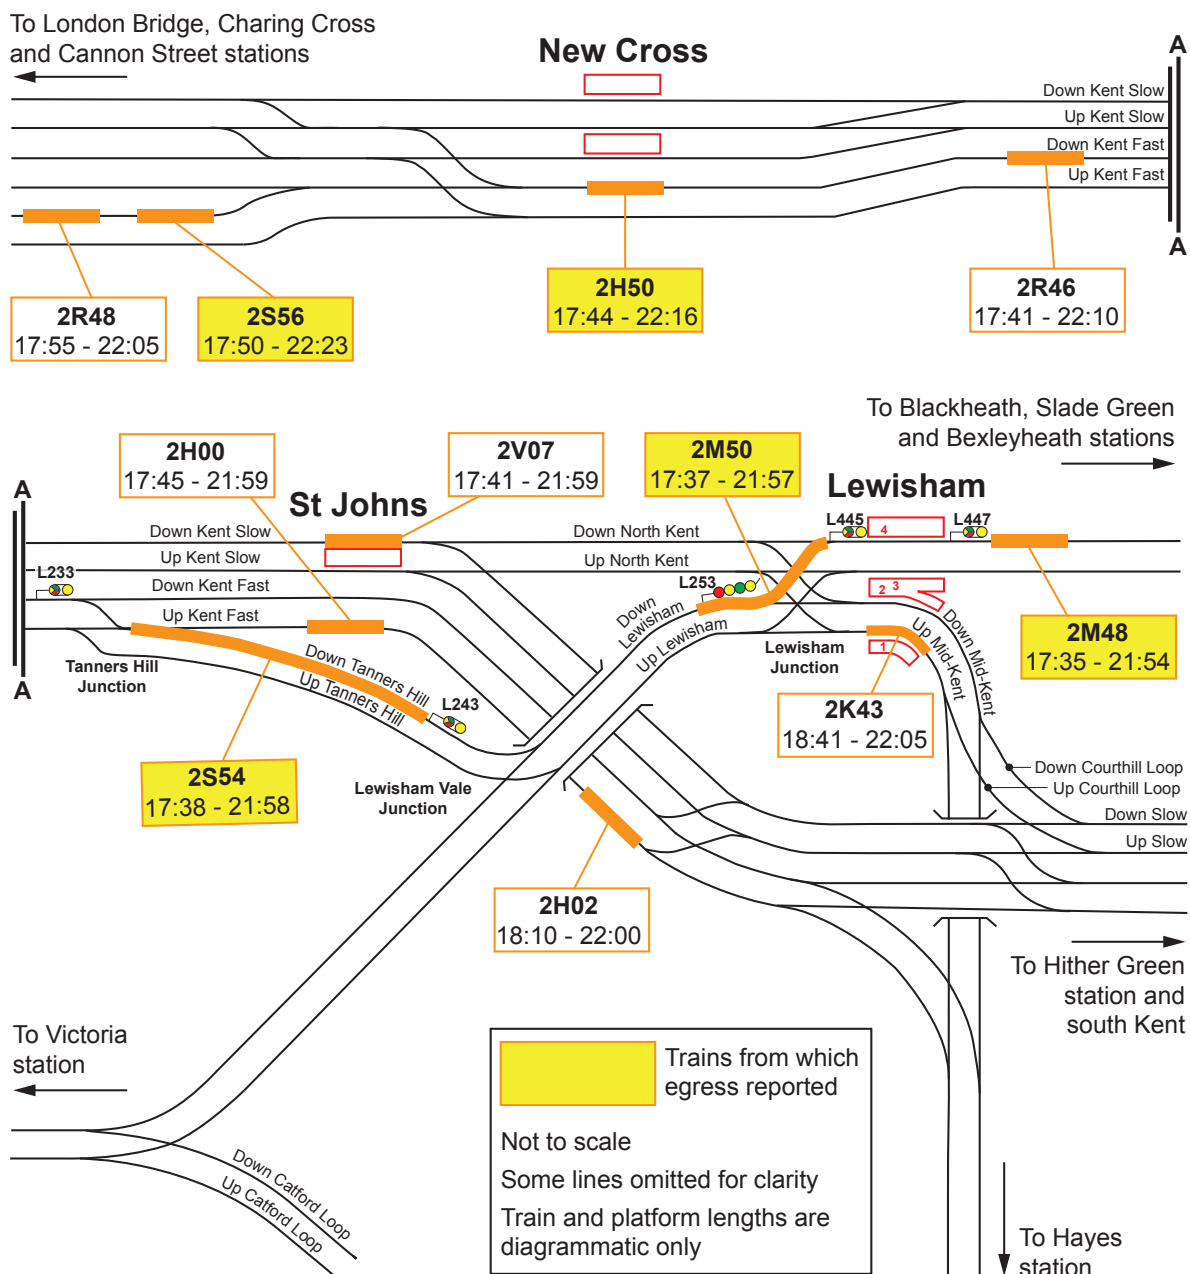
- 4 Platform 4 at Lewisham station is on the Down North Kent line. Trains 2M48 and 2M50 had been routed there from the Down Kent Fast line, via Tanners Hill Junction, the Down Tanners Hill line, Lewisham Vale Junction, the Down Lewisham line and Lewisham Junction. When train 2M50 was standing at L445 signal, it was occupying Lewisham Junction and extended back to the signal on the approach of the junction, L253 signal. This prevented train 2S54, which followed it, being able to proceed beyond L243 signal on the Down Tanners Hill line. Because of its length, the back of train 2S54 blocked Tanners Hill Junction, which prevented trains passing on either the Up Kent Fast line or the Down Kent Fast line. The result was that, within 18 minutes of train 2M50 stopping at L445 signal, a total of ten trains had come to a stand (figure 2). Only one of these was in a station platform<sup>2</sup>.

Figure 2: Track layout of Lewisham station and the lines approaching from London. The figure shows the key signals, the position of the stranded trains and the time over which they were at a stand, and where passenger egress was reported.

- 166 A total of ten trains became stranded as a direct result of the problems encountered by train 2M48 at Lewisham (paragraph 4). The majority were unable to move for around four and a half hours, and records indicate that passengers got out and went on to the track from at least five of them (figure 2). Although conductor rails were only electrically live when the first passengers on trains 2M50 and 2S54 got out, the detraining of a large number of passengers onto the track is, in general, potentially unsafe, particularly in wintry conditions. Passengers climbed down from open train doors in the dark, many unaided and some carrying their possessions, onto terrain that was covered with snow which hid inherent slip, trip and fall hazards. Therefore, it is fortunate that there were no instances of serious injury.

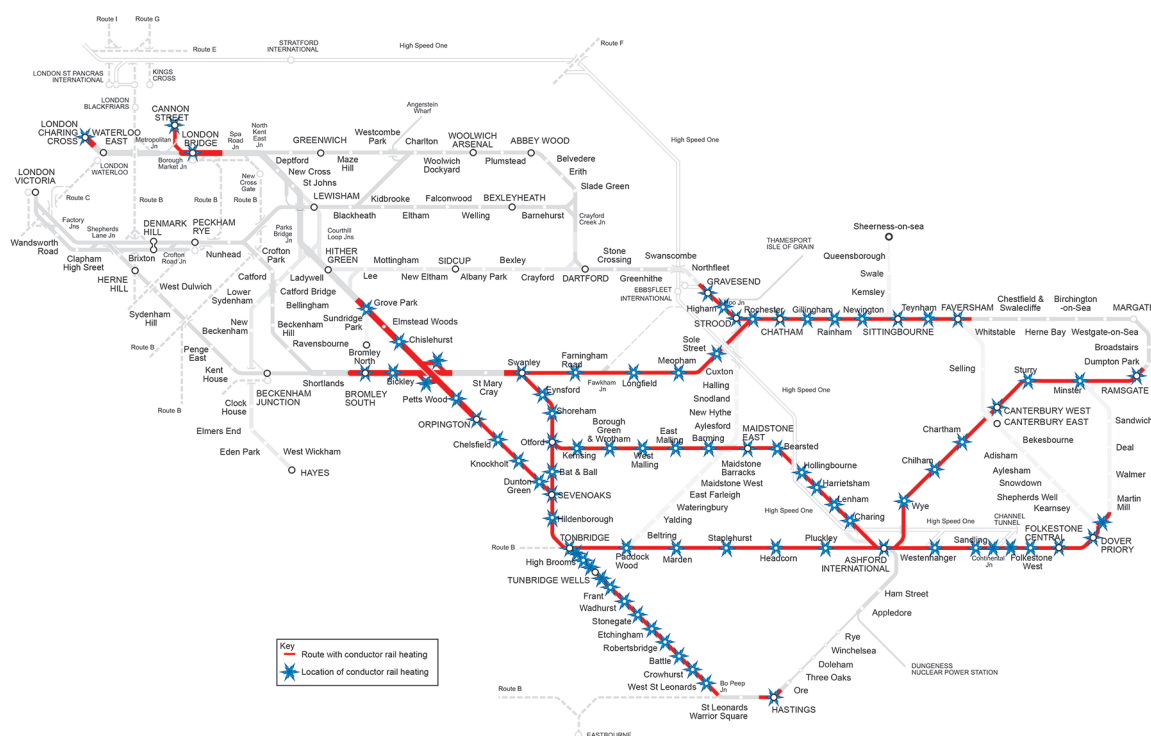
Figure 17: Map showing the location of conductor rail heating in the Kent Area (map courtesy of Network Rail)

- 111 On 2 March 2018, Network Rail advised that traction problems had been experienced at locations where conductor rail heating was installed. This suggests that the ice accumulation at Lewisham may have been particularly severe on that day. Although standard conductor rail heating may not have overcome all the traction difficulties encountered by train 2M48, its provision on the Down North Kent line in platform 4 is likely to have been beneficial in the circumstances.

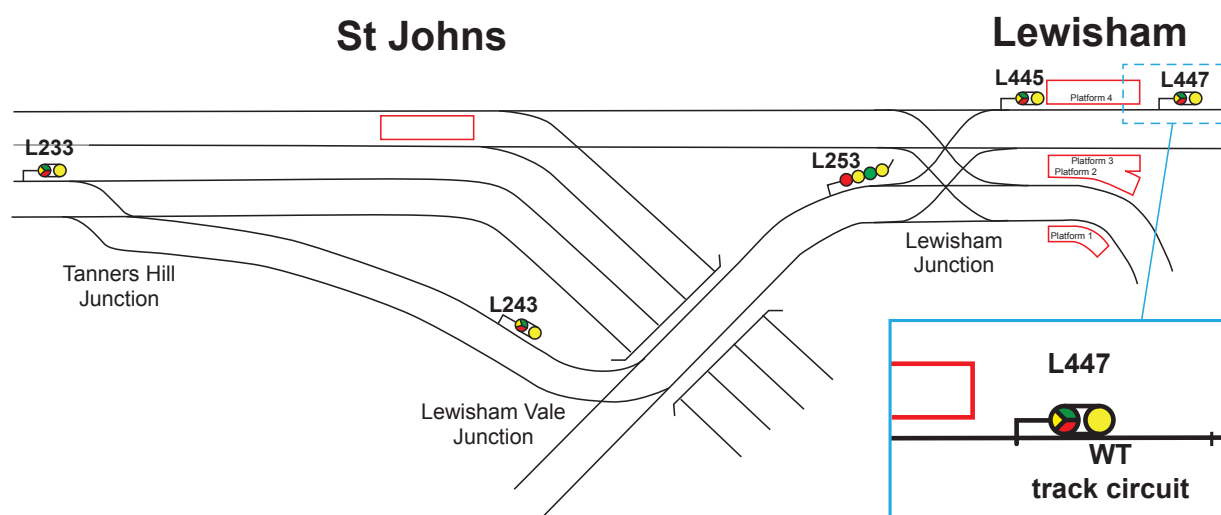
133 Train 2M50 was not held at a signal that would have allowed it to be subsequently diverted onto an alternative line.

Figure 19: Signalling layout at Lewisham station

135 In what would have been routine, Signaller 1 routed train 2M50 so that it closely followed train 2M48 into Lewisham by manually setting a route as far as L253 signal. L253 signal has an automatic working facility that signallers use to aid route setting into platform 4 (footnote 8). There is evidence that this facility was selected<sup>27</sup>. This meant that the signalling system automatically extended the set route so that trains could reach platform 4 without the signaller needing to take further intervention. To have prevented the train being able to pass L253 signal the signaller would have needed to de-select the automatic working facility. The signalling data logs showed Signaller 1 set the route for train 2M50 around four minutes after train 2M48 had started to depart and two minutes after he had received a call from the driver of train 2M48 that he was having traction difficulties (paragraph 61). Shortly afterwards the signaller set the route for train 2S54 to approach L243 signal, following train 2M50 onto the Down Tanners Hill line (paragraph 62).
