# Rail Accident Report

## **Collision at Plymouth station 3 April 2016**

Report 02/2017  
February 2017

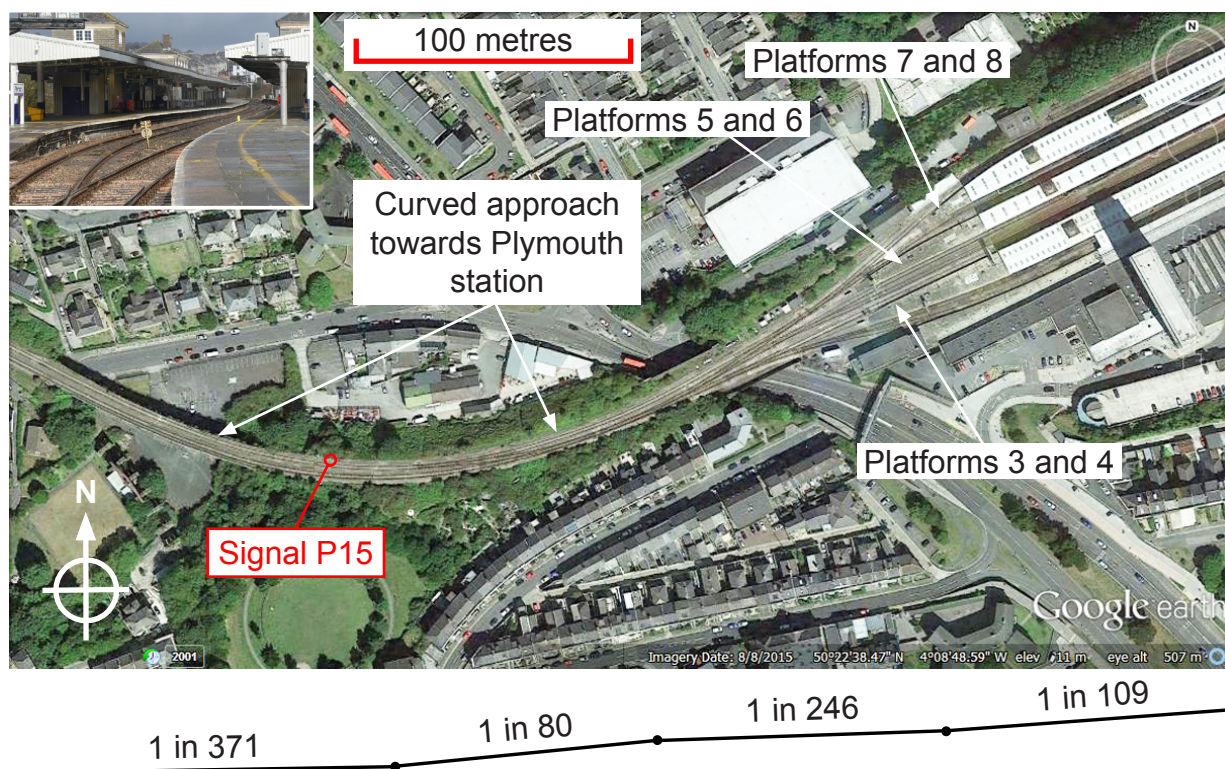
Figure 3: Plymouth station approach showing track curvature, gradients and platform curvature (inset image)

- 7 A maximum permitted speed of 25 mph (40 km/h) applies to trains approaching platforms 4, 5, 6, 7 and 8 from the west. Trains approaching from this direction have to negotiate an uphill gradient (about 1 in 80 at its steepest) and a left-hand curve, this becomes a right-hand curve as trains enter platforms 6, 7 and 8 (figure 3).

- 70 The presence of track curvature, vegetation and railway buildings (figures 3, 4 and 12) meant that the driver of 2E68 could not see platforms 7 and 8, and so could not establish the location of platform 6 by counting across from platform 8, until about 13 seconds (125 metres) before the collision. Counting at this stage would have revealed that train 1A91 was in platform 6 and would have given the driver sufficient time to stop his train safely. He did not count platforms at this stage because he had concluded that there was insufficient room for his train to share the platform occupied by train 1A91, and so had discounted the possibility of his train being routed into this platform. Although the driver of train 2E68 was competent to drive the route to Plymouth, he was still gaining practical experience driving it. It is possible that a more experienced driver would have recognised that train 1A91 was occupying platform 6 in time to prevent a collision (paragraphs 66 and 67).

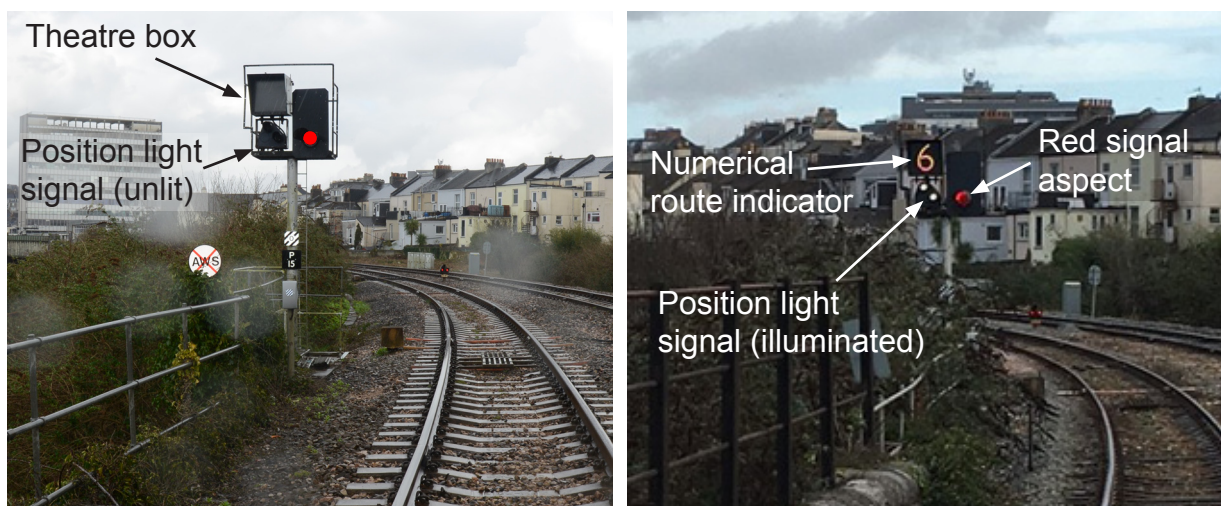
Figure 5: Signal P15 showing a stop indication (left image) and a permissive working authority towards platform 6 (right image)

- 15 Train movements approaching Plymouth station from the west (the route followed by train 2E68) are controlled by signal P15. This signal is located 270 metres from the western end of platform 6. It moved to its current position in the late 1980s and the signal's head (displaying the coloured lights) was replaced in 2007<sup>2</sup> with a light emitting diode type signal head (known as LED). Signal P15 is capable of signalling trains into any of the platforms at Plymouth. When displaying a proceed indication, the appropriate platform number is displayed adjacent to the signal head (figure 5).
- 16 If a platform is already occupied, another train can be signalled into the same platform under permissive working arrangements (paragraph 32). In these circumstances signal P15 will display two white lights (known as position lights), at an angle of 45° adjacent to the red aspect.

- 17 There is no evidence that the functioning of signal P15 was a factor in the accident. Although the signal was re-positioned before the current Railway Group standard was introduced, the distance of 270 metres between the signal and the platform is compatible with Railway Group standard GK/RT0044 'Controls for signalling a train onto an occupied line'. The December 2014 version of this standard required the distance to be 'minimised, as far as reasonably practicable', and the previous version (February 2000) required that the spacing 'shall not be greater than 400 metres'.

- 33 Where permissive working is authorised, distinctive signals are provided. Signal P15 approaching Plymouth is of this type (paragraph 16, figure 5). When the position lights illuminate at this type of signal, a train is allowed to proceed past the red *main aspect*. In these circumstances, the railway rulebook<sup>4</sup> states that 'The driver must be prepared to stop short of any train, vehicle or obstruction'.

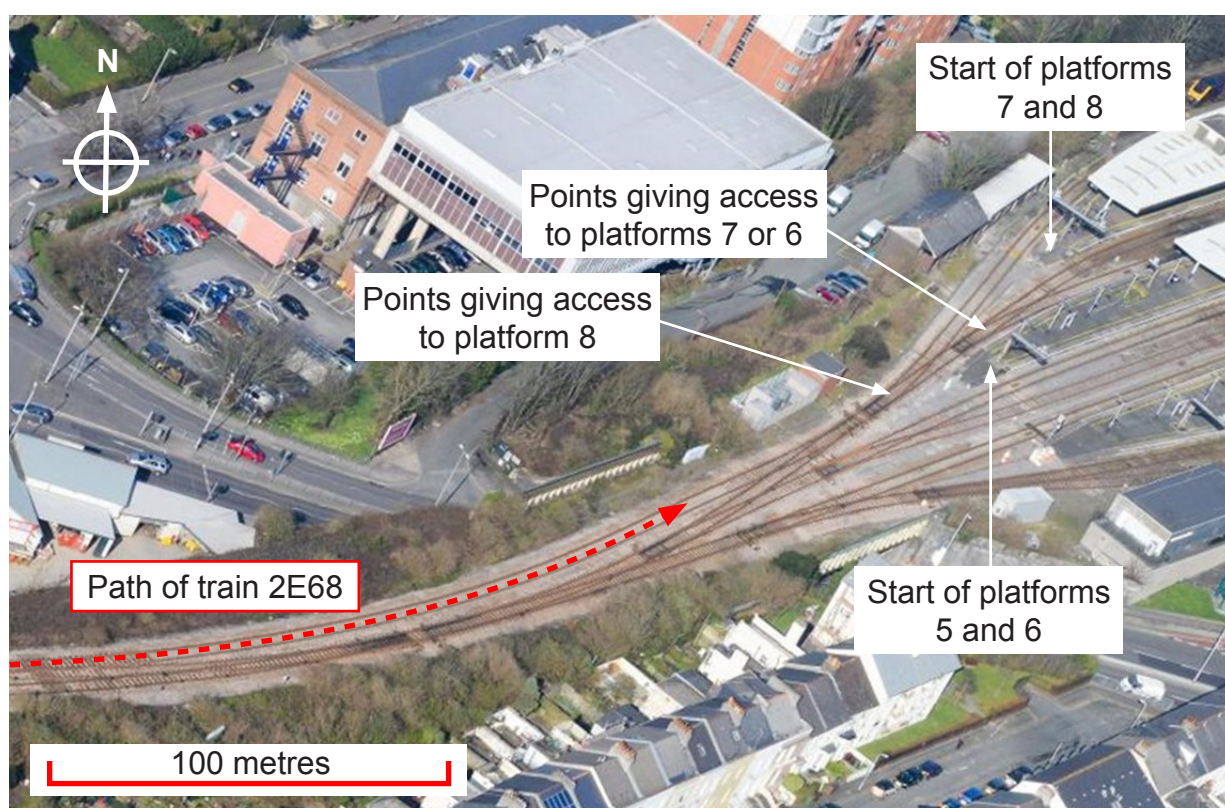
Figure 6: The points giving access to platform 8, and platforms 7 and 6 (image courtesy of Network Rail)

- 18 Around 46 metres after passing signal P15, trains pass over a set of *facing points* which provide routes to platforms 3, 4, and 5. A second set of *points*, located around 32 metres before the western end of platform 6, provide a left-hand route to platform 8 or a straight-ahead route towards platforms 6 and 7. A third set of points, located at the start of platform 6, provides a straight-ahead route into platform 7, or a right-hand route into platform 6 (figure 6).

- 68 About 10 seconds (91 metres) before the collision, train 2E68 approached the points giving access to platform 8 (figures 6 and 14). The driver stated he looked at the points and saw that they were set for the straight ahead route, and continued to believe that his train was not going into the platform occupied by train 1A91.

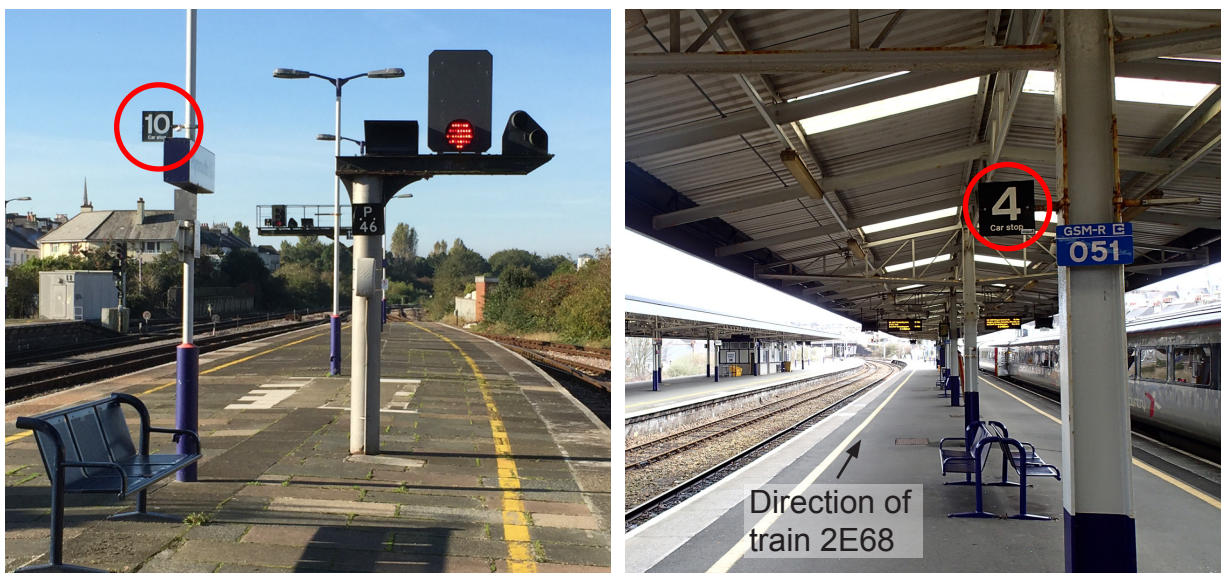
Figure 7: 10-car and 4-car stop signs relevant to the accident

- 19 Signs are provided on each platform to indicate to drivers where to stop the front of their train. Because trains of different length serve the station, each platform has several of these signs; these are referred to as *car stop signs* in this report. The signs relevant to the accident are listed below (figures 7 and 8):
- A 10-car stop sign on platform 6 applicable to trains from the east (the direction train 1A91 came from). This is located adjacent to signal P46, about 47 metres from the western end of the platform.
  - 4-car stop signs applicable to trains from the west (the direction train 2E68 came from). These are located approximately midway along platforms 8, 7, and 6, with the sign on platform 6 being around 165 metres from the western end of the platform.

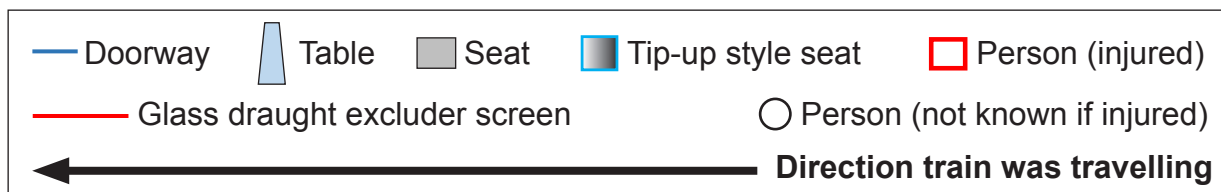
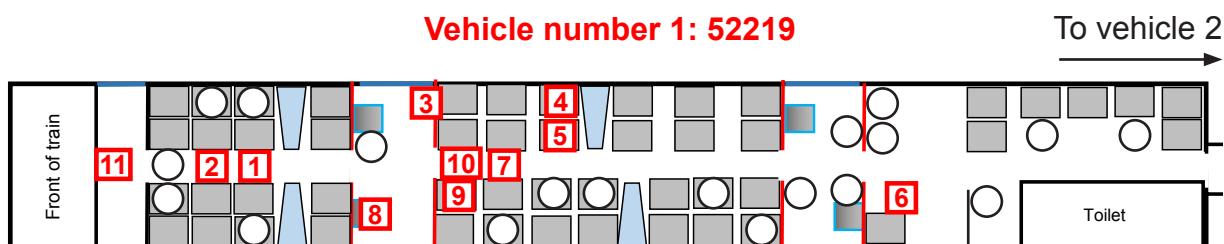
Identifier	Seated/standing	Cause
1	Standing	Fall to floor
2	Standing	Elbow possibly struck door handle. Other passengers falling on them caused other injuries.
3	Standing	Impact with glass partition
4	Seated	Movement during collision
5	Seated	Movement during collision
6	Standing	Impact with pole they were holding and overhead luggage falling on them
7	Standing	Hit arm rest and floor
8	Standing	Possibly hit head on floor
9	Seated	Possible impact with glass panel. Also other passenger contact.
10	Standing	Impact with other passengers
11	Standing	Impact with door frame

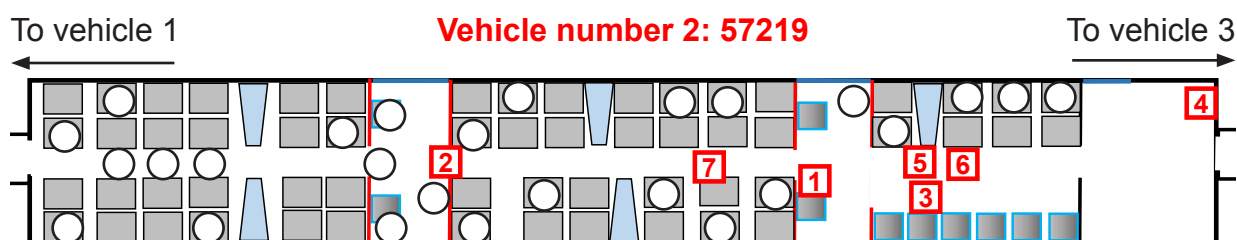
Identifier	Seated/standing	Cause
1	Standing	Fall to floor. Secondary impacts from other passengers.
2	Standing	Hit head on lower partition (not glass part)
3	Standing	Impact with glass partition
4	Standing	Impact with partition wall between driving cab and vestibule
5	Standing	Impact with floor
6	Standing	Impact with floor
7	Standing	Impact with seat

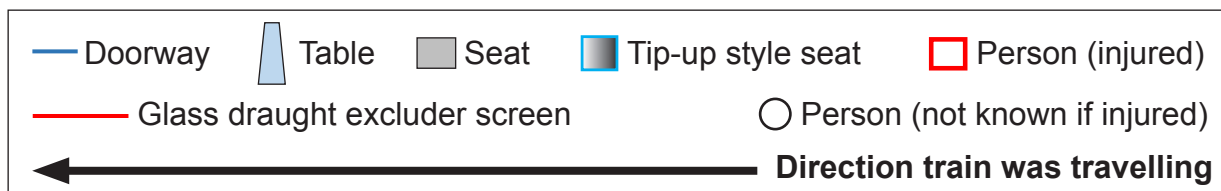
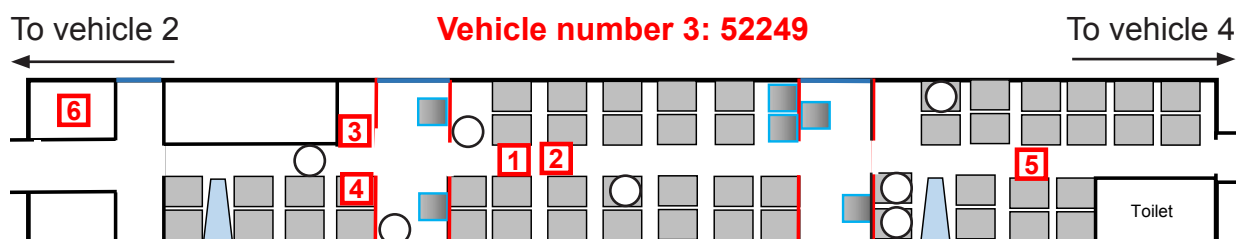
Identifier	Seated/standing	Cause
1	Standing	Impact with other passenger
2	Standing	Impact with other passengers
3	Standing	Impact with vehicle interior
4	Seated	Impact with seat in front and being thrown to the floor
5	Standing	Thrown to the floor
6	Standing	Hit head on door frame

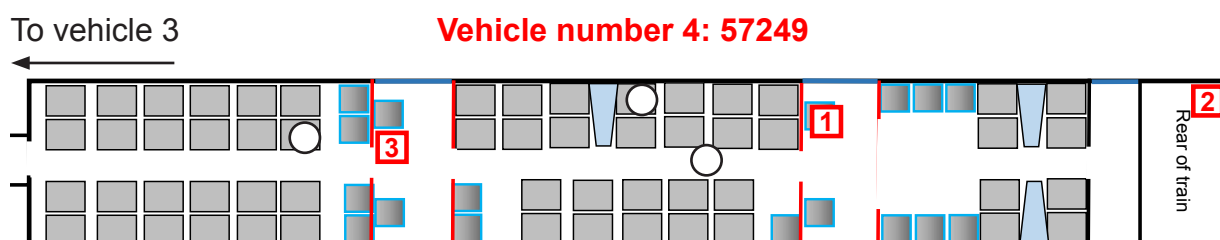
Identifier	Seated/standing	Cause
1	Standing	Impact (and shattering) with glass internal panel
2	Standing	Impact with bulkhead wall in rear cab
3	Standing	Impact with arm rest
