# Rail Accident Report

## **Overspeed at Queen's Park, London 5 January 2016**

Report 19/2016  
October 2016

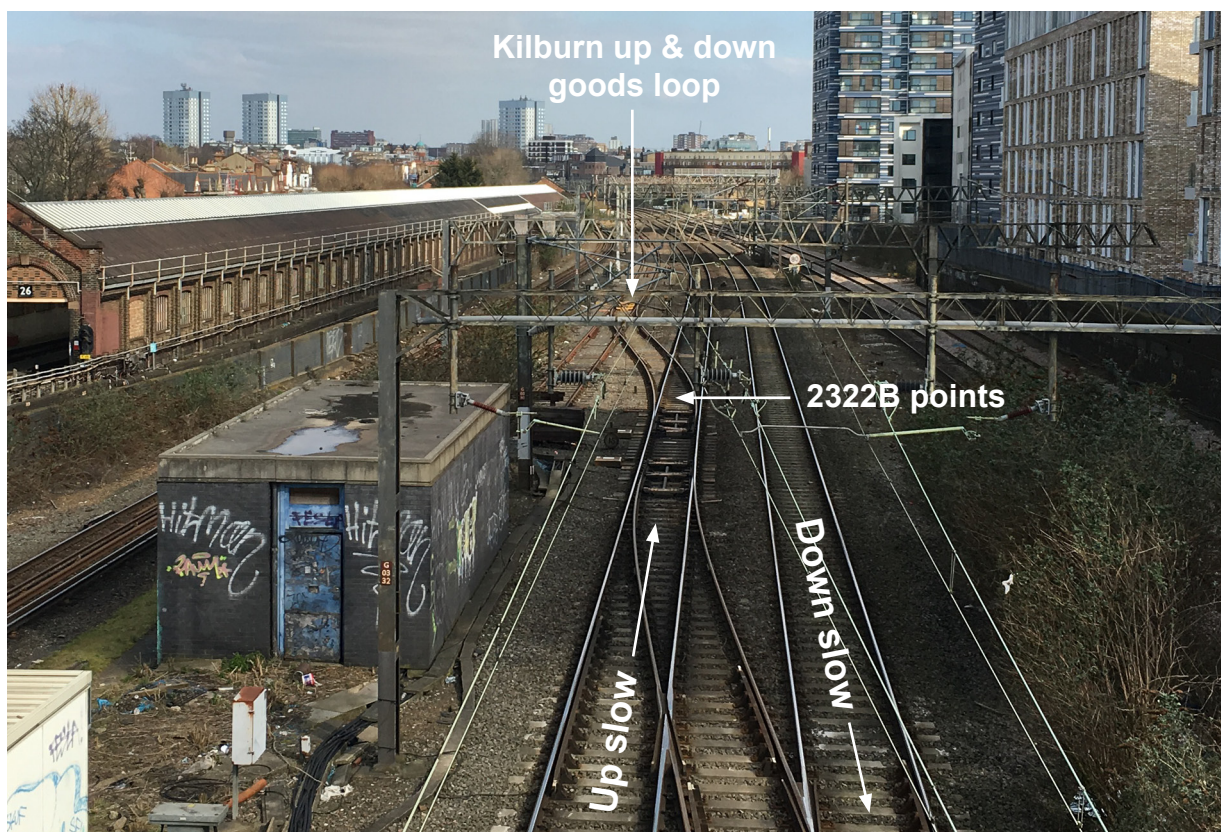
Figure 3: Incident location

- 16 The incident occurred at points number 2322B which have *inclined, flat bottom CEN60* rails with ‘C’ switch length. These are on the up slow line and give access to the western end of Kilburn up and down goods loop (figure 3). The points included a *crossing*, a component needed to allow the passage of wheel flanges across other rails where tracks intersect (figure 4).
- 17 London Midland’s Bletchley train crew and driver managers are based in facilities at Bletchley station. These facilities include an office shared by the driver managers and the train crew booking-on point, housing the *late notice case*.
