# Rail Accident Report

**Near miss with a group of track workers at  
Egmanton level crossing, Nottinghamshire  
5 October 2017**

Report 11/2018  
August 2018

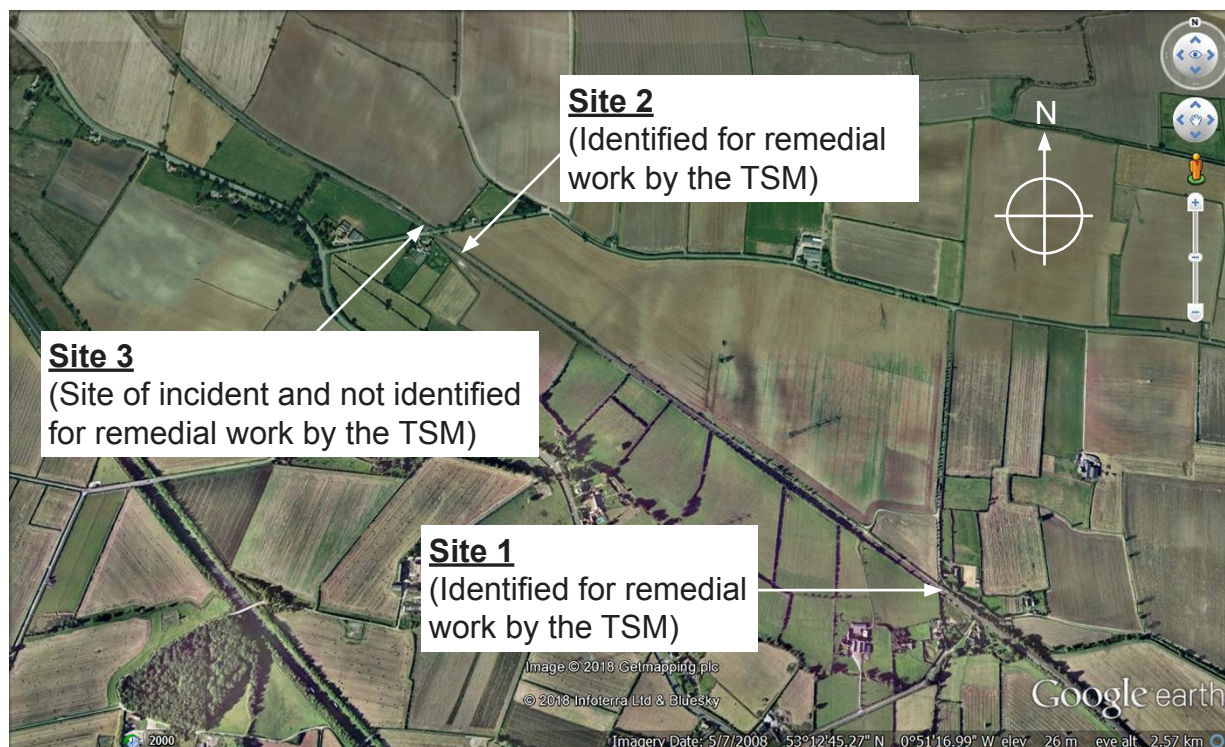
- 31 The first site of work covered by this SWP was approximately 1 mile (1.6 km) south of Egmonton level crossing and the second was around 20 metres south of the crossing (figure 3). The PiC and the planner, who was also familiar with the area, agreed that this plan could be used to cover both sites of work. The SWP covered a distance of approximately 2.75 miles (4.4 km), allowing the PiC to decide the most appropriate entry and exit points to the railway. The planner suggested that Egmonton level crossing be an access location to the second site of work, so this became the northerly limit stated on the SWP.

Figure 3: Locations of the three sites of work (image courtesy of Google Earth)

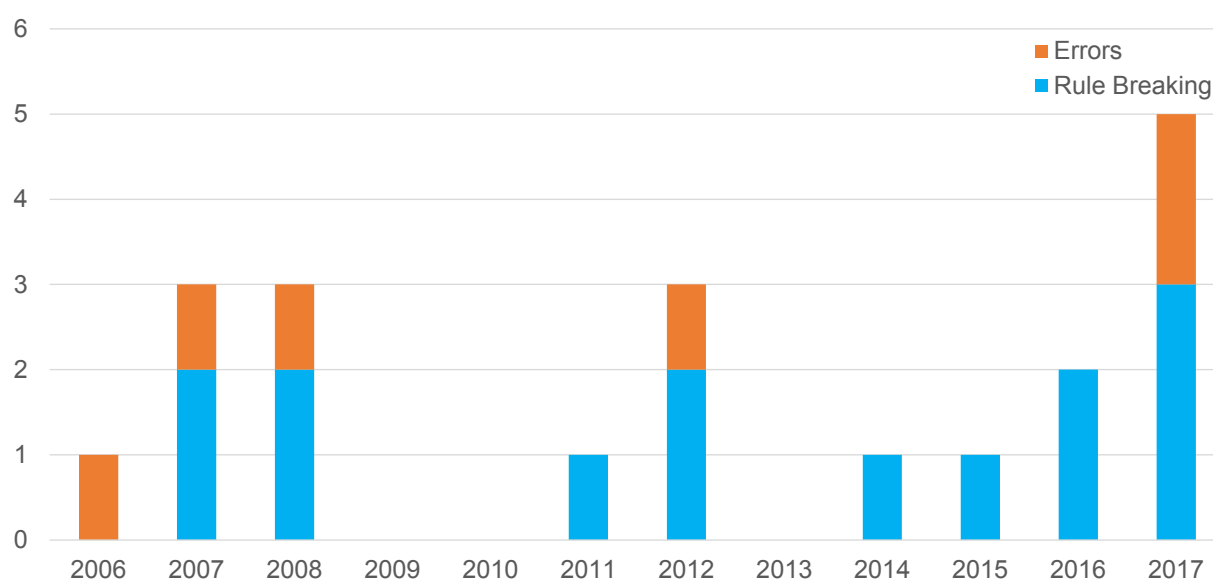
112 The RAIB undertook a review of its previous investigations into track worker fatalities and serious near misses (ie incidents in which track workers narrowly avoided being struck by trains) from moving trains outside possessions, over the period January 2006 to December 2017 inclusive. The number of incidents each year in which the COSS's actions were a causal factor is shown in figure 9, subdivided into those arising from errors and those caused by rule breaking behaviour on the part of the COSS. The data indicates that rule breaking behaviour by the COSS was a factor in 14 of the 20 incidents.

113 Figure 9 shows the number of RAIB investigations into serious track worker incidents and accidents for every year since 2006. This suggests a persistent problem with track safety behaviours and leadership.

Figure 9: Stacked bar chart showing RAIB investigations into serious track worker incidents and accidents with moving trains, from 2006 to 2017 inclusive, where a causal factor was either an error, or rule breaking behaviour, by the COSS
