Rail Accident Report

Dangerous train door incident at Bank station on the Docklands Light Railway 6 February 2017

Report 12/2017
September 2017

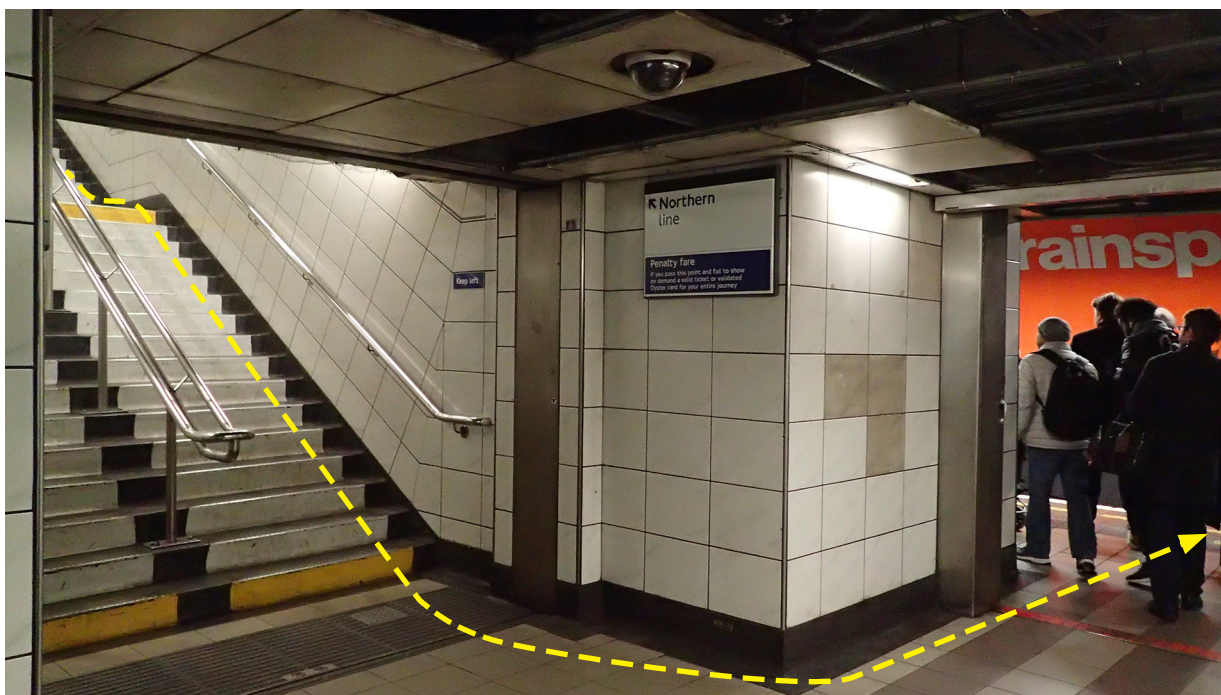
Figure 3: The Northern Line Steps and the access to platform 9 at Bank station where the incident took place. Arrow indicates path of the passenger

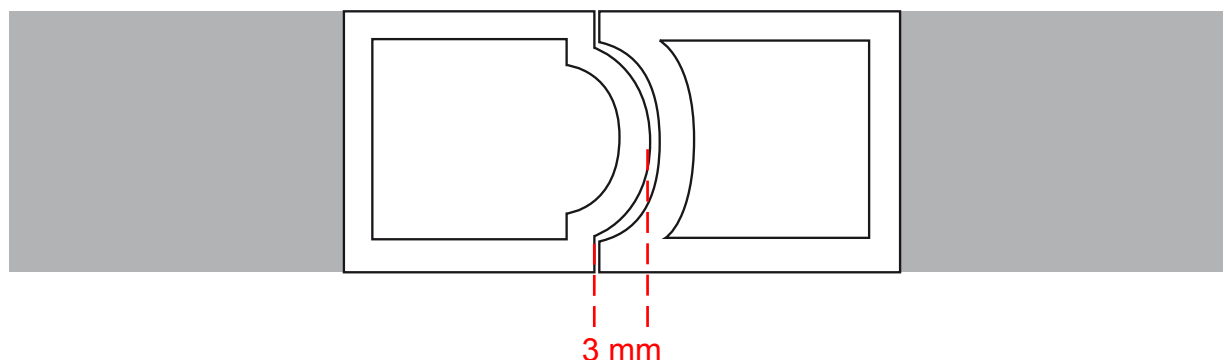
- 65 The nosing rubbers are able to compress around small objects when the doors close, but are intended to have sufficient flexibility, when combined with a *pushback mechanism*, to allow trapped objects to be withdrawn. The shape, flexibility and friction characteristics of the nosing rubbers affects the ease with which trapped objects can be pulled from the doors. The interlocking between the two halves of the nosing rubbers on the DLR cars is around 16 mm. It is greater than that on LUL vehicles² (figure 12), which is around 3 mm. Although the RAIB has not carried out any comparative tests, it is evident that the more convoluted the path that a flexible object, such as a piece of trapped clothing, has to take to be extracted the greater the extraction forces are likely to be, for a given type of nosing rubber design.

- 66 The RAIB also carried out testing using a piece of clothing trapped in the doors of DLR cars and found that forces in excess of 200 N were required to withdraw a fabric test piece. By comparison, the maximum force criteria used by LUL in its tests using a fabric test piece is 90 N.

Figure 12: Nosing rubber elements on the LUL trains
