Rail Accident Report

Track worker struck by a train at Stoats Nest Junction, near Purley 6 November 2018

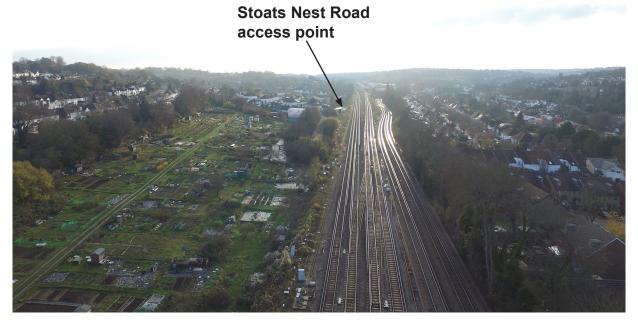
Figure 3: Image looking south towards Stoats Nest Road access point

- There is a railway access point for vehicles at Stoats Nest Road, a short distance south of the junction (figure 3). There is also a pedestrian access point (adjacent to the down slow line), which was used by the track worker prior to the accident, located on Old Lodge Lane (figures 4 and 5) at 14 miles and 88 yards, 792 yards (723 metres) north of the Stoats Nest Road access point.

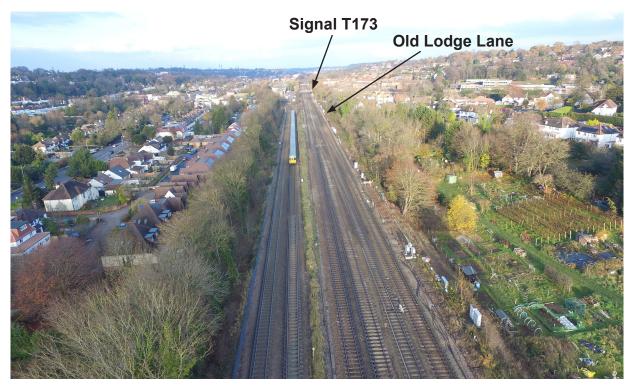
Figure 4: Image looking north towards Old Lodge Lane and signal T 173

- 10 At Stoats Nest Junction, the protecting signals for the south end of the possession were T173 on the down slow line and T184 on the up Redhill line. Signal T173 is on a gantry north of the access point at Old Lodge Lane. The actual limits of the possession at Stoats Nest Junction were clear of (ie immediately north of) points 1664 on the down slow line and switch diamonds³ 1663 on the up slow line (figure 2).

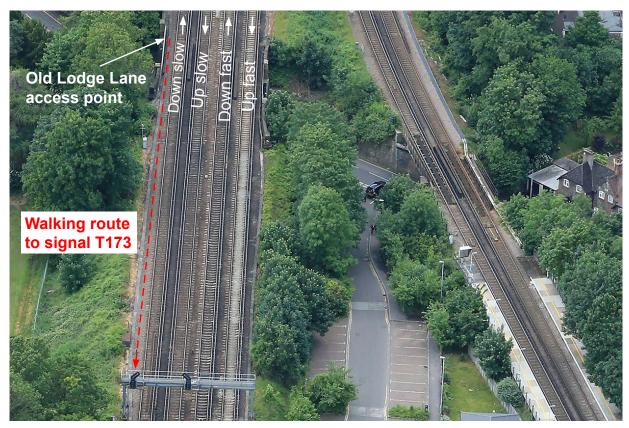
Figure 5: Routeview image showing Old Lodge Lane access point, up and down slow and fast lines and signal T173 (image courtesy of Network Rail)

- 35 At around 20:45 hrs the COSS returned home and spent time with his family, and prepared his food for the night shift. Although the COSS had been asked to meet the PICOP at Cover House, when he left home at around 22:00 hrs he travelled directly to Old Lodge Lane (figure 5).

- 36 At 22:47 hrs the COSS called the PICOP to report for duty, and said that he was now parked in his vehicle on Old Lodge Lane ready to place the protection for the planned possession starting at 00:01 hrs.

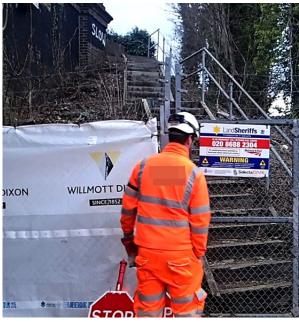
Figure 6: Access gate at Old Lodge Lane

42 Around 00:18 hrs the COSS, now carrying the two possession limit boards and six detonators, entered the railway via the Old Lodge Lane access gate, and walked up the steps (figure 6) to the down slow cess. The COSS then walked towards signal T173 (figures 5 and 7).

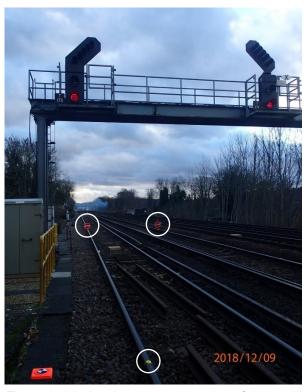
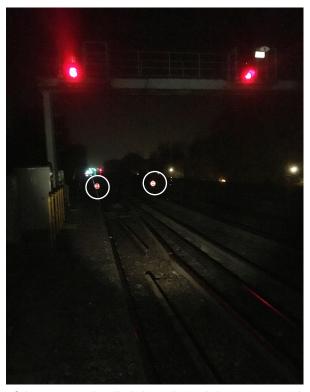
Figure 9: (a) showing a reconstruction of the position of the possession limit boards and detonators and (b) showing signal T173 and the possession limit boards after the accident on 6 November 2018

- 43 Signalling data shows that at 00:19:56 hrs a train on the up fast line passed through Stoats Nest Junction. Based upon the times derived from a RAIB reconstruction of the events, it is likely that this train passed through the junction as the COSS was walking towards T173 signal.
- The COSS then placed the protection equipment on the up and down slow lines (figure 8) and at 00:21 hrs he called the PICOP to confirm he had placed the protection (figures 9a and 9b). The PICOP asked the COSS to be available to lift the protection at around 04:40 hrs.
