# Rail Accident Report

**Container detachments at Scout Green,  
Cumbria, 7 March 2015 and near Deeping St  
Nicholas, Lincolnshire, 31 March 2015**

# **Container detachments at Scout Green, Cumbria, 7 March 2015 and near Deeping St Nicholas, Lincolnshire, 31 March 2015**

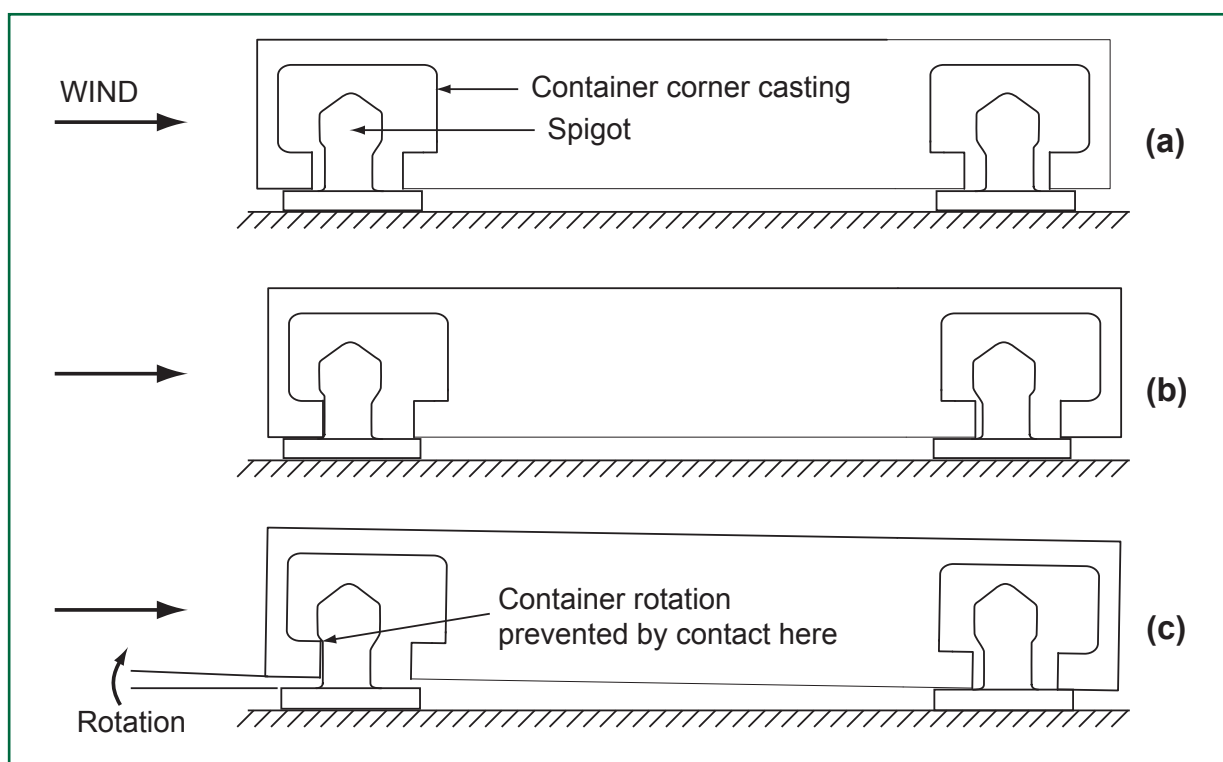
- 18 The head of a UIC spigot is shaped to guide the container corner casting on and off the spigot during loading and unloading. A UIC spigot that complies with UIC 571-4 also provides overturning restraint in windy conditions. The principal of operation of a UIC spigot is illustrated in figure 5. Studies<sup>5</sup> have shown that wind forces acting on the windward side of the empty container will first slide the container laterally from its central position relative to the spigots (figure 5a) until the windward corner castings contact the neck of the windward spigot (figure 5b). If the wind is strong enough to cause the windward side of the container to lift, the corner castings on the windward side of the container will engage with the underside of the spigot heads (figure 5c). This engagement provides the necessary vertical restraint to hold the container and stop it from lifting further.

Figure 5: Principle of operation of spigots in windy conditions
