Rail Accident Report

**Signal passed at danger on approach to
Wootton Bassett Junction, Wiltshire
7 March 2015**

Signal passed at danger on approach to Wootton Bassett Junction, Wiltshire, 7 March 2015

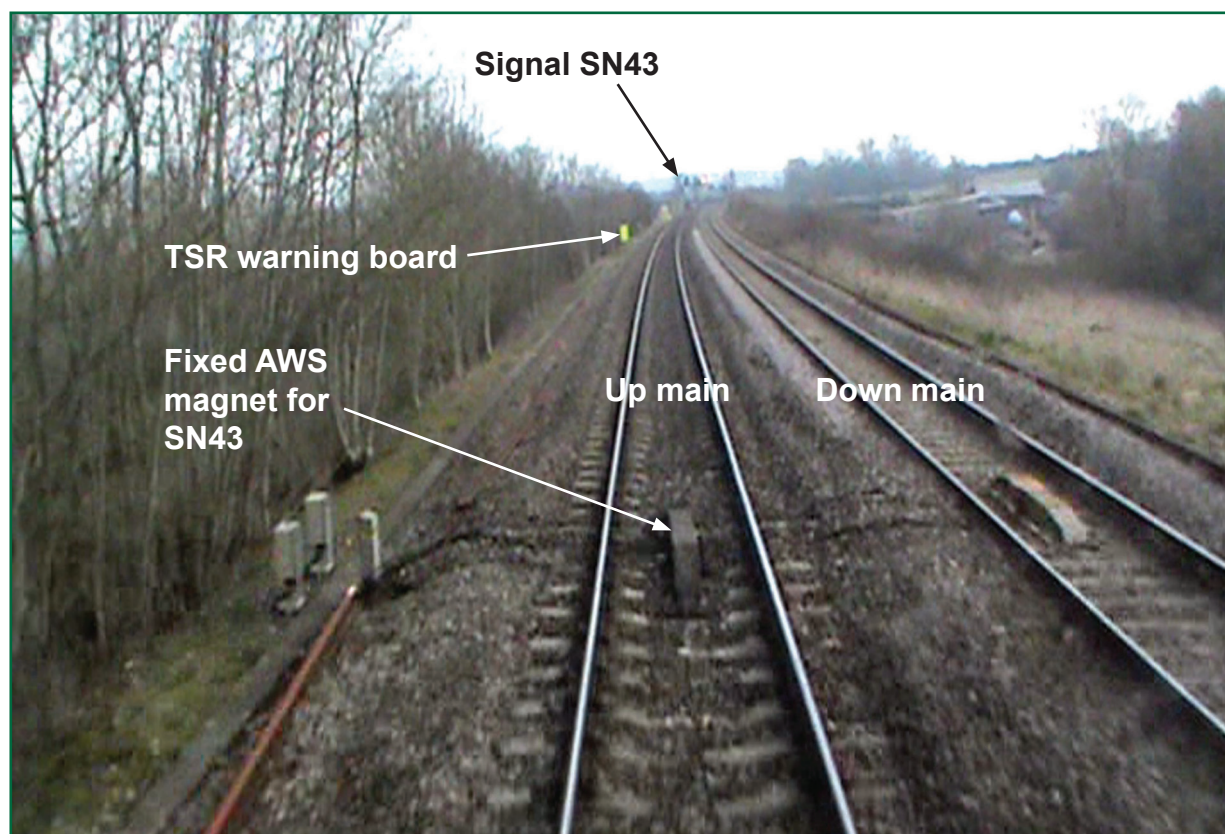
Figure 6: A video image of the warning board taken shortly after the incident (image courtesy of Network Rail)

- 84 The driver stated that he thought that the warning was associated with a TSR because he had seen a warning board as he received the AWS warning. Analysis of video images showed that the warning board for the TSR had been placed between the fixed AWS magnet for SN43 and the signal itself (figure 5). This suggests that the driver saw it during the second AWS warning, which related to signal SN43 and not to the TSR.

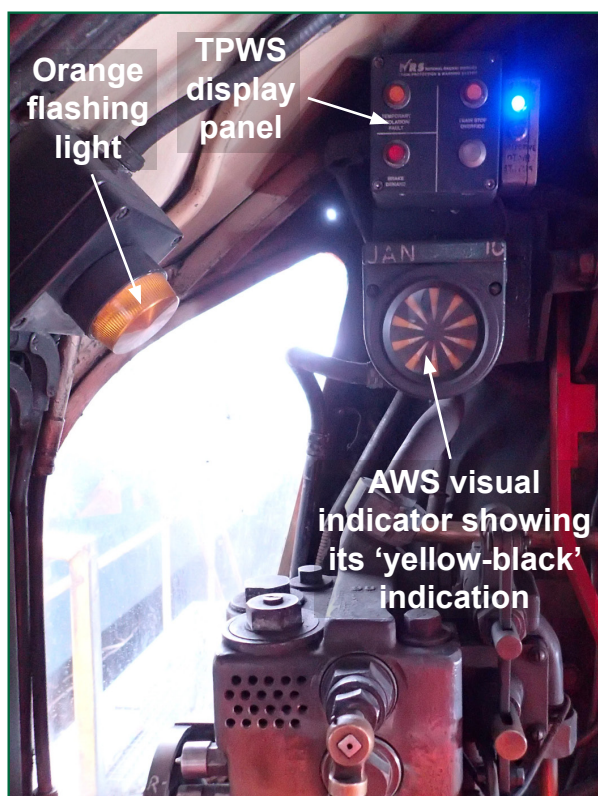
- 15 At the time of the incident, the AWS audible warning indicator on Tangmere was positioned on the inside of the cab roof, just above the *driving position* (which is on the left-hand side of this locomotive) and towards the rear of the driver's side window. The orange flashing light was also positioned on the inside of the cab roof, slightly higher than the audible warning indicator and to the front of the driver's side window (figures 8 and 9). The AWS visual indicator (commonly called the 'sunflower') is mounted in front of the driving position just above the main driving controls, with the TPWS display panel positioned directly above it (figure 9).

Figure 9: The position of the AWS flashing light, AWS visual indicator and TPWS display panel on 7 March 2015. Note: the blue light next to the TPWS display panel relates to the locomotive's OTDR.

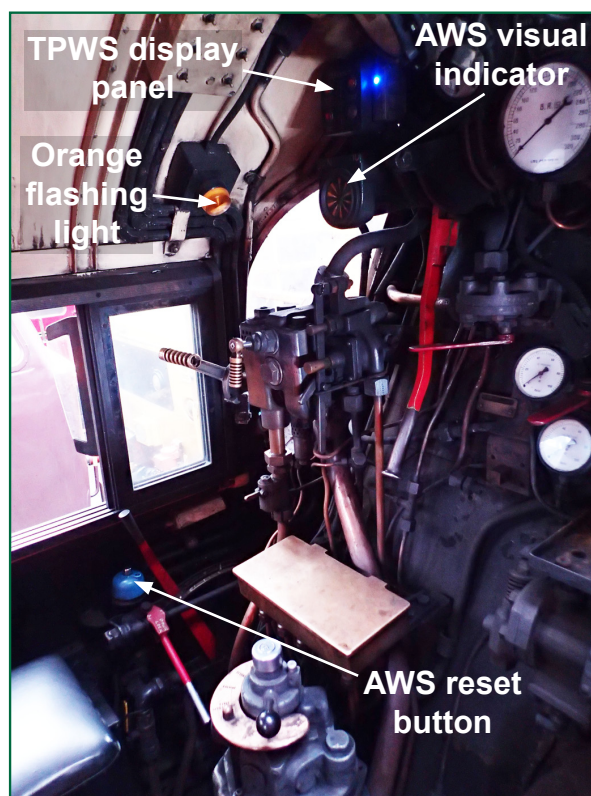
- 16 Drivers acknowledge AWS warnings on Tangmere by pressing and releasing the AWS reset pushbutton, which is located to the left of the driver's seat (figure 10). The *railway group standards* applicable at the time that Tangmere's AWS system was installed required that the driver be given a period of up to 2.7 seconds to acknowledge warnings. Should a driver not acknowledge an AWS warning within this time period, then the combined AWS/TPWS control unit will generate an AWS brake demand. The relevant standards required that AWS brake demands remain active until the driver acknowledged the warning and that any brake demand continue for at least 59 seconds after this had been done. In the event that an AWS brake demand occurs, the *Rule Book*⁴ requires drivers to immediately bring their trains to a stand and then to contact the signaller.

Figure 10: The position of the AWS flashing light, AWS visual indicator, AWS reset pushbutton and TPWS display panel on 7 March 2015
