Rail Accident Report

Occupied wheelchair contacting a passing train at Twyford station 7 April 2016

Report 01/2017
January 2017

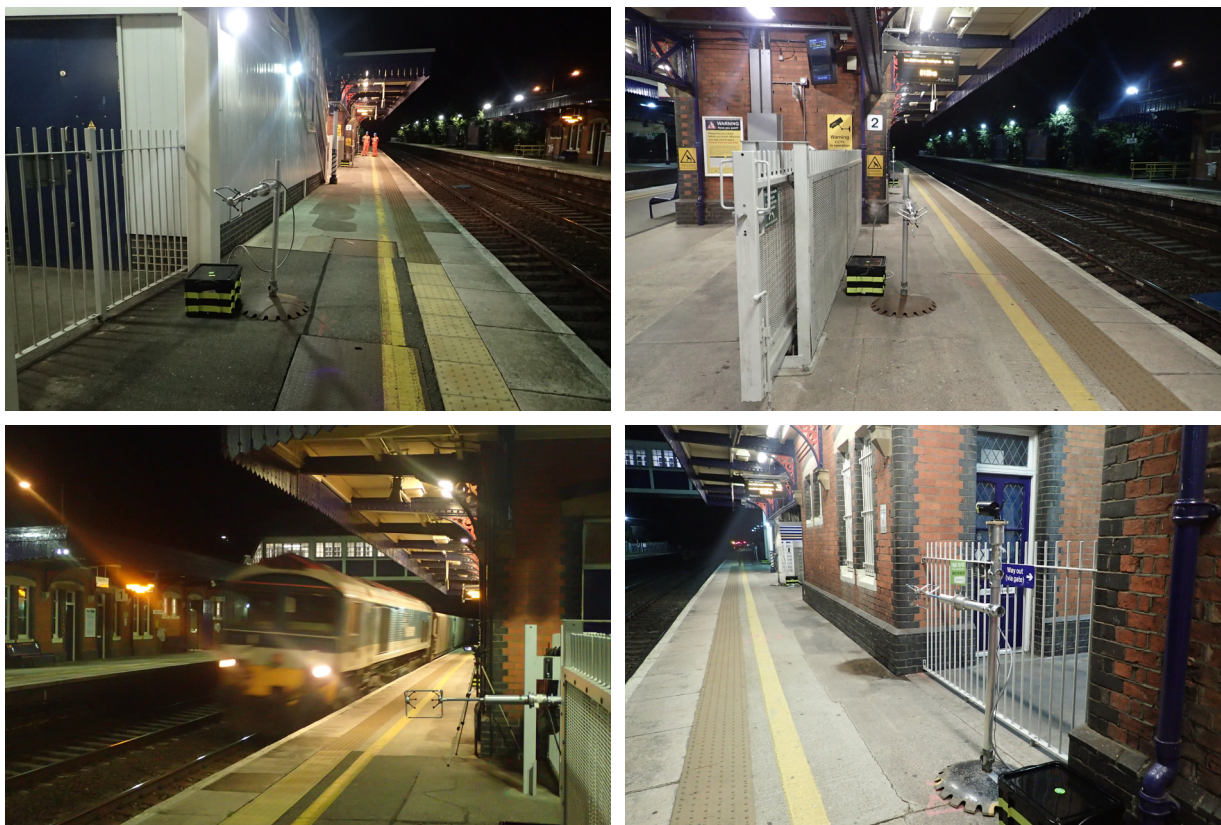
Figure 13: Anemometers set-up at Twyford station platform 2

- 41 In order to understand the magnitude of the slipstreams generated by trains passing through Twyford station, the RAIB commissioned tests by the University of Birmingham during August 2016. The tests were undertaken at night. Due to overnight engineering work, trains passing through Twyford station during the testing period went through platform 2 so the testing had to be done on this platform instead of platform 4⁶. Slipstream measurements were made by means of four *sonic anemometers* positioned 2.4 metres from the platform edge (figure 13), which was the distance from the platform edge of the centre line of the wheelchair before it started moving (paragraph 20). The anemometers were spaced approximately 17 metres apart along the platform. The anemometers recorded air flows as trains passed, and also recorded the ambient conditions in the absence of a train. The ambient wind measured during the testing was negligible. The speed of passing trains was measured using a radar speed gun.

- 43 Measurements for the trains of a similar configuration to train 7A09 were analysed. Figure 14 shows the slipstream velocities measured by an anemometer when such a train passed through platform 2. It should be noted that there was significant variability in the anemometer measurements between trains and also between anemometers during the passage of a single train.

⁶ There are physical differences between the layouts of platforms 2 and 4, such as the proximity of station buildings to the track and the presence of the kiosk on platform 4. However, a comparison between the anemometer readings obtained for platform 2 suggests that these physical differences would not have resulted in significantly different results had the tests been carried out on platform 4.
