Rail Accident Report

Explosion inside an underframe equipment case at Guildford 7 July 2017

Report 05/2018
March 2018

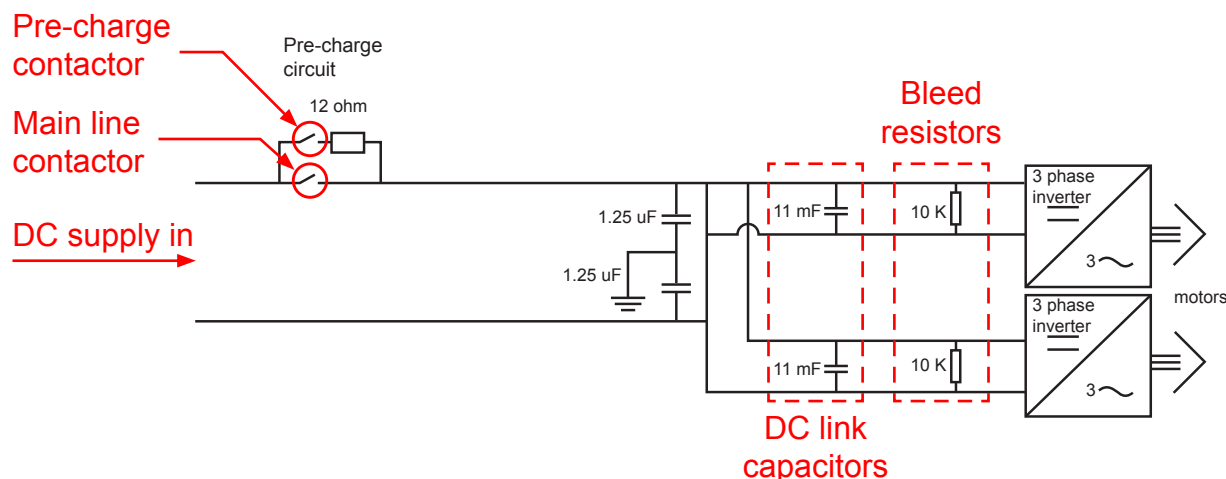
Figure 5: Simplified electrical schematic for Class 455 IGBT propulsion, showing equipment for two traction motors

- 40 The electrical supply to the DC link is switched by two *contactors* within the traction equipment case (figure 5). These are:
 - A large main line contactor, which connects the IGBT DC link to the supply from the conductor rail. This contactor remains closed (and keeps the DC link energised) unless the train is stationary for more than ten minutes, when the contactor will automatically open.

- 42 It is necessary to provide for a controlled discharge of the DC link capacitors to ensure the safety of maintenance staff working on train electrical equipment. To provide this controlled discharge, *bleed resistors* (figure 5) are provided. The bleed resistors will discharge the DC link capacitors in approximately five minutes after the supply to them has been removed.

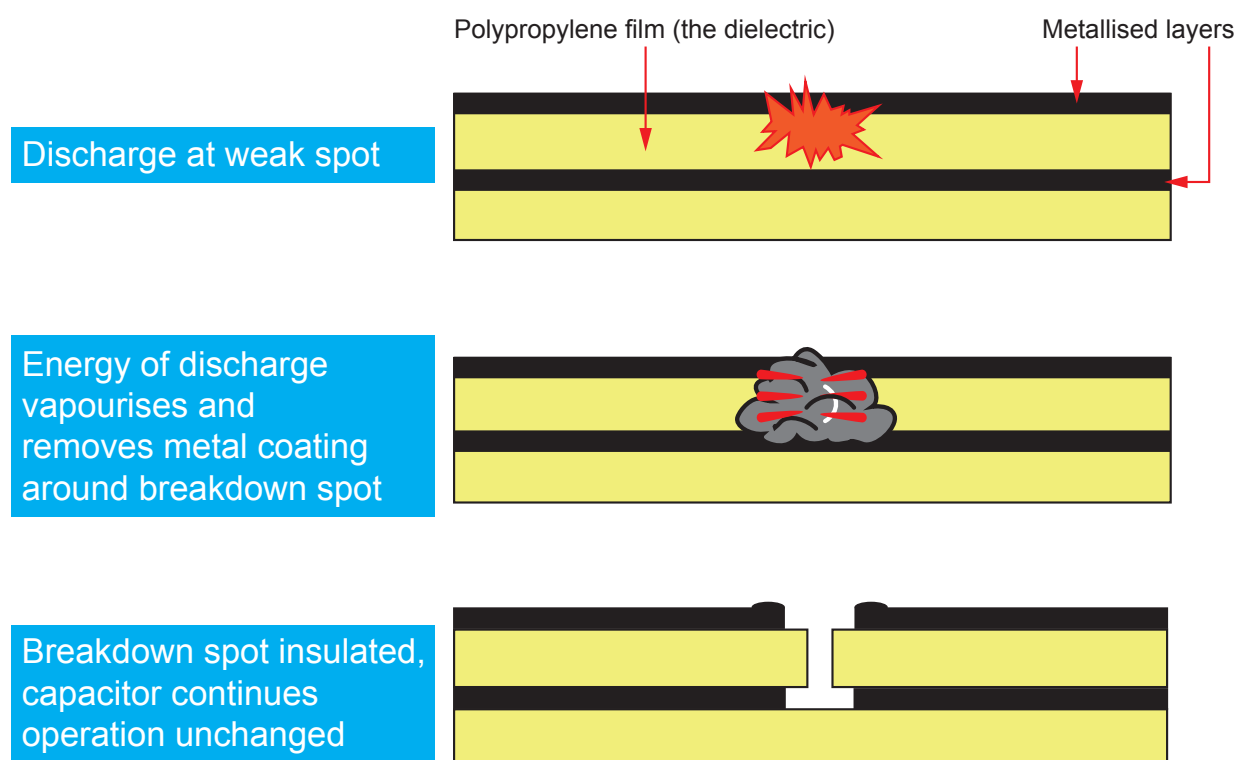
- 51 A property of film-type capacitors is their ability to 'self-heal'. Self-healing occurs on a microscopic level at minor irregularities in the polypropylene film. Such irregularities can result in a small electrical discharge between the metallised layers at weak spots in the polypropylene film. This discharge vaporises and removes the metallic coating around the weak spot, which electrically isolates the irregularity. The self-healing process is depicted in figure 6. It continues through the lifespan of a capacitor. As this occurs on a microscopic level, the resulting loss of capacitance is negligible, even after a typical 30-year life span for a film-type capacitor.

Figure 6: The process of self-healing within a film-type capacitor

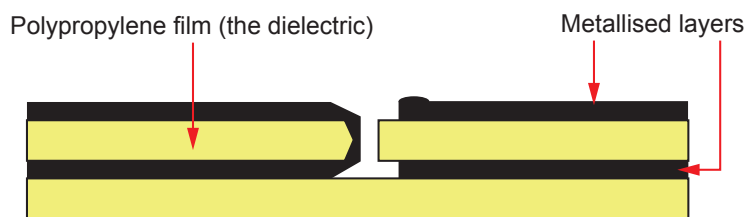
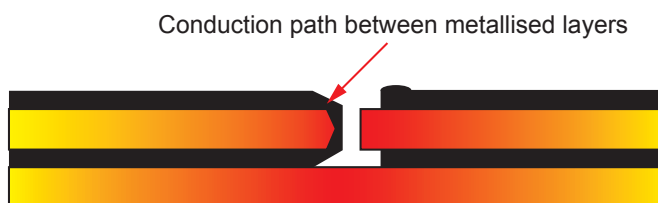
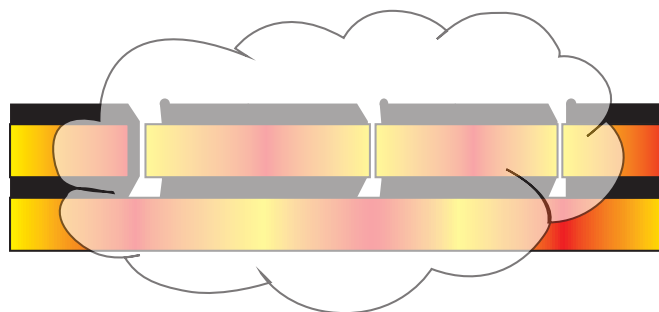
Figure 7: Drawing illustrating failure of self-healing

- 52 However, in some circumstances, it is also possible for the self-healing process to fail. This can occur if the polypropylene film is damaged or distorted. Such damage can lead to direct electric discharge at the site of an irregularity. Increased conduction of leakage current between the metallised layers then occurs, and this leads to localised heating as shown in figure 7.
- 53 The localised heating will then further degrade the polypropylene film in the vicinity, resulting in further discharges and damage to the film. This process can create a runaway process of damage and heating to the capacitor winding. Ultimately this heating can lead to *pyrolysis* of the polypropylene film.

Incomplete insulation,
leakage current rising slowly

Step-by-step increase
of temperature around
the breakdown spot

Decomposition of
Polypropylene film leads to
runaway process of further
breakdowns, release of
gas and pressure rise
inside capacitor case
