Rail Accident Report

**Fatal accident involving a train passenger near
Balham
7 August 2016**

Report 09/2017
May 2017

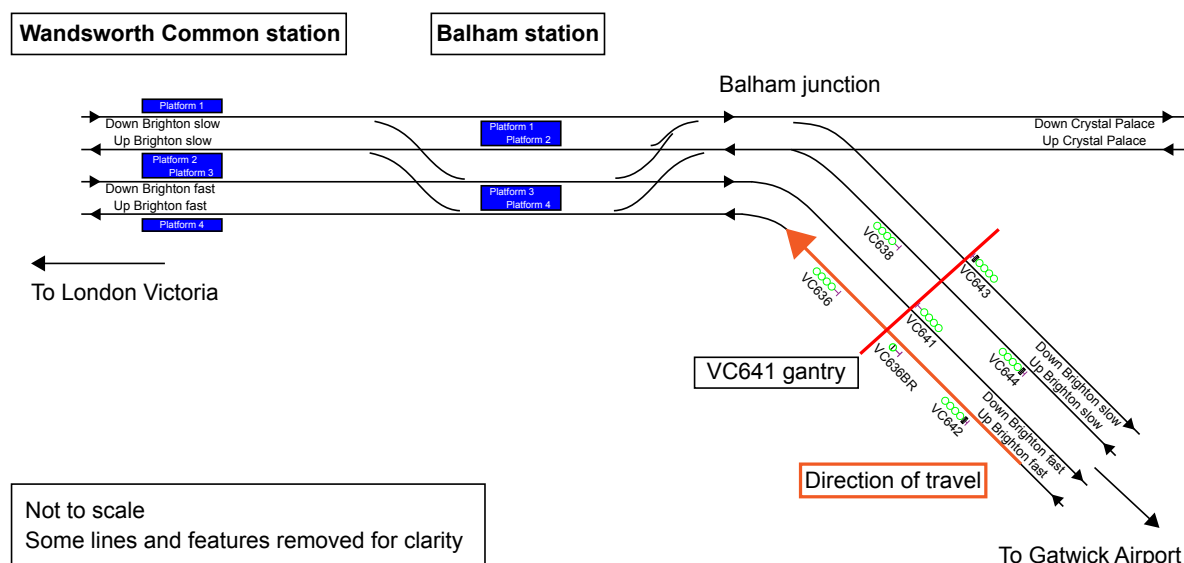
Figure 2: Schematic diagram of the track layout

- 4 The signal gantry is located at around 5 miles 12 *chains*¹ on the line from London Victoria to Brighton (*engineer's line reference* at this location is VTB1). The railway at this location comprises four tracks: the *up* and *down* Brighton fast lines, and the *up* and *down* Brighton slow lines (figure 2).
- 5 Signalling in this area is controlled by the Victoria Area Signalling Centre (ASC).
- 6 The train was travelling on the *up* Brighton fast line. The maximum permitted speed is 70 mph (113 km/h) at this point, reducing to 60 mph (97 km/h) shortly after the signal gantry.

- 7 In the direction of travel of the train, the gantry is located on a left-hand curve with a radius of 600 m.

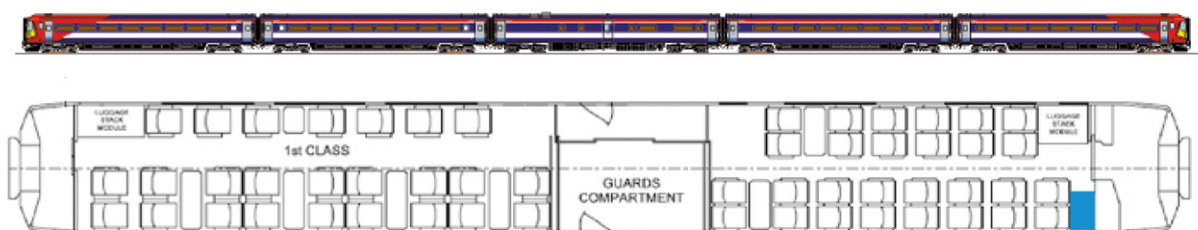
Figure 3: Layout of the Class 442 unit and detail of middle carriage (courtesy of GTR)

- 13 Each Class 442 unit comprises five carriages, and each carriage is 23 metres long (compared to 20 metres on the Class 460 and Class 387 units). The formation includes a driving cab at each end of the train and a guard's compartment at the centre of the middle carriage. This compartment separates two areas of passenger seating; a corridor running along one side of the carriage adjacent to the guard's compartment allows passengers to move between these areas (figure 3).

- 14 There are power-operated external doors at each end of every carriage for passengers to use when boarding and alighting the train. In addition, there are manually-operated external doors at the centre of the middle carriage intended for use only by the guard during train dispatch at stations (figure 4). One of these doors is in the guard's compartment, while the other is opposite the compartment in the connecting corridor. When not in use, these doors are locked with a carriage key.
