Rail Accident Report

Train dispatch accident at Elstree & Borehamwood station 7 September 2018

Report 03/2019
May 2019

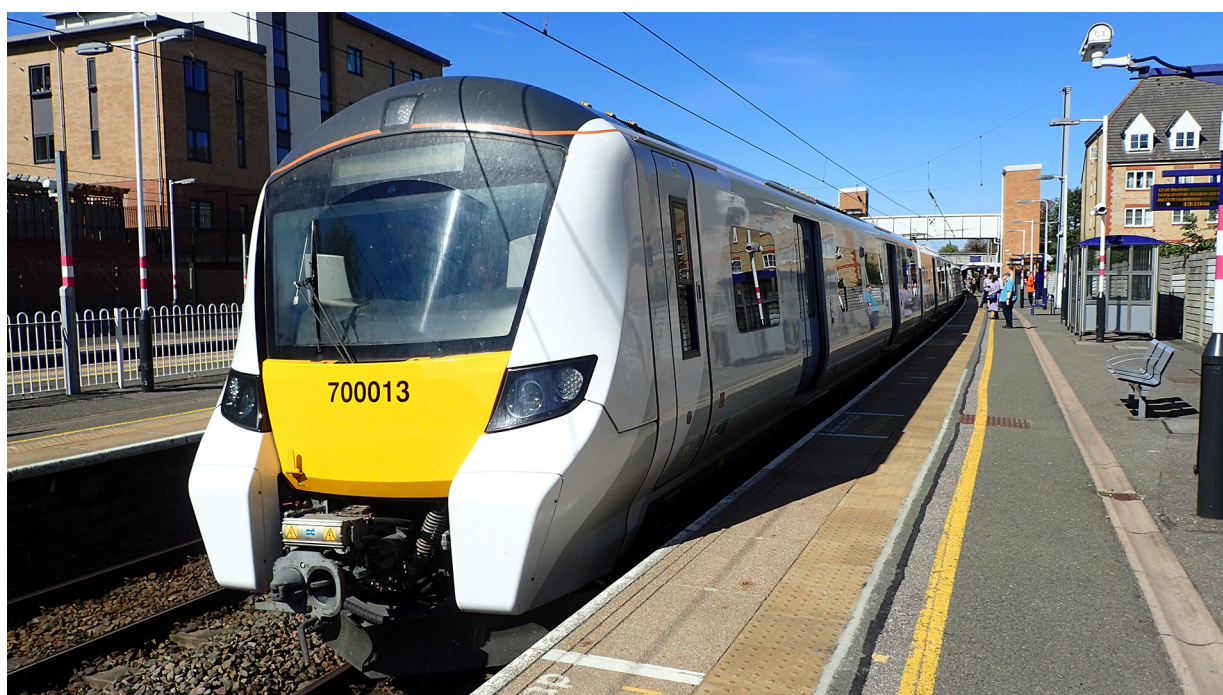
- 13 The train service involved was 9O47³, the 13:52 hrs service from St Albans City to Sutton, running via the Thameslink route through central London (figure 2).
- 14 Train 9O47 was formed of an eight coach class 700 Electric Multiple Unit (EMU)⁴ (figure 4), unit number 700060. This unit was first accepted into traffic by GTR on 2 July 2018⁵. By the date of the accident, it had covered approximately 19,000 miles and therefore had not yet reached the 20,000 mile interval for its first planned maintenance intervention since delivery.

Figure 4: A class 700 EMU of the type involved in the accident

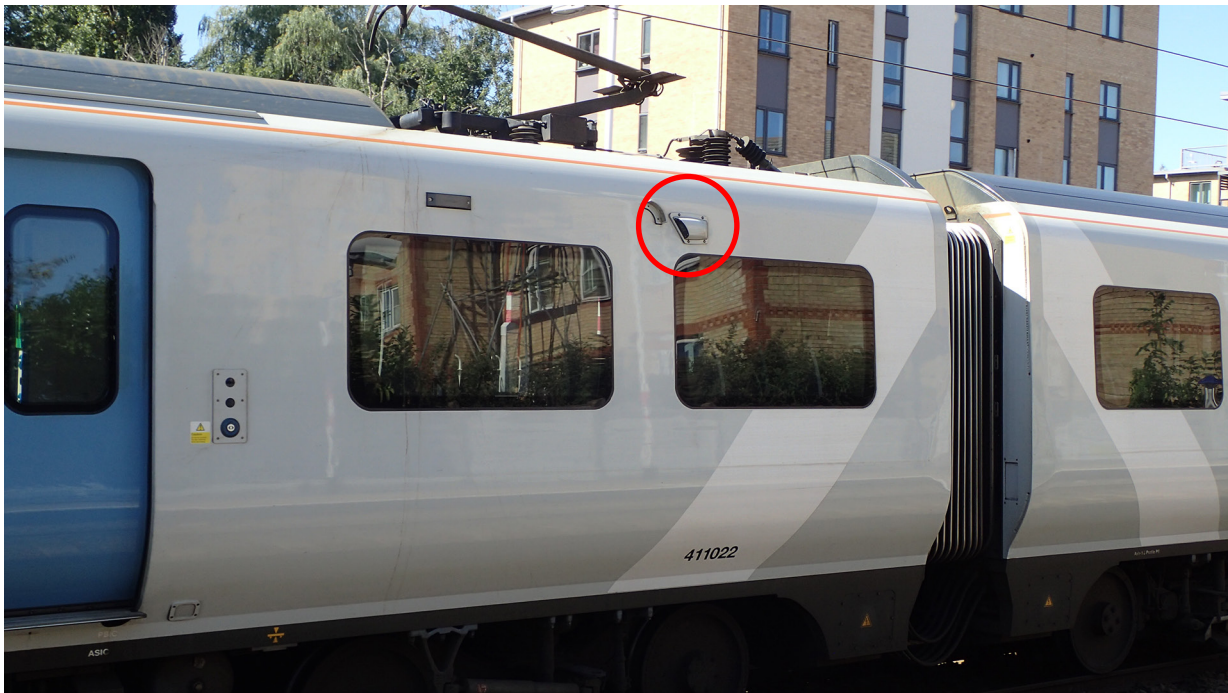
- 39 Each coach on a class 700 train is fitted with exterior mounted CCTV cameras, one on each side (figure 5). These provide an external image of the doors, the side of the vehicles and the adjacent platform edge.
- 40 The CCTV images are displayed to the driver on two monitor screens in the cab, located to the left side of the driving position (figure 6). On an eight-coach class 700 train, four images, one for each coach, are displayed on each of the screens (figure 7). Each image measures 104 mm horizontally by 87 mm vertically. A 'heartbeat' indicator displayed on the screen confirms to the driver that the images are 'live' and that the screens have not 'frozen'.

Figure 5: Exterior mounted CCTV camera (circled) on a class 700 coach

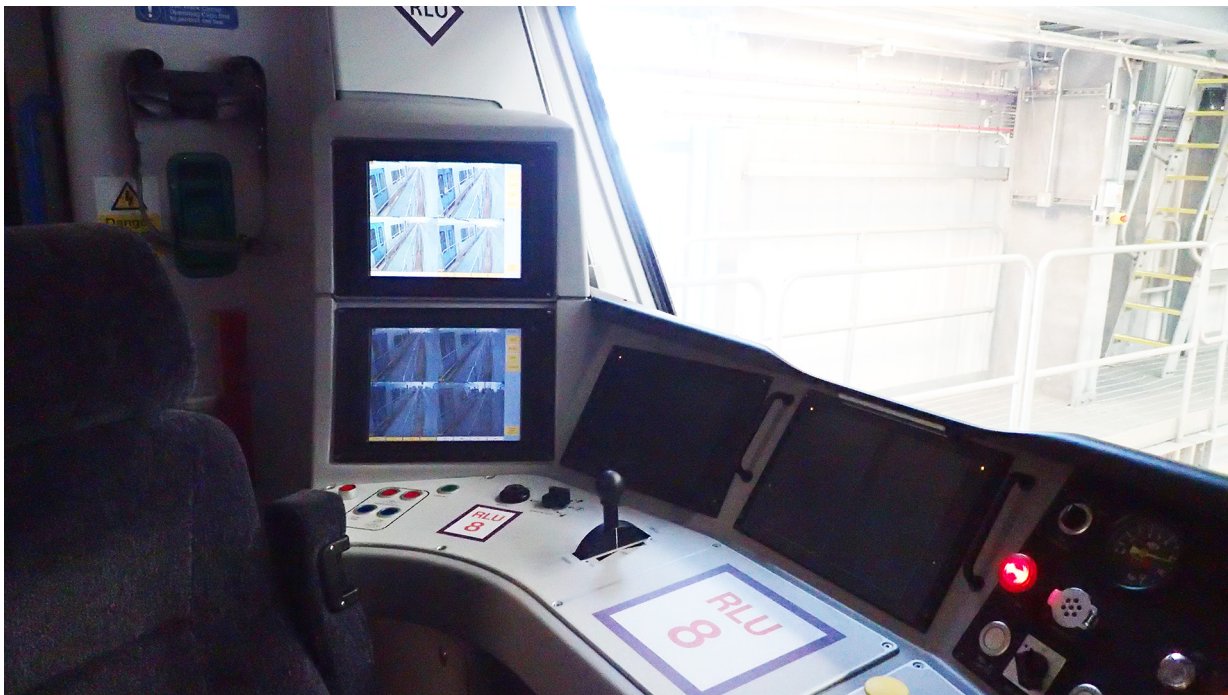
Figure 6: The cab desk of a class 700 train
