# Rail Accident Report

## **Derailment at Knaresborough 7 November 2015**

Report 16/2016  
August 2016

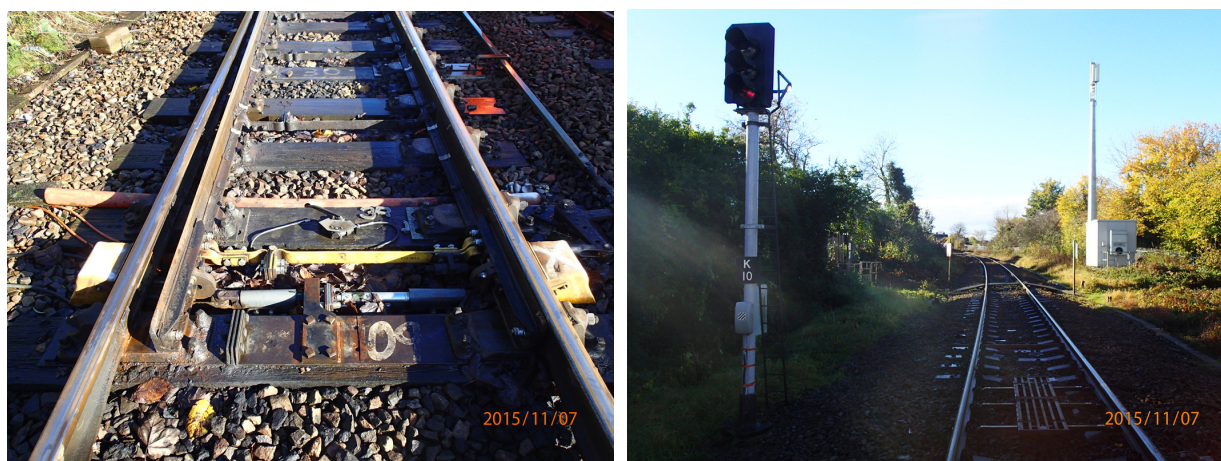
Figure 4: Points 3 in the 'normal' position and signal K10

- 14 Points 3A are of the *E-type*, using *flat bottom rails* laid vertically. The points are fitted with an electrical '*clamp lock*' machine and a mechanical *back drive* used to move the *switch rails* from one position to the other. When in the '*normal*' position, the points are set for a train approaching from the single line to remain on the DownYork line. When in the '*reverse*' position, the points are set for a train approaching from the Up York line moving onto the single line.

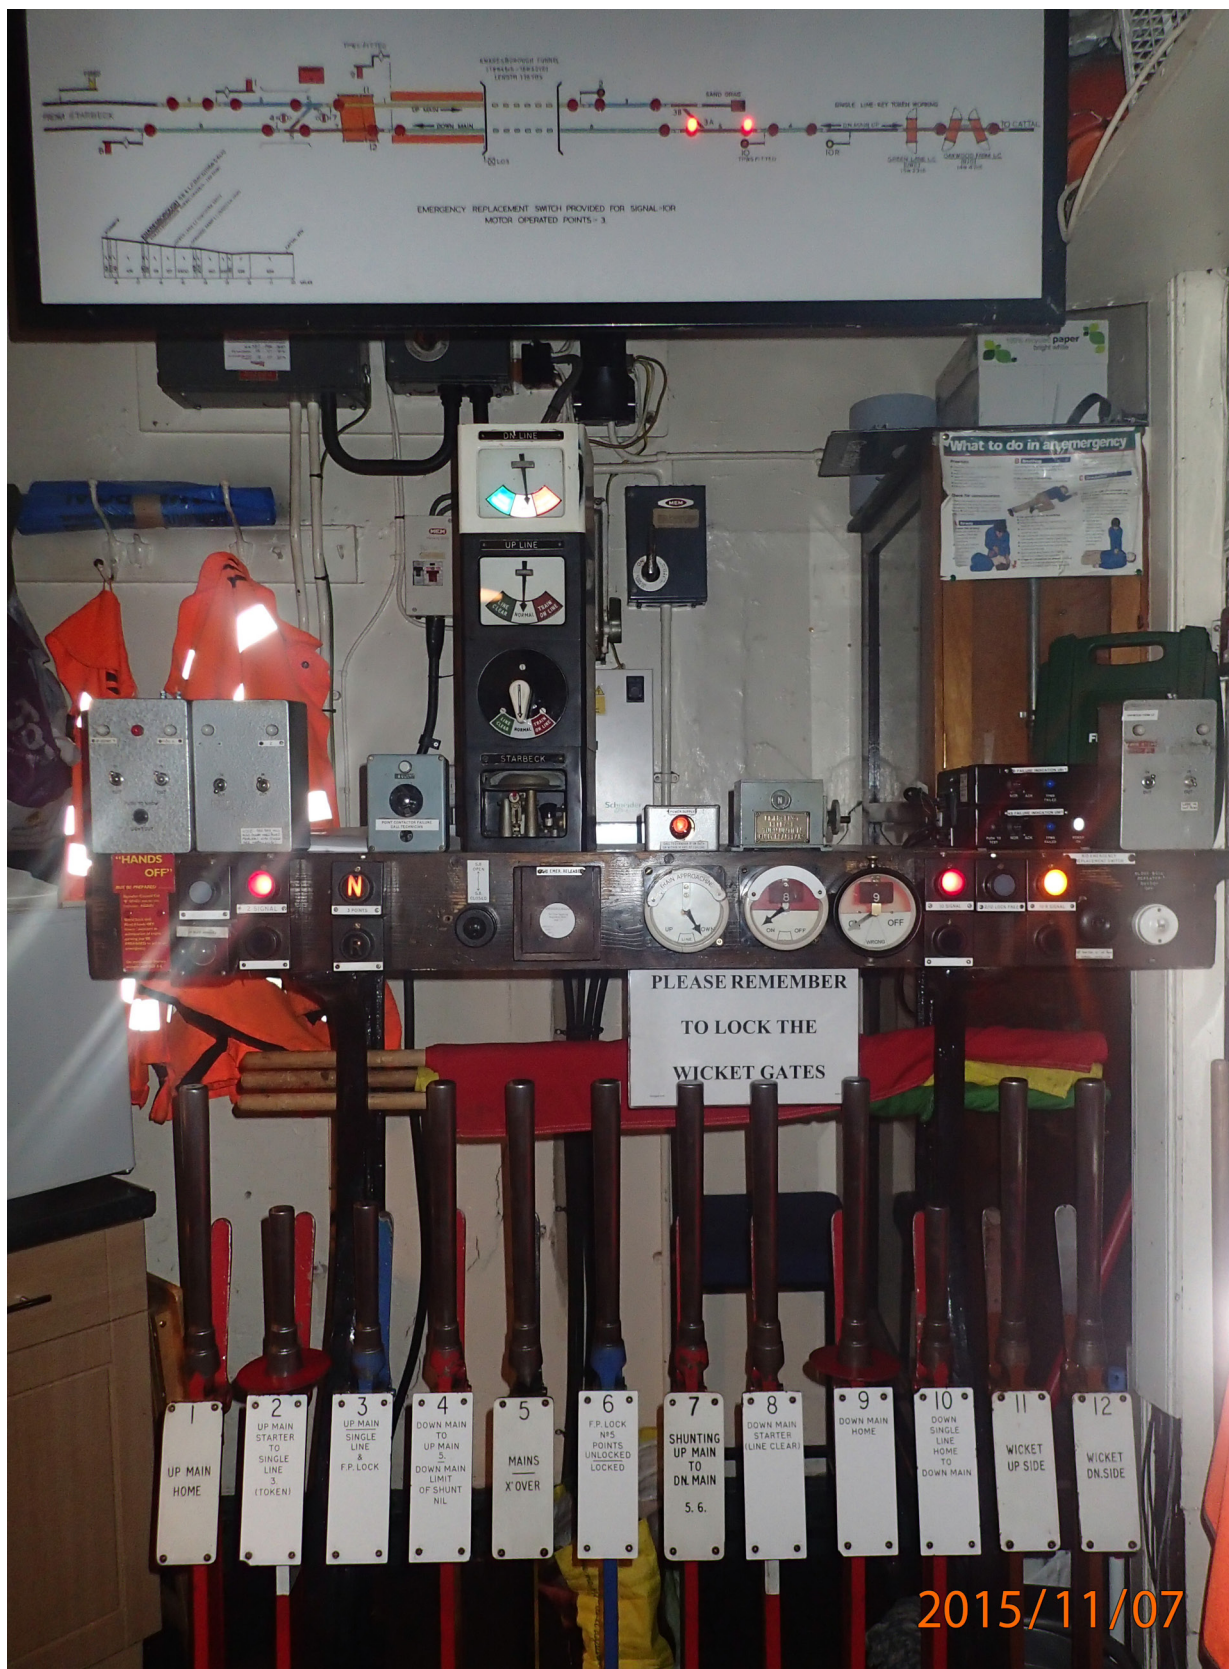
Figure 5: Knaresborough signal box lever frame

- 16 Knaresborough signal box is fitted with a frame containing 12 mechanical levers. The levers are used to operate the points and signals controlled by the signal box. The area controlled by the box spans from Oakwood Farm crossing to the east to signal K8 on the DownYork line to the west.

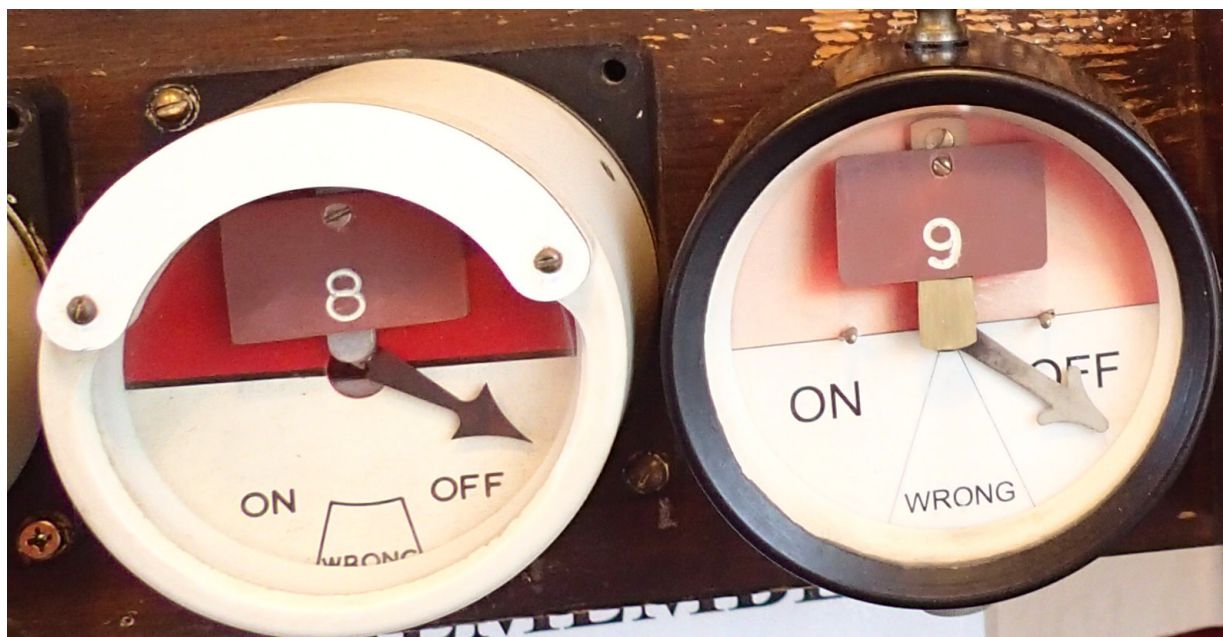
Figure 6: Signal aspect indication at Knaresborough signal box for signals K8 and K9 (semaphore)

- 24 Mechanically operated semaphore signals are moved by a wire which pulls the arm to the 'clear' (or 'off') position when the signaller reverses the corresponding lever. An indicator, located on the shelf above the signal lever provides the signaller with confirmation of the position of the semaphore arm (figure 6).

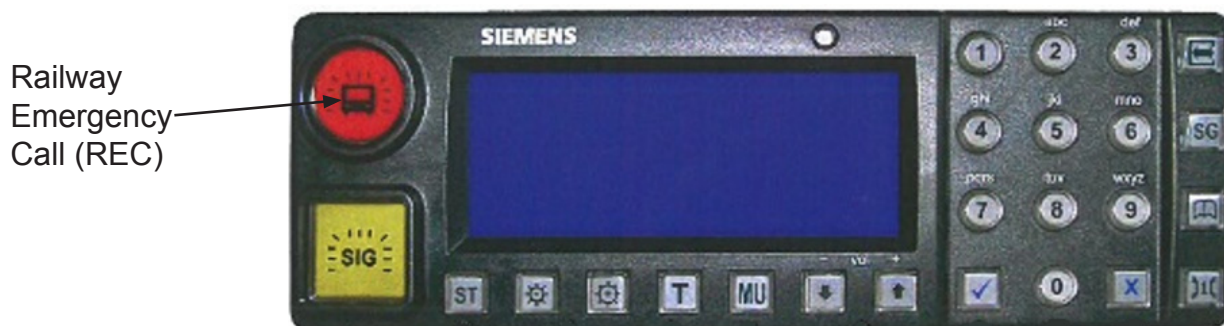
Figure 10: GSM-R terminal

<sup>7</sup> The yellow button on the GSM-R terminal initiates a call between the driver and the signaller in the controlling signal box (figure 10 shows a picture of the GSM-R terminal). The red button on the terminal (Railway Emergency Call – REC) sends an 'all train stop' signal to any train in the same operational area.

- 92 During the derailment, the driver brought his train to a stop using a succession of brake applications in various brake steps. Had he used the emergency brake, the distance travelled post derailment would have been less and therefore the damage caused could have been reduced.
- 93 The driver used the yellow button on his GSM-R terminal to try to contact the signaller after the derailment (figure 10). This was unsuccessful as the signaller was on the station platform at the time, waiting for the token to be handed back to him. This had no effect on the incident but it would have been more appropriate to immediately use the REC button to raise the alarm. The REC button sends an 'all trains stop' signal to any train in the same operational area to reduce the risk of a secondary collision.
