Rail Accident Report

Runaway of a road-rail vehicle at Bradford Interchange 8 June 2018

Report 01/2019
March 2019

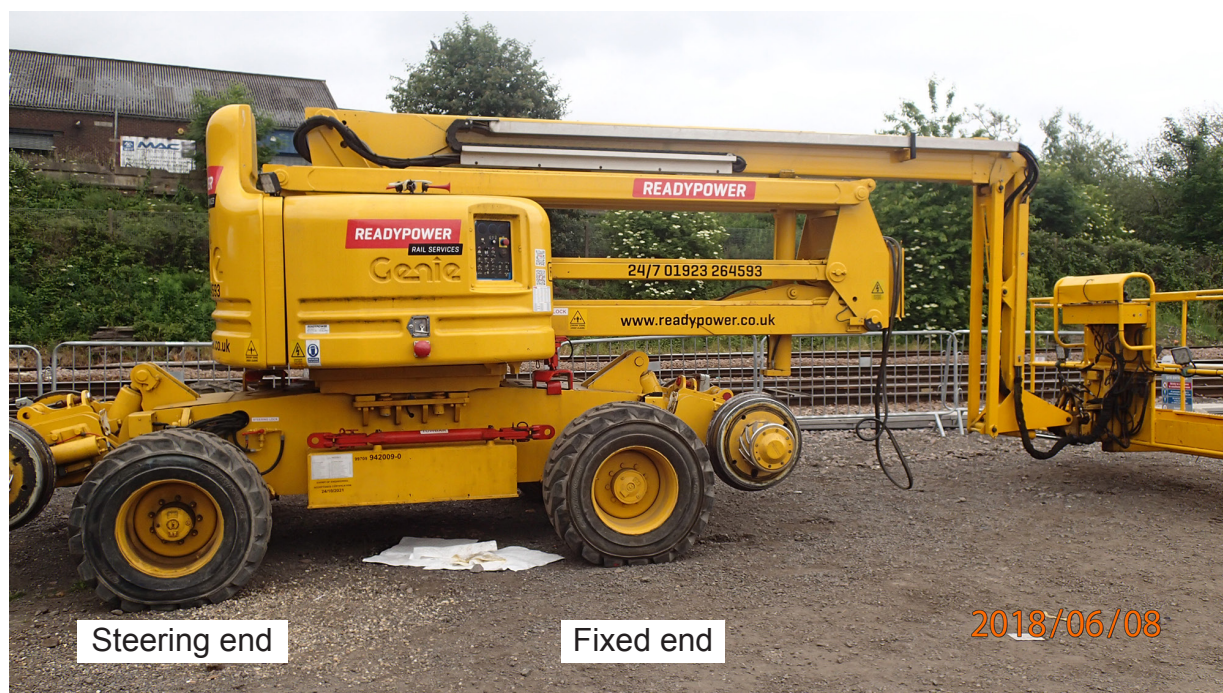
Figure 2: The RRV involved in the incident

- 4 The RRV was a Genie Z60/34 Mobile Elevating Work Platform (MEWP), which was owned and operated by Readypower Rail Services Ltd (referred to as Readypower in the rest of this report) (figure 2). It weighed 17.5 tonnes. There were two members of Readypower's staff with the MEWP at the time of the on-tracking operation, a machine operator and a machine controller. Unable to stop the runaway, they both were able to keep up with the silent and unlit machine as it ran towards the station, and they warned others of its approach.

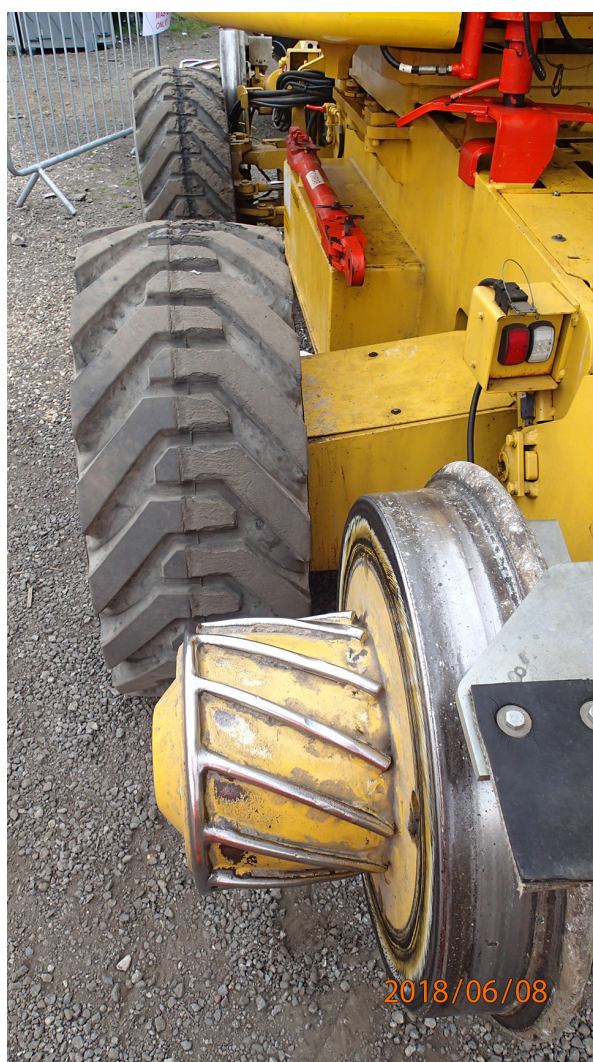
Figure 4: Hubs at the end of the rail axles

- 13 The MEWP is known as a high-ride type 9b RRV. Machines of this type have rail wheels that are driven and braked by friction forces transmitted through the tyres of the road wheels onto hubs fitted at the end of the rail axles (figure 4). Since 2014, this RRV type has also been fitted with brakes on its rail wheels (the Direct Rail Wheel Braking system). This is a supplementary braking system which acts directly on the rail wheels using brake callipers pushing pads onto discs that are fitted to the rail axles. The DRWB system works in parallel with the braking achieved through the road wheels. However, it is the only effective braking system when the road wheels are not touching the ground and are not in full contact with the rail wheel hubs (figure 5). The DRWB system was retrofitted to all type 9b machines following previous runaway incidents. The project to do this was led and financed by Network Rail between 2011 and 2014.

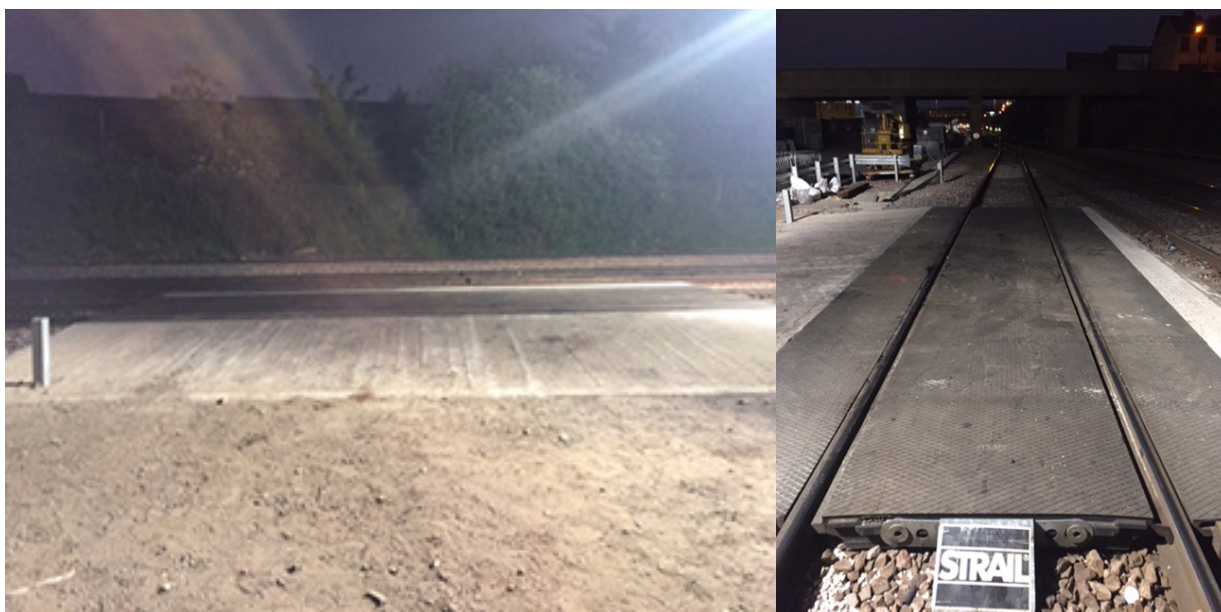
Figure 9: Britannia Street RRAP on night of the incident (courtesy of Network Rail)

- 18 It was a dry, mild night with a temperature of 10°C recorded at a nearby weather station in Bradford at the time of the incident. It was dark, but ample artificial light was provided at the RRAP by temporary flood lights (figure 9).

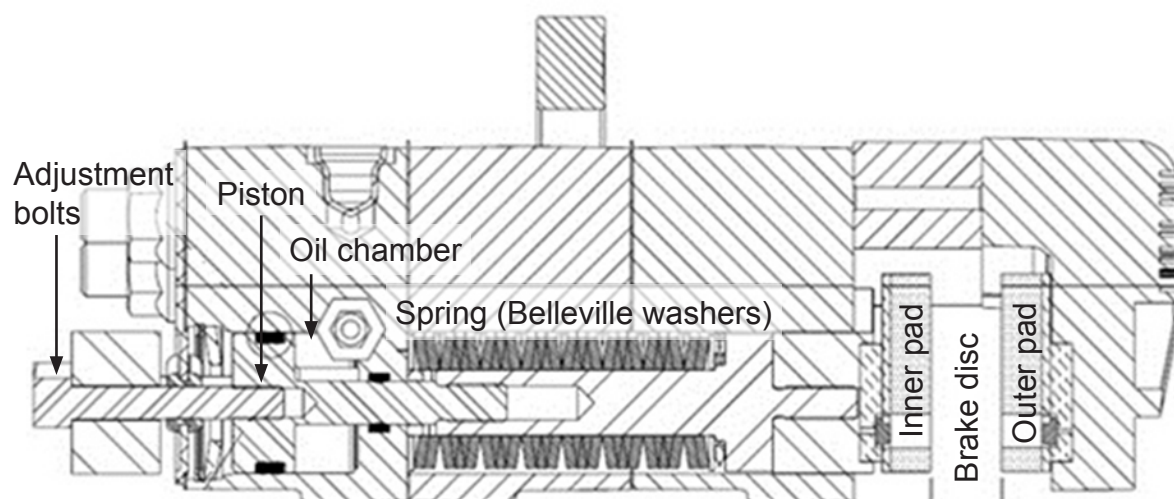
Figure 18: Calliper cross-section

67 The brake pads were worn.

- 68 Figure 17 shows the DRWB system fitted to the incident MEWP and figure 18 shows a cross-section of the calliper. The Hargreaves design uses a single acting calliper installed on a floating mount to accommodate a fixed brake disc. This design is replicated at every wheel. The clamping load (applying the brake) is provided by a spring made of Belleville washers¹⁰ in compression. In order to release the brakes, hydraulic pressure is provided to the calliper to further compress the spring. The calliper is fail-safe as a loss of hydraulic pressure results in the brakes being applied.

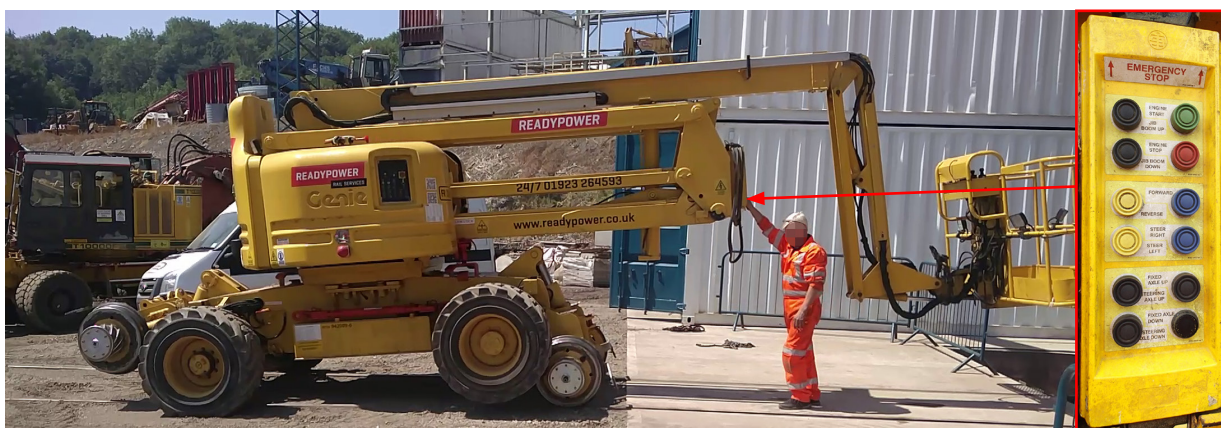
Figure 21: Operator pressing the rail axle deployment button at bottom of pendant

- 99 As the MEWP started to roll away, the machine operator and machine controller stated that they started to panic. The engine had stopped either because of an engine fault or because the emergency stop button had been pressed, and it needed to be restarted before the deployment of one of the rail axles could be completed. However, having elected to leave the pendant in its housing, the machine operator was now unable to press the 'engine start' button which was located at the top of the pendant, out of reach¹⁵ (figure 21). He was also unaware that the emergency stop button had been pressed; it needed to be reset before the engine could be restarted.

¹⁵ The buttons to raise and lower the rail axles are at the bottom of the pendant.
