Rail Accident Report

Overturning of a tram at Sandilands junction, Croydon 9 November 2016

Report 18/2017
December 2017

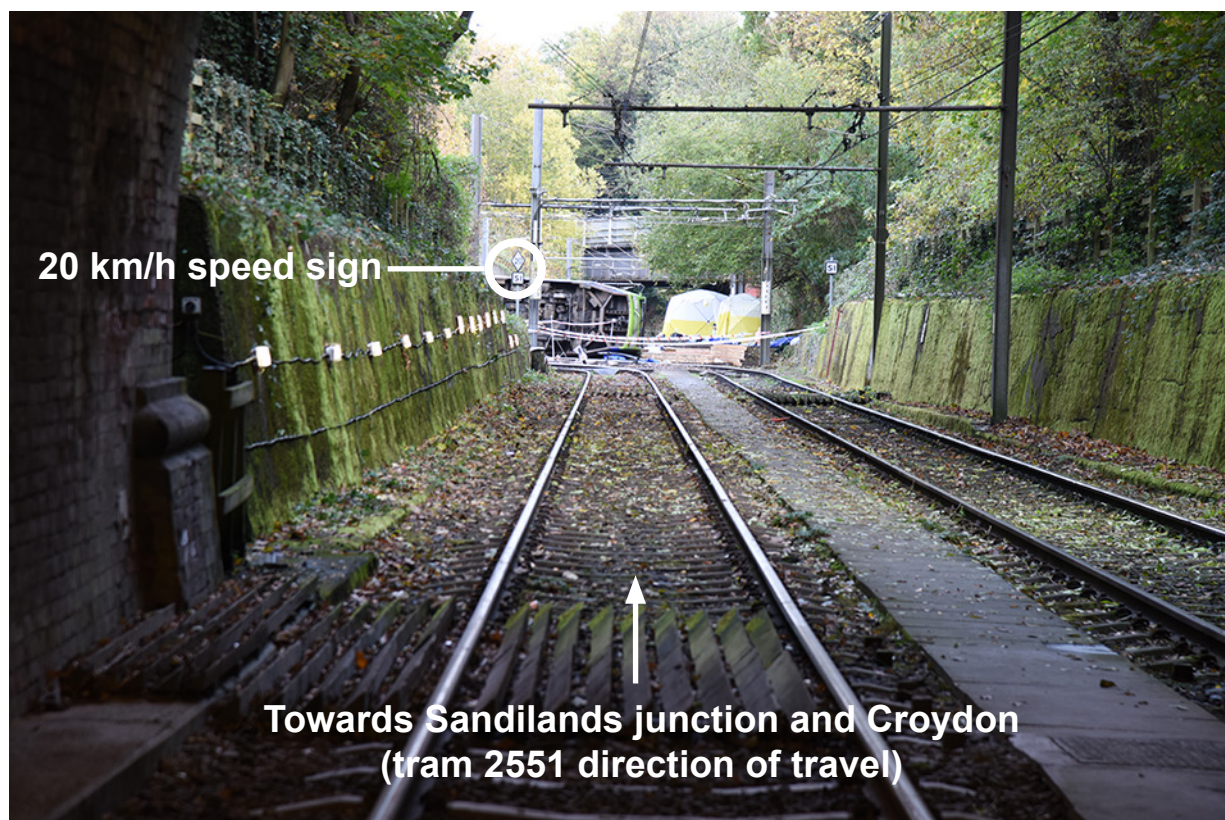
Figure S1: View emerging from the tunnels

- S4 The tram passed through the tunnels at around 80 km/h (50 mph). When it emerged from the far end (figure S1), at 06:07 hrs, it had not slowed down as trams normally do, and was still travelling at 78 km/h (48 mph). Through the darkness and heavy rain, the tram approached the reflective sign which marked the point where its speed should have been reduced to 20 km/h (12 mph) to negotiate the curve. The driver applied the brakes, but the tram was still travelling at 73 km/h (45 mph) when it passed the sign, entered the curve, and began to turn over onto its right-hand side.

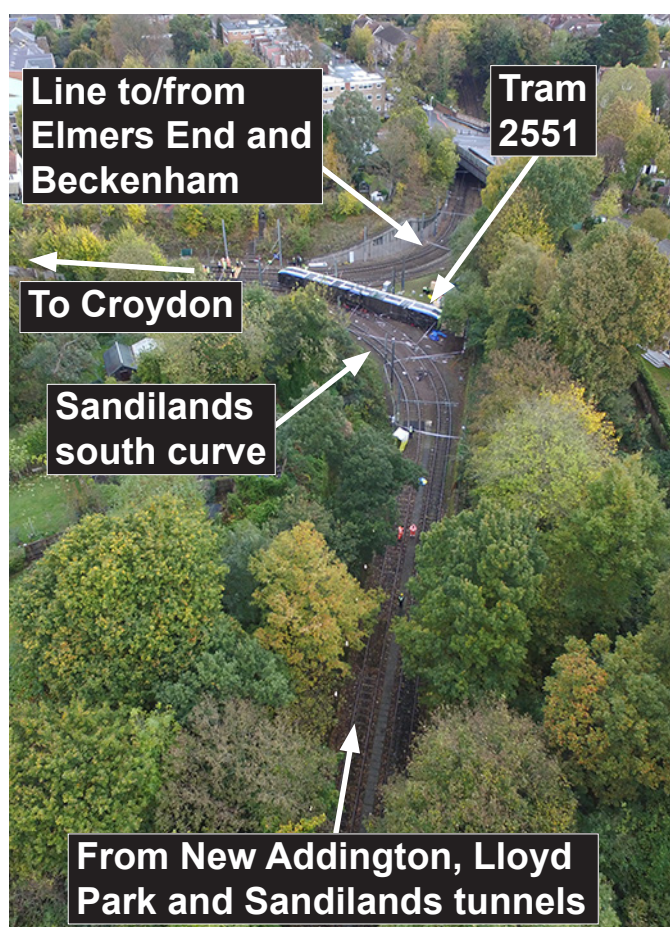
Figure S2: Final position of the tram

- S5 The passengers on the tram had no warning of what was to come. Some of them were standing, but most were seated, and as the tram began to tilt they were thrown across and around the vehicle. Some described it as “like being in a washing machine”. The windows on the right-hand side smashed as passengers were thrown against them, and as the tram hit the ground. Some of the doors on that side were torn off. People fell through the openings where the doors and windows had been, and were crushed under the tram as it slid to a stop, about three seconds after leaving the rails. The tram came to rest after travelling a distance of about 27 metres from the place where it left the rails (figure S2).

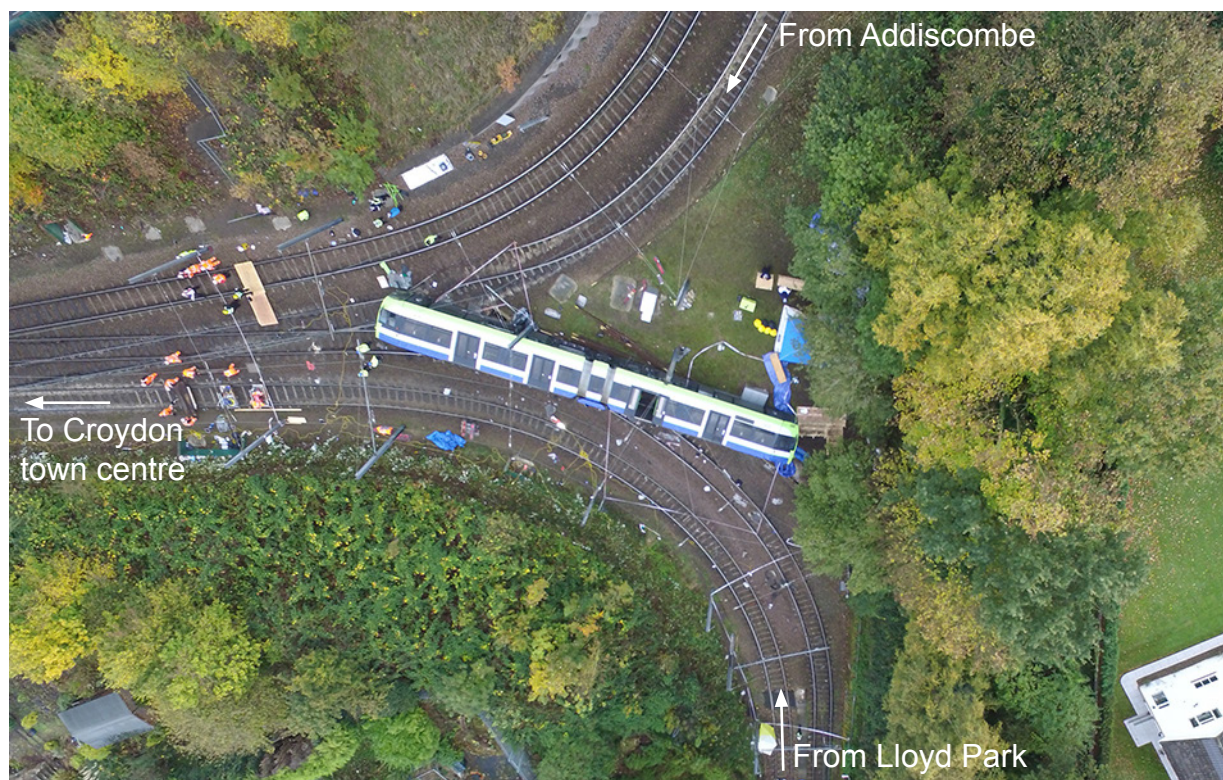
Figure 4: Final position of the tram

- 55 The tram came to rest after travelling for about three seconds and covering a distance of about 27 metres from the place where it left the rails. Approximately 18 metres of this distance was while the tram was rolling onto its side. It then slid on its side for the remaining 9 metres (figure 15). It had struck various items of lineside equipment and was lying across the outbound curve to Lloyd Park and the inbound curve from Addiscombe (figure 4).

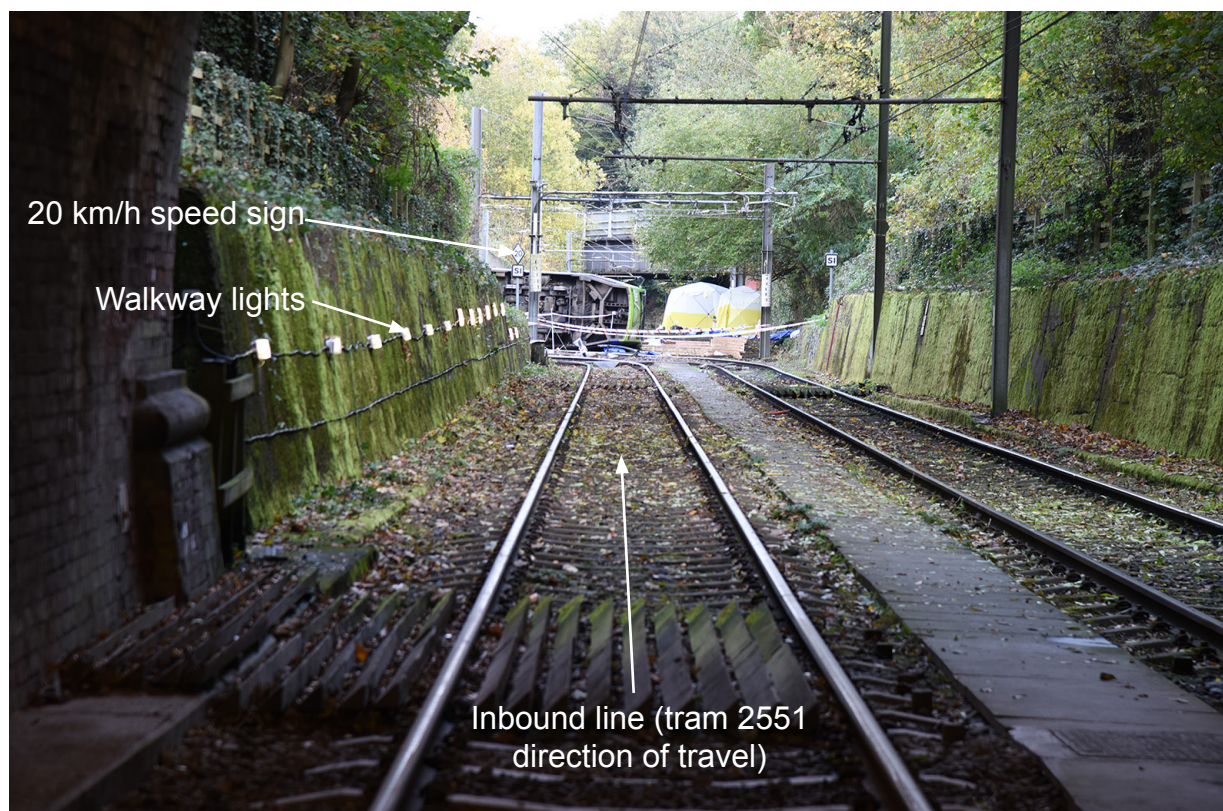
Figure 9: Approach to Sandilands south curve viewed from tunnel exit (overturned tram visible in distance)

- 23 On exiting from the Sandilands tunnels, trams travelling towards Sandilands junction emerge into a cutting and continue in a broadly straight line for a distance of about 94 metres until they reach the start of the left-hand curve on which the accident occurred (figures 8 and 9).

- 24 Along this section of straight track, and starting seven metres beyond the tunnel exit, there is a row of walkway lights fitted to the cutting wall adjacent to the left side of the track. These are positioned approximately five metres apart for a distance of around 70 metres, and are between 0.8 and 1.3 metres above ground level. These lights were installed in 2013 to illuminate a walkway used by tram drivers when they needed to park trams at that location during engineering works (figure 9).

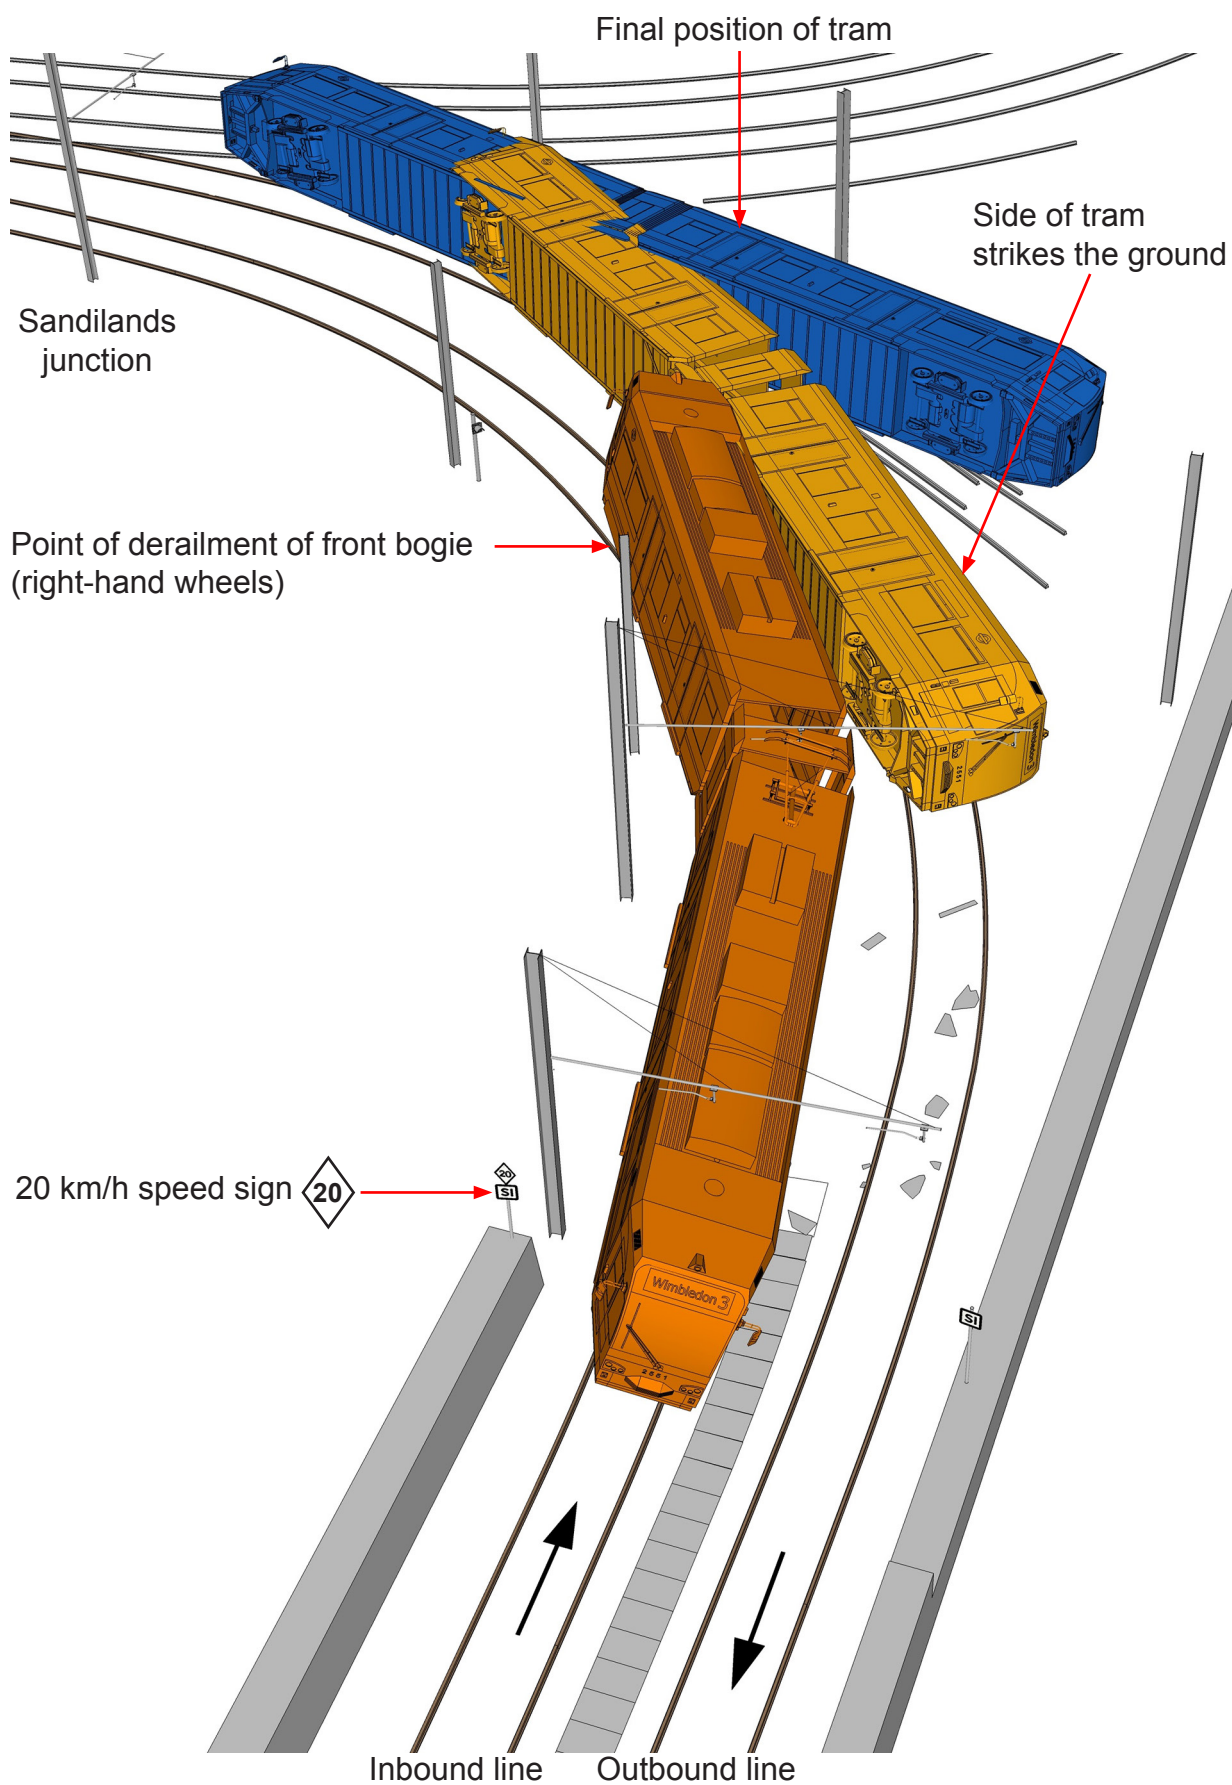
Figure 15: Accident sequence

- 115 The tram's path comprised two separate phases: one during which the tram continued to overturn and one during which the overturned tram slid along the ground before coming to rest. An overview of this motion is shown in figure 15 and details are illustrated in figures G.1 onwards (Appendix G). The tram travelled for approximately 18 metres once it had left the track before it fully overturned, and then slid on its side for approximately 9 metres. Overall, these two phases lasted for around three seconds.

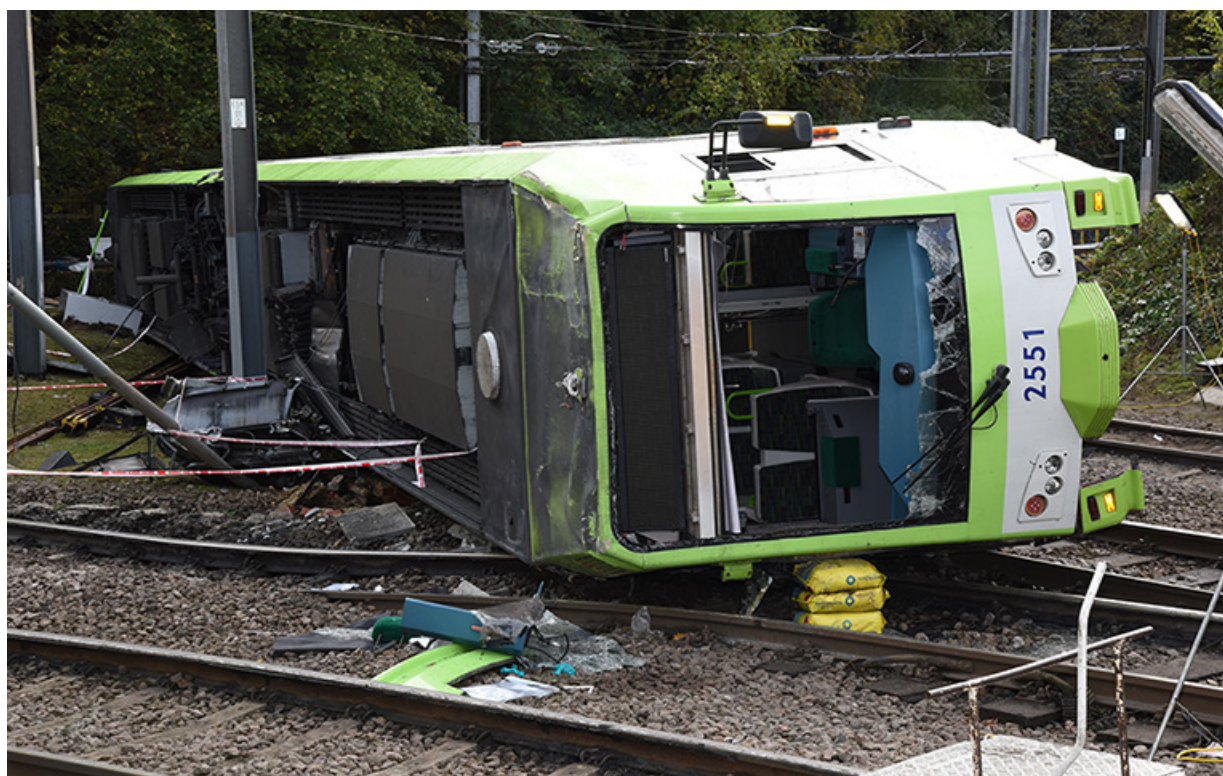
Figure 16: Front of tram with windscreen removed to evacuate passengers (initial hole formed by tram drivers/police officer, remainder removed by fire service)

- 62 One police officer helped the tram drivers enlarge the hole in the front windscreen. Together, they made the hole large enough for more passengers to leave the tram (figure 16). Meanwhile, other police officers were arriving and three made their way to the rear of the tram to try and break the rear windscreen. Several minutes later, the rear windscreen was successfully breached.

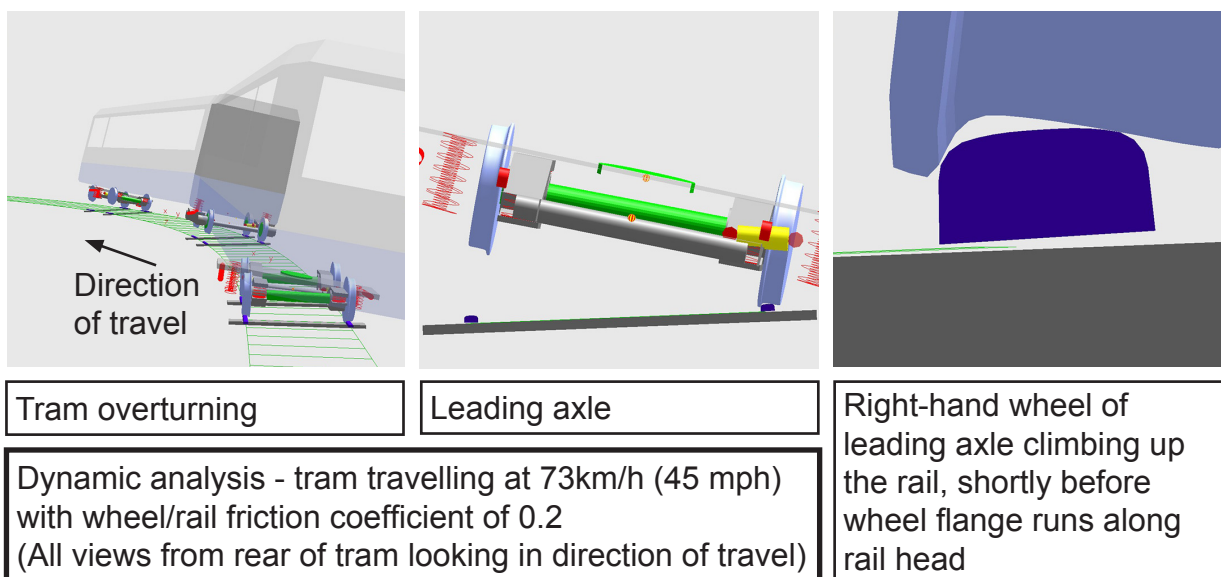
Figure 19: Tram overturning in dynamic simulation (images courtesy of Bombardier Transportation)

- 110 Figure 19 shows a pictorial representation of the output of the simulation in which the tram overturns when travelling at 73 km/h (45 mph) with a friction coefficient of 0.2. As the tram enters the curve, the lateral acceleration increases and induces roll on the vehicles. At the point shown in figure 19, the roll angle on the leading wheelset is approximately 13 degrees and the roll angle for the leading vehicle is similar. As the leading vehicle rolls, the intermediate and trailing vehicles follow it into roll. The simulation stops as the right-hand wheel starts sliding on the top of the right-hand rail.

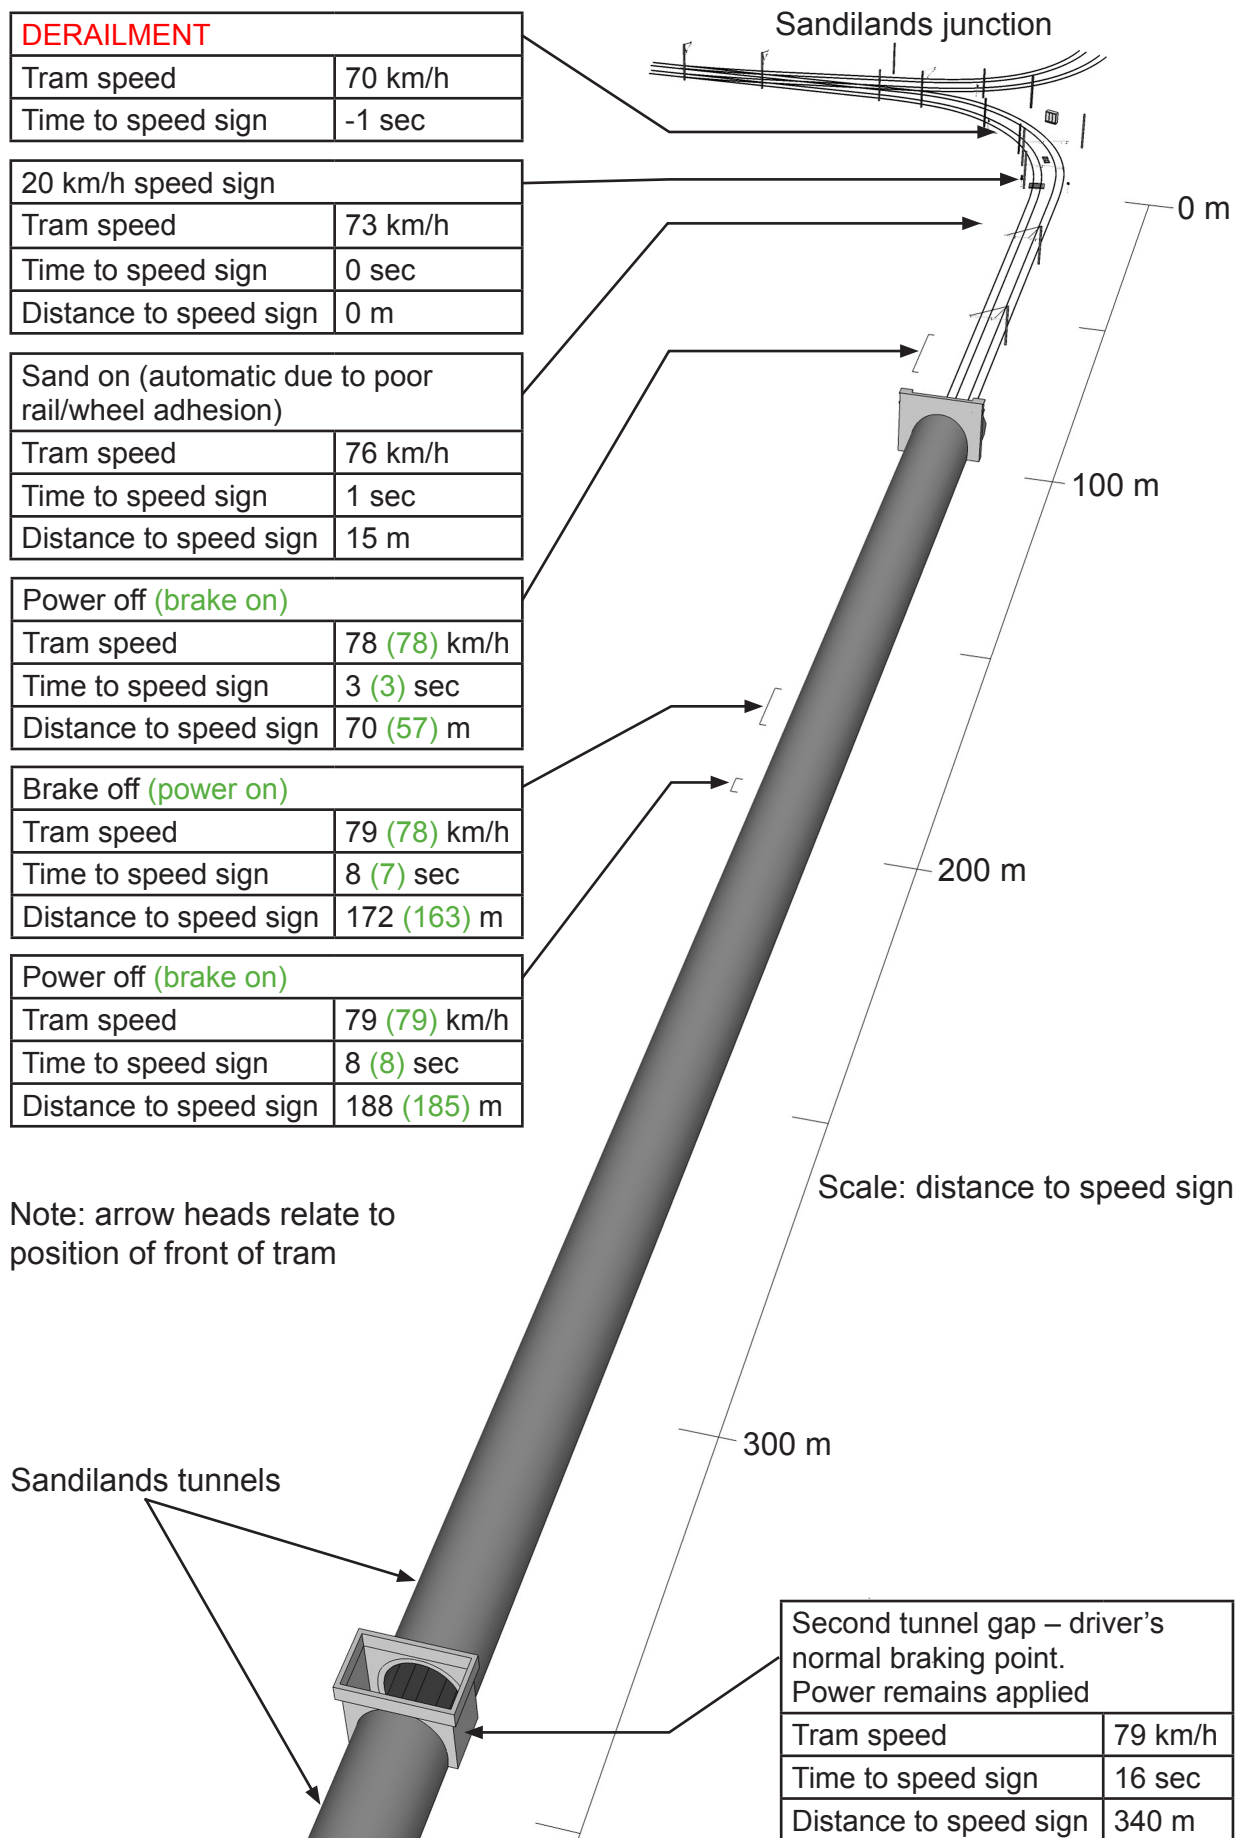
Figure 23: Information recorded by the OTDR as tram approached accident site

- 129 Information from the OTDR (figure 23) showed that when the tram passed the second tunnel gap, the TBC was in the drive position with the tram travelling at 79 km/h (49 mph). The TBC remained in drive for a further eight seconds. By then the tram was about 155 metres beyond the driver's normal braking point. At this point, about 185 metres from the 20 km/h speed sign, the driver then made a brief brake application of less than one second (paragraph 51). The driver stated that he realised that he had become disorientated at about the time that the tram passed the second tunnel gap. Although he cannot recall making this brake application, he believes that it may have been when he was reorienting himself (paragraph 153).

- 130 The driver's application of the service brake after exiting the Sandilands end of the tunnels took place about 57 metres, about three seconds, before reaching the 20 km/h speed sign at the start of the Sandilands south curve (figure 23). The driver was not able to recall why he had applied the brakes at this point but stated that this brake application was not because he now realised the tram was approaching the curve at Sandilands junction.

- 131 The OTDR does not record the level of service brake applied in the last 57 metres before reaching the 20 km/h speed sign. However, the tram's speed only reduced by 5 km/h over this distance (paragraph 52 and 53). Deceleration rates are determined by a combination of the amount of brake applied and the adhesion available at the wheel-rail interface. The exact effect of using alternative braking scenarios on the day of the accident cannot be determined with confidence because the wet condition of the rails at the time of the accident (paragraph 108) means it is possible that the available adhesion would have extended the braking distances given in table 1 (paragraph 32).

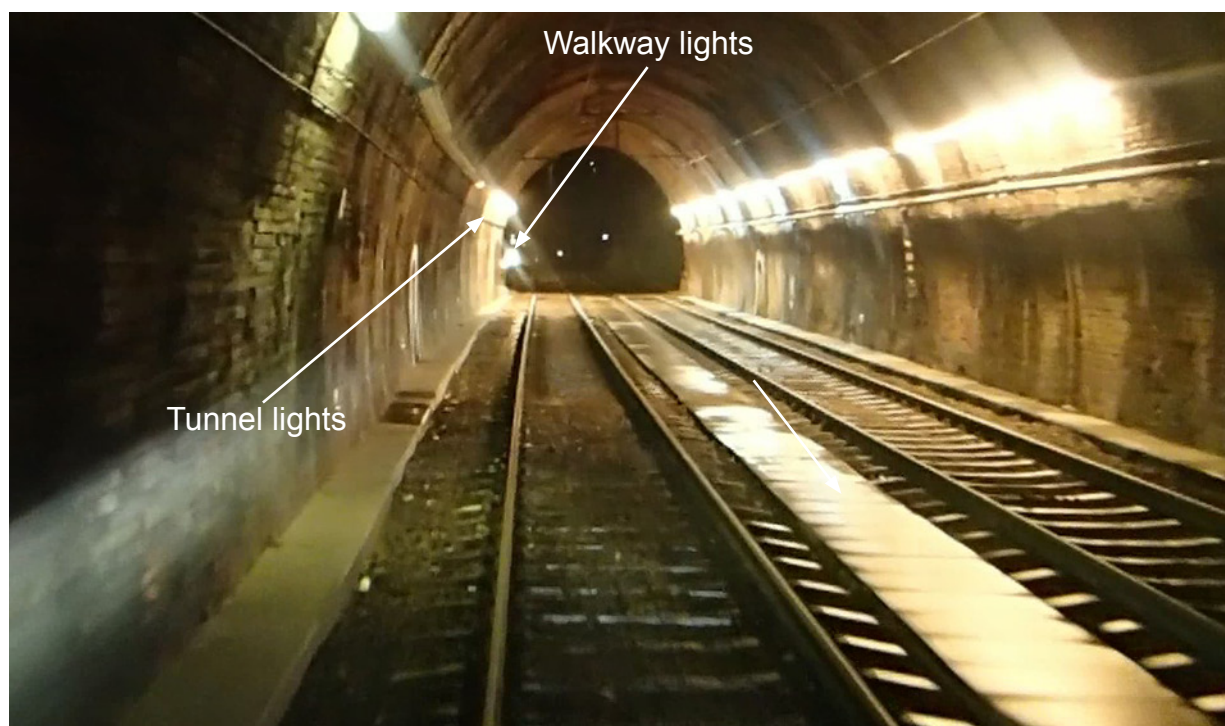
Figure 25: Walkway lights viewed approaching Sandilands west curve, about 80 metres from tunnel exit

168 The walkway lights adjacent to the left-hand side of the track on the exit from the tunnel were probably the strongest cue that the tram was exiting the Sandilands junction end of the tunnels. Similar lights are not provided when exiting towards Lloyd Park. The walkway lights start seven metres outside the tunnel mouth and continue at intervals of about five metres for a distance of 70 metres (until about 18 metres from the speed sign at the start of the curve). Testing by the RAIB and TRL showed that, when travelling towards Sandilands, these lights were visible about 250 metres before exiting the tunnel but are not distinguishable from the tunnel lighting until around 80 metres from the tunnel end (figure 25). At a distance of 50 metres from the tunnel exit, about seven seconds before reaching the 20 km/h speed sign, these lights would have been clear and distinct. Tram 2551 passed the last of the walkway lights less than a second before reaching the 20 km/h speed sign. Although it was raining heavily, visual perception of the lights is unlikely to have been affected by the rain.

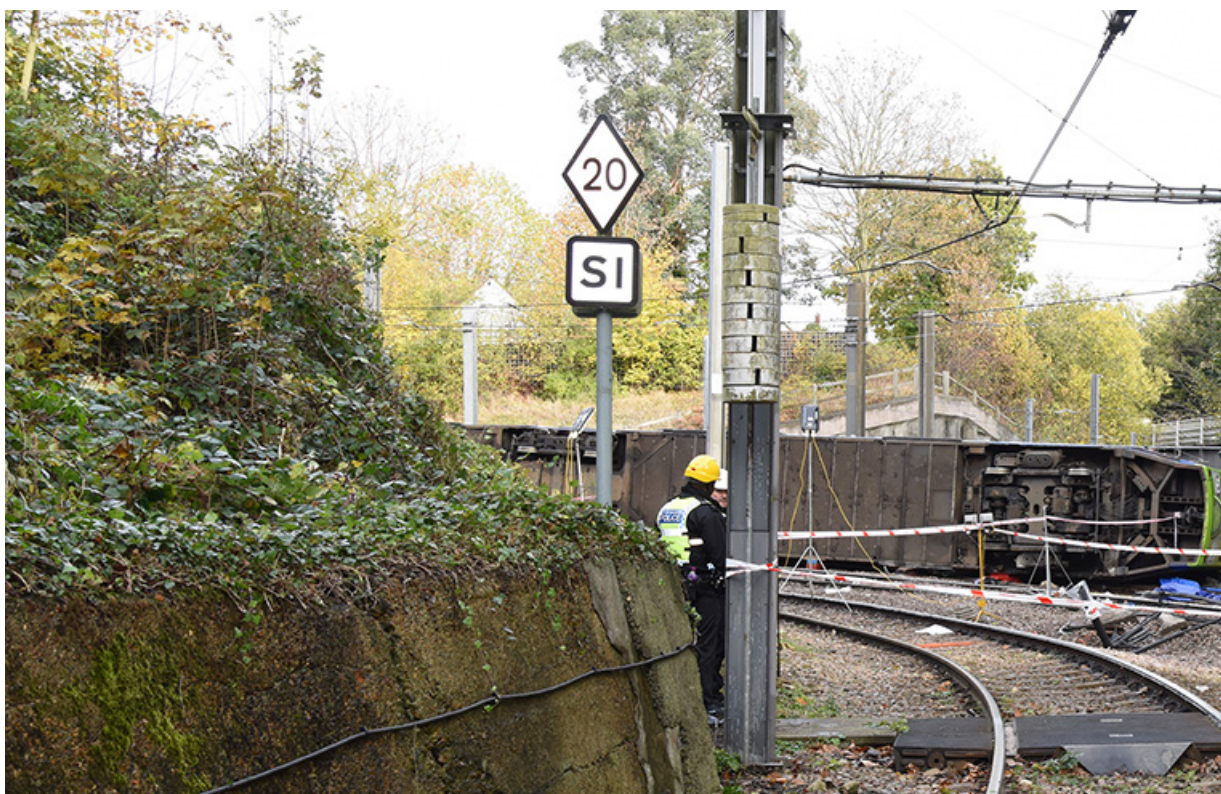
Figure 26: 20 km/h speed sign and 'SI' sign at the start of the west curve

- 169 The 20 km/h speed sign (figure 26), and sighting of the curve itself (figure 10), were both potential cues to the driver that he was approaching Sandilands south curve. If not recognised as being at Sandilands south curve, they provided information about the need to slow the tram rapidly. However, neither of these cues alerted the driver to apply the braking needed to avoid the accident and neither resulted in the driver applying the hazard brake.

- 170 Post-accident testing found that the 20 km/h speed sign¹⁵ at the bend was readable at night from about 90 metres when the tram's headlamps were set to main beam, and about 60 metres when set to dipped beam. The testing also found that the left-hand curve was first visible at the same time as the speed restriction sign.

- The presence of an SI sign (figure 26) immediately beneath the speed sign which reduced the conspicuity of the speed restriction sign. Testing by TRL found that from 90 metres the speed restriction sign and SI sign reflected about the same amount of light, and that from 60 metres the SI sign reflected more light than the speed restriction sign. This was true of both main and dipped beam headlamp settings.

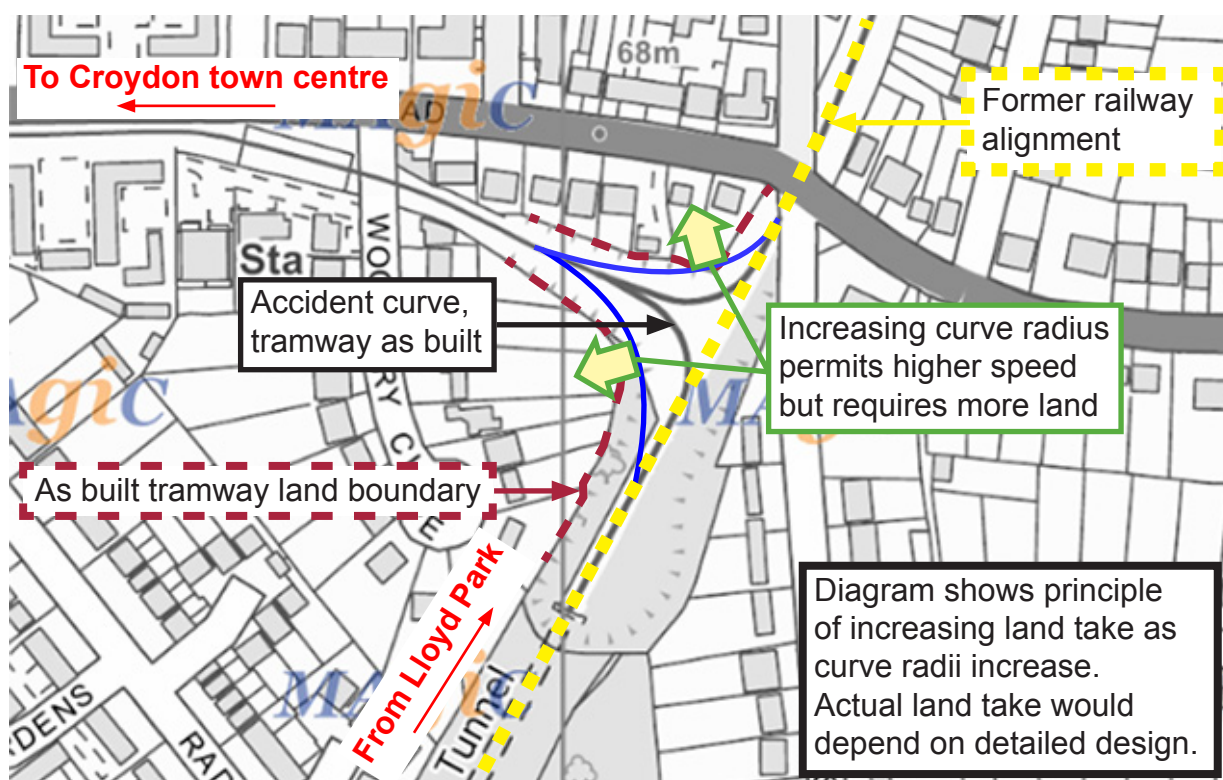
Figure 27: Land required at Sandilands junction (courtesy of magic.gov.uk)

- 193 The amount of land required for tramway construction in part depended on the radii of the curves linking the former alignment with the junction, with smaller radius curves requiring less land (figure 27). As the area was occupied by houses and gardens, there was a desire among designers, residents and others for the amount of land acquisition to be minimised. For this reason, relatively tight curves of approximately 30 metre radius were adopted and legal authority to acquire land was limited to the area needed for these relatively tight curves.

- 194 The installation of tight radius curves is normal on tramway systems in the UK and elsewhere in the world and can be essential to fit a tramway into an urban area. However, such curves, particularly those located after long stretches of high speed running, introduce a risk that overspeeding can result in derailment and overturning. This is a risk that needs to be recognised, assessed and adequately mitigated.

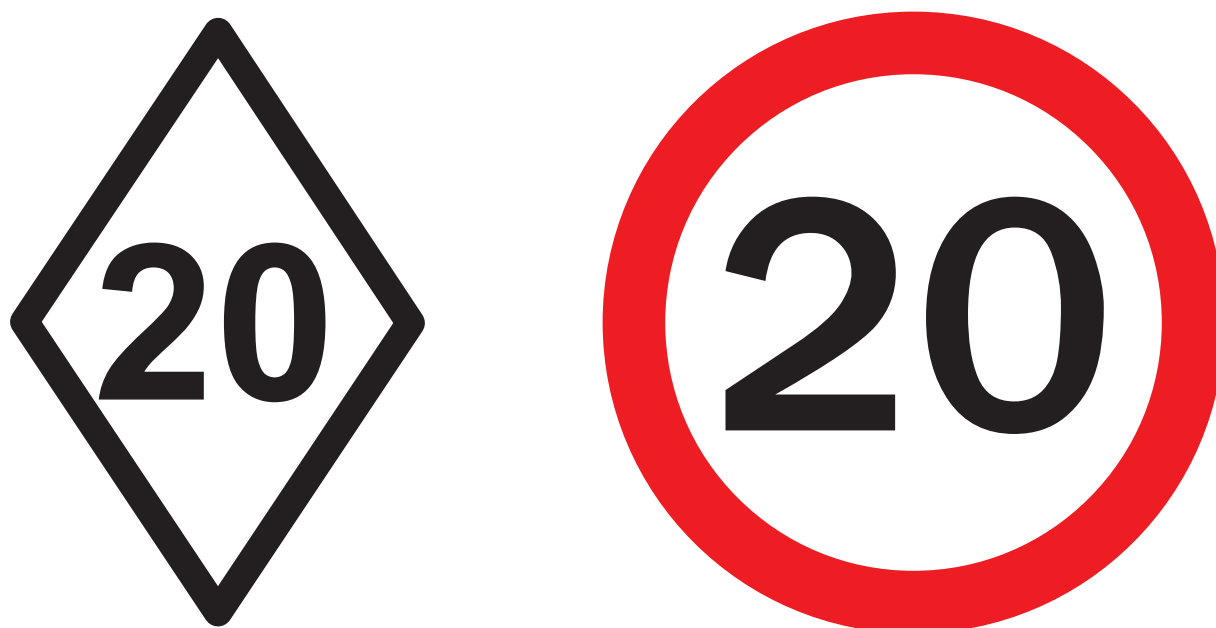
Figure 31: Maximum speed signs (to same scale) for trams (left image) and road vehicles (right image)

- 272 The speed limit signs for trams are different from those used for other road vehicles (figure 31) and both are described in The Traffic Signs Regulations and General Directions. TRL compared the surface area of the tramway speed sign from Sandilands with the equivalent road maximum speed sign that would be located on a road at which vehicles can approach at a maximum speed of 50 mph (80 km/h) (table 13). The tram speed restriction sign at Sandilands junction at the time of the accident had a surface area only 43% of that of an equivalent road speed limit sign. Therefore, the tram speed restriction sign will be less conspicuous than an equivalent road speed limit sign when installed in the same physical location with the same level of background lighting.

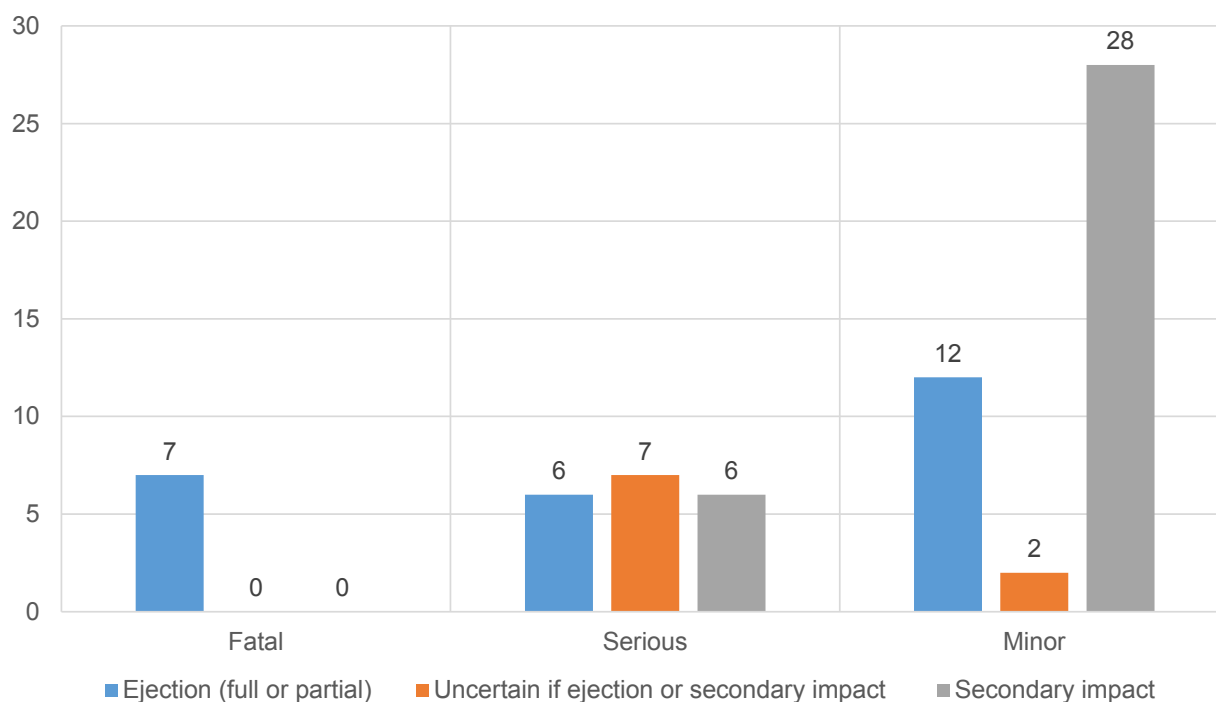
Figure 44: Primary cause of passenger injuries

305 The RAIB and its medical expert reviewed the accounts given by the passengers and the medical professionals who treated their injuries to determine what the main injury causation mechanisms were. The RAIB found that the only causes of significant injuries in this accident were ejection (full or partial) and secondary impacts. There is no evidence to suggest that any of the other injury causation mechanisms were encountered. Figure 44 shows the distribution of ejection and secondary impact injuries.

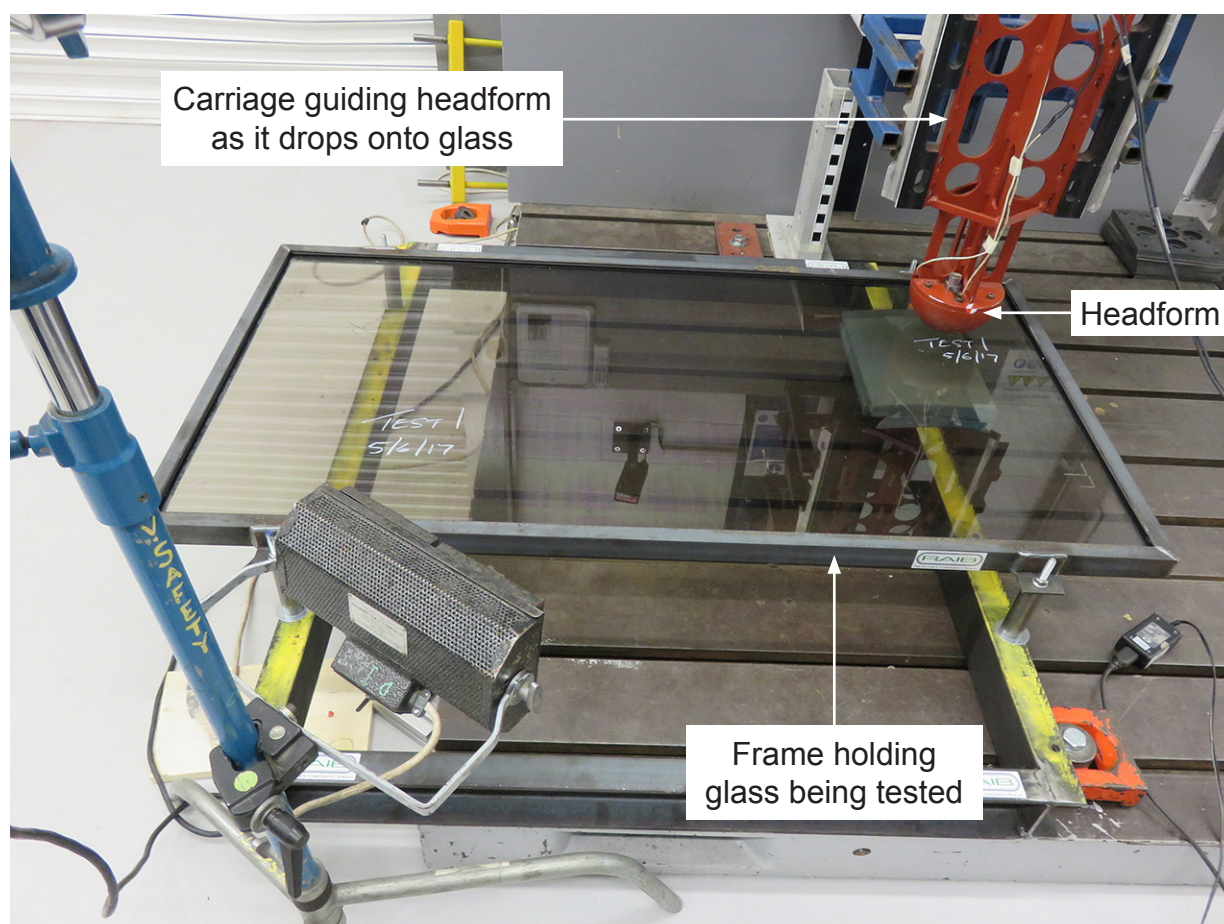
Figure 46: Window testing

- 325 In order to understand more about the mechanical strength of toughened glass, the RAIB conducted a series of tests on four intact windows from tram 2551 (the accident tram) and on another set of windows which had recently been removed from another CR4000 tram (both sets of windows were fitted with anti-vandal film, except one door window noted in table 16). The tests were carried out at Horiba MIRA³⁴, a UK-based testing facility for the automotive industry. They used a headform weighing 7 kg, dropped onto the windows from an increasing height, until the windows shattered. These tests were carried out on three types of window (window types 1, 2 and 3) and the headform was dropped in the corner or at the geometrical centre of the window. Figure 46 shows the window test setup.

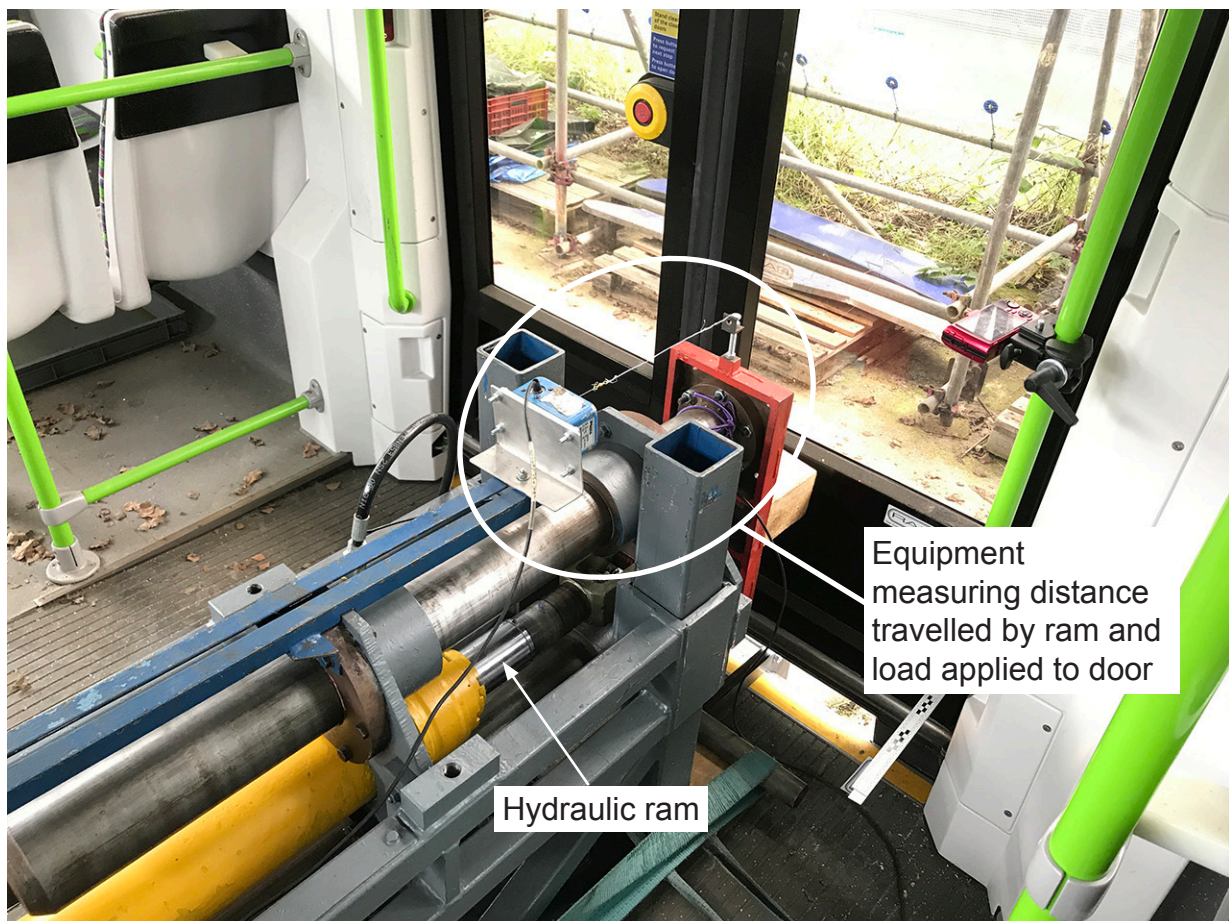
- 336 The RAIB tested undamaged doors from the left-hand side of the tram to understand why doors on the right-hand side had deformed and become detached during the accident. Loads were applied using a ram pushing against doors at either the height specified in BS EN 17452 or at locations approximately matching those where the damaged doors appear to have been struck by people who had been thrown across the tram (figures 47 and 48).

Figure 48: Door test ram and measuring equipment

- 337 In the first test, the proof load specified in BS EN 17452 was applied to one set of doors using a rigid beam mounted at 1300 mm above the door threshold and bearing against the doors' structural members. The doors suffered no permanent deformation and the force required to open the doors after the test, with the emergency release pulled, had not been increased. Hence, the doors were shown to meet the requirement specified in BS EN 17452. In the second test, the proof load specified in BS EN 17452 was multiplied by a factor of 1.5 to represent an ultimate loading condition where permanent deformation is allowed but without catastrophic failure. By the end of this test, the doors had suffered no permanent deformation and the force required to open the doors after the test, with the emergency release pulled, had not increased. In a third test, the door was taken to catastrophic failure (in this case, the rollers becoming disengaged from the retaining channel). This occurred at a load approximately seven times greater than the proof load in BS EN 17452.

- 338 The RAIB tested another two sets of doors with the loads applied at locations approximately matching those where the damaged doors appear to have been struck by people who had been thrown across the tram. These locations were lower than in the previous sets of tests (approximately 450 mm above the door threshold) and concentrated on the inner edge of one door leaf (near to where the door leaves meet when closed). In those tests (figure 49), the hydraulic ram was gradually extended and the displacement and load required to extend the ram were recorded. These tests showed that the load and energy required to force one door leaf open to create a gap large enough for someone to pass between the bottom of the door and the floor was smaller than in the previous sets of tests (to BS EN 17452) and was comparable to the load and energy from an individual passenger being thrown against the door. The RAIB therefore concluded that it was feasible for a passenger to have been ejected through this mechanism.

339 During these tests, the failure sequence for the door started with the glass shattering, followed by the corner casting at the top of the inner edge breaking. This was then followed by the failure of the second corner casting in the opposite corner. At that point the bottom of the door leaf was virtually unrestrained and would become detached under minimal additional load. The RAIB noted that these failure mechanisms seemed to be consistent with the failures observed on the right-hand side doors that became detached during the accident.

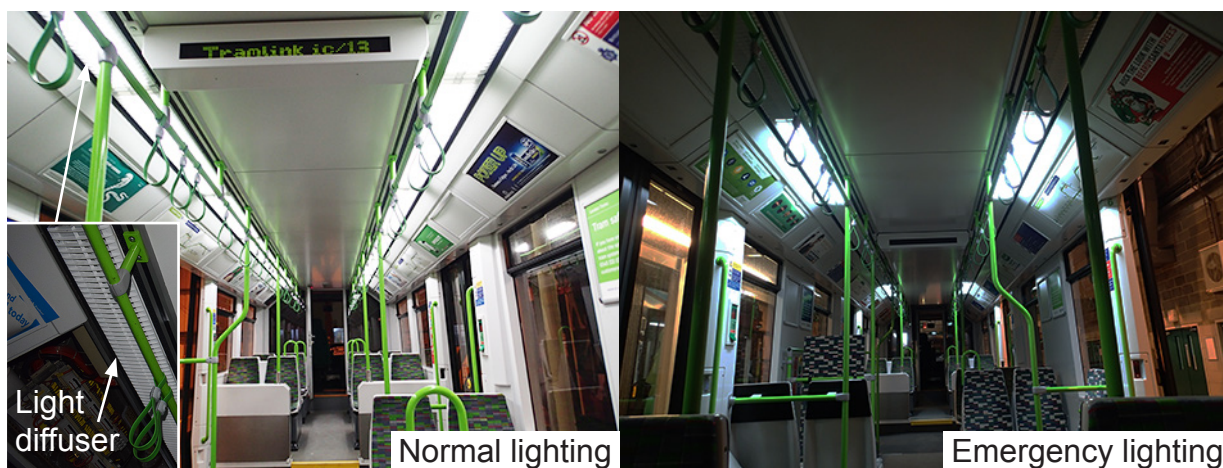
345 The tram's emergency lighting did not work once the tram had overturned.

346 The tram is provided with two rows of fluorescent tubes running along the length of the ceiling and fitted with light diffusers (figure 50). In the event of a loss of supply from the overhead power line, power is provided through roof-mounted batteries, but to a reduced number of tubes which are located around the doorways.

Figure 50: Lighting system

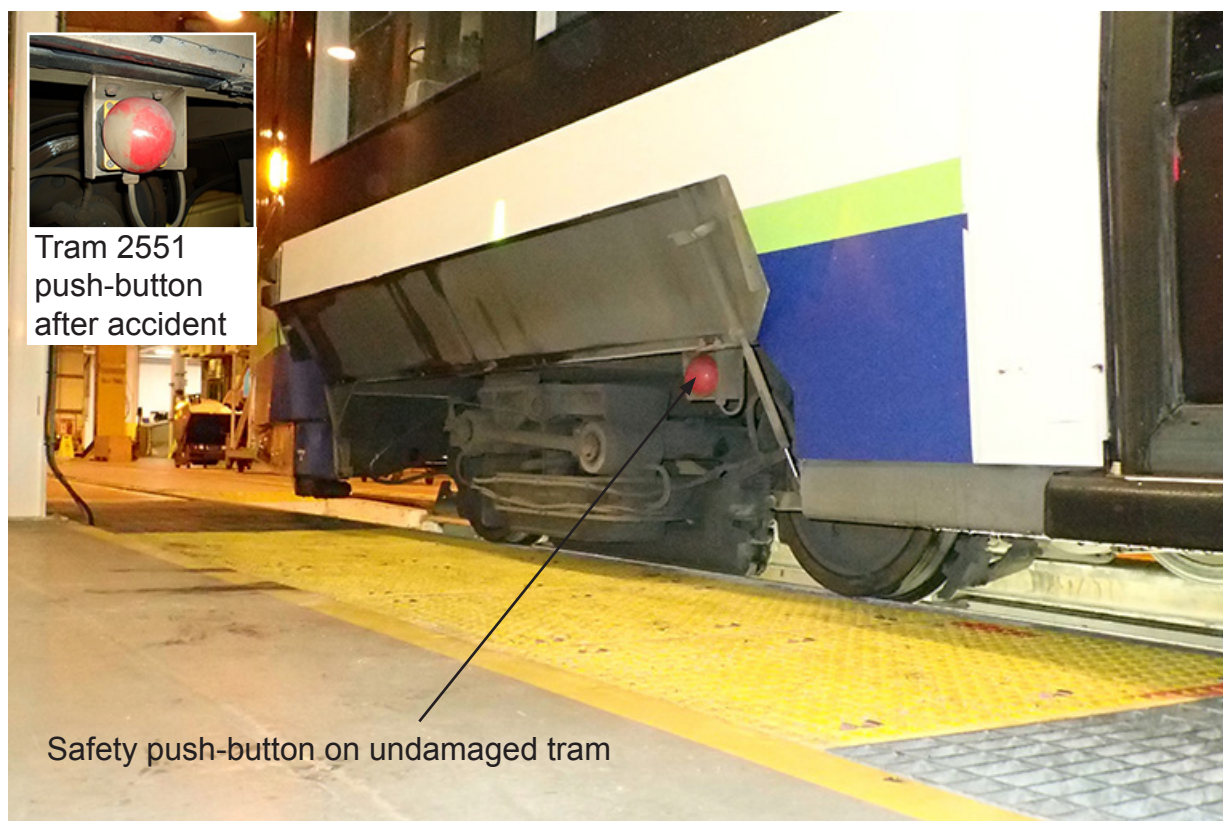
348 As the tram overturned, the lighting system became completely disabled when a safety push-button (figure 51) was operated when the side of the tram came into contact with the ground. This cut off all power supplies, including the one from the batteries³⁵. This push-button is provided to allow the tram to be electrically disabled by the emergency services.

Figure 51: Safety push-button for tram's electrical system

³⁵ All the roof-mounted batteries that supply the lighting system were damaged during the accident but two of the four batteries remained available to power the emergency lights.
