Rail Accident Report

Overturning of a tram at Sandilands junction, Croydon 9 November 2016

Report 18/2017
December 2017

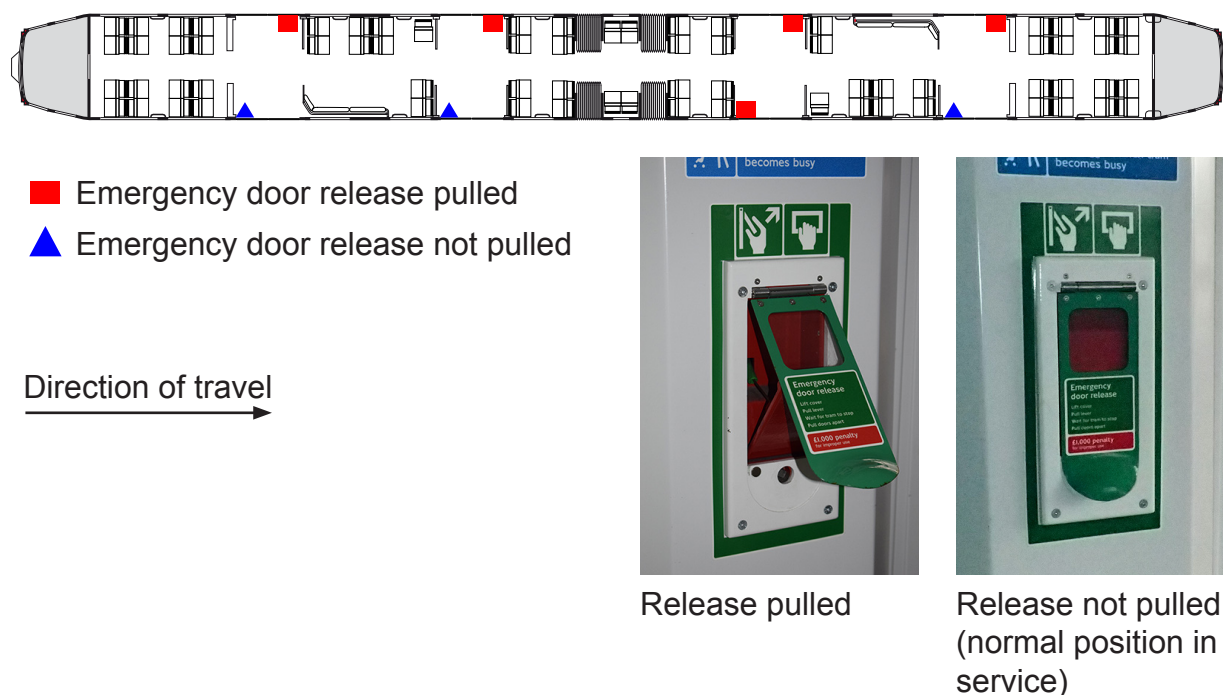
353 Each door is fitted with an emergency door release handle. Operation of the handle disengages the door driving mechanism and enables the user to manually push the door leaves open. Figure 52 shows the emergency door release handles and identifies the handles that had been pulled after the accident.

Figure 52: Emergency door release system

354 The position of the tram after the accident meant that the door leaves had to be pushed upwards before they could be moved apart (after operation of the door release handle). This was a difficult operation to complete for the passengers as these doors were above them and they were working at height and against gravity.

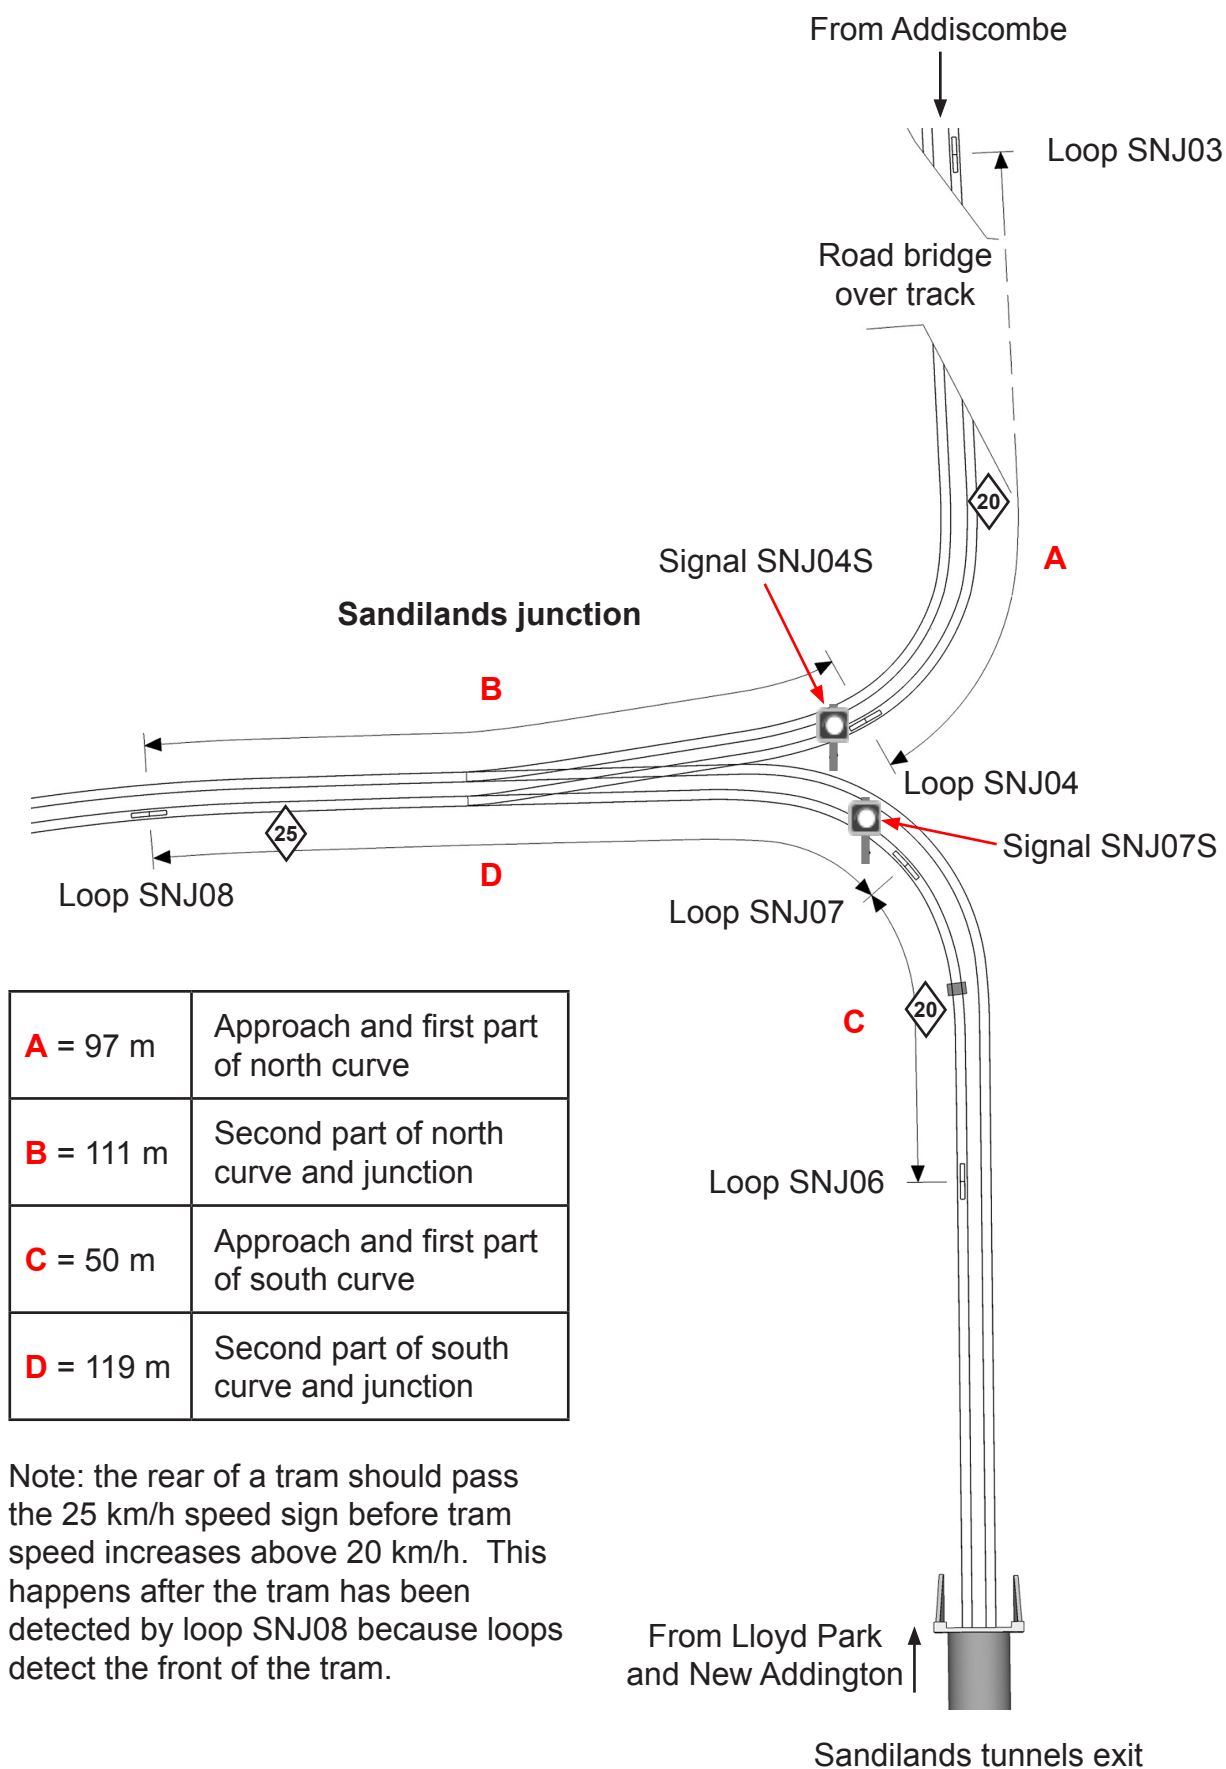
- 386 Loop data from 1 January 2015 to 21 December 2016 was analysed for pairs of loops on the Sandilands curves. This includes almost all tram transits in this period (a small proportion, less than 10%, were not analysed for reasons explained in Appendix D). Each loop pair is either the approach to a speed restriction plus part of that restriction or entirely within a speed restriction. The RAIB has calculated the maximum permitted average speed between each loop pair taking account of the higher speed permitted in the first part of some loop pairs (figure 53).

Figure 53: Position of loops used in the RAIB analysis

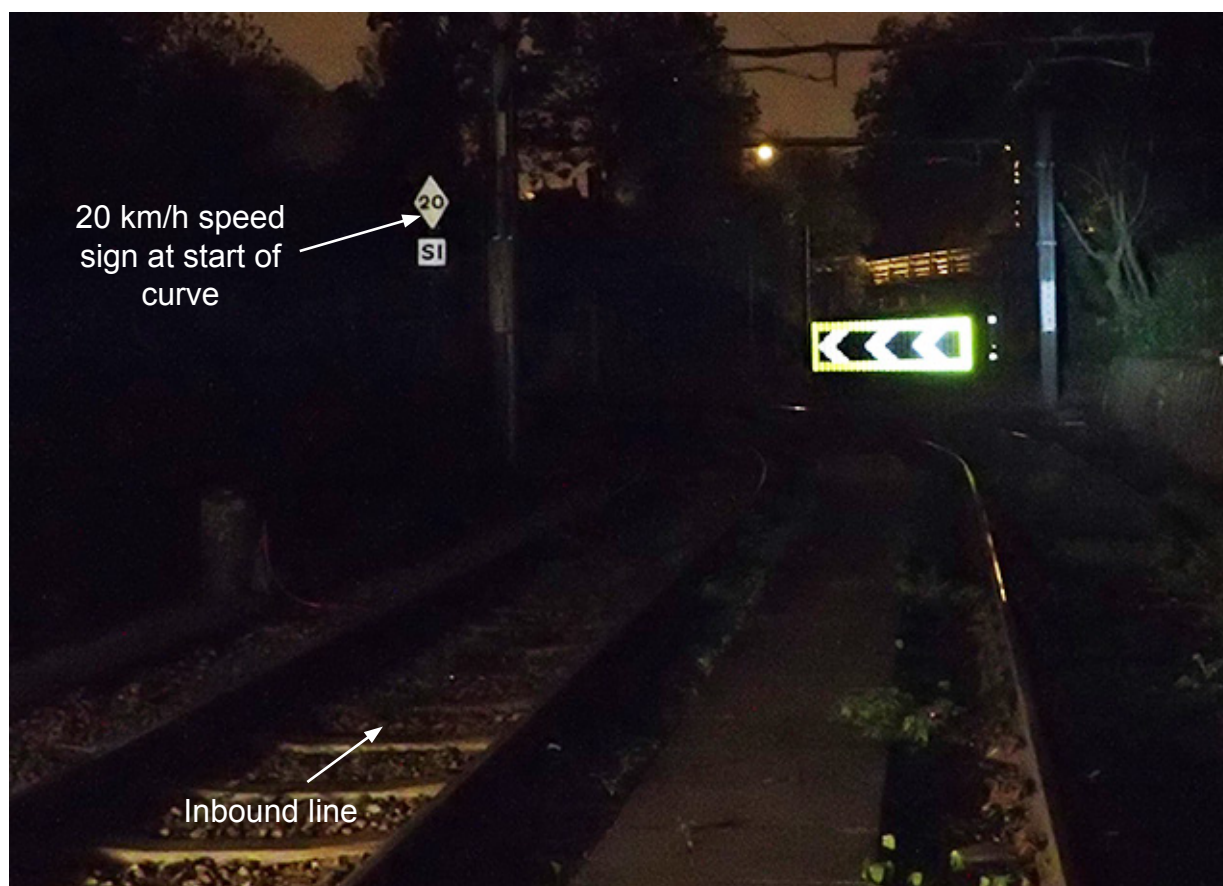
Figure 54: Chevron sign fitted as part of the signage changes at Sandilands south curve after the accident

479 In response to the Urgent Safety Advice issued by the RAIB (paragraph 65, Appendix F), additional signage, intended to remind drivers of the need to reduce speed, was added at Sandilands south curve before tram services restarted at this location (figure 54). LT report that it also installed additional signage at three other locations on the Croydon tramway.

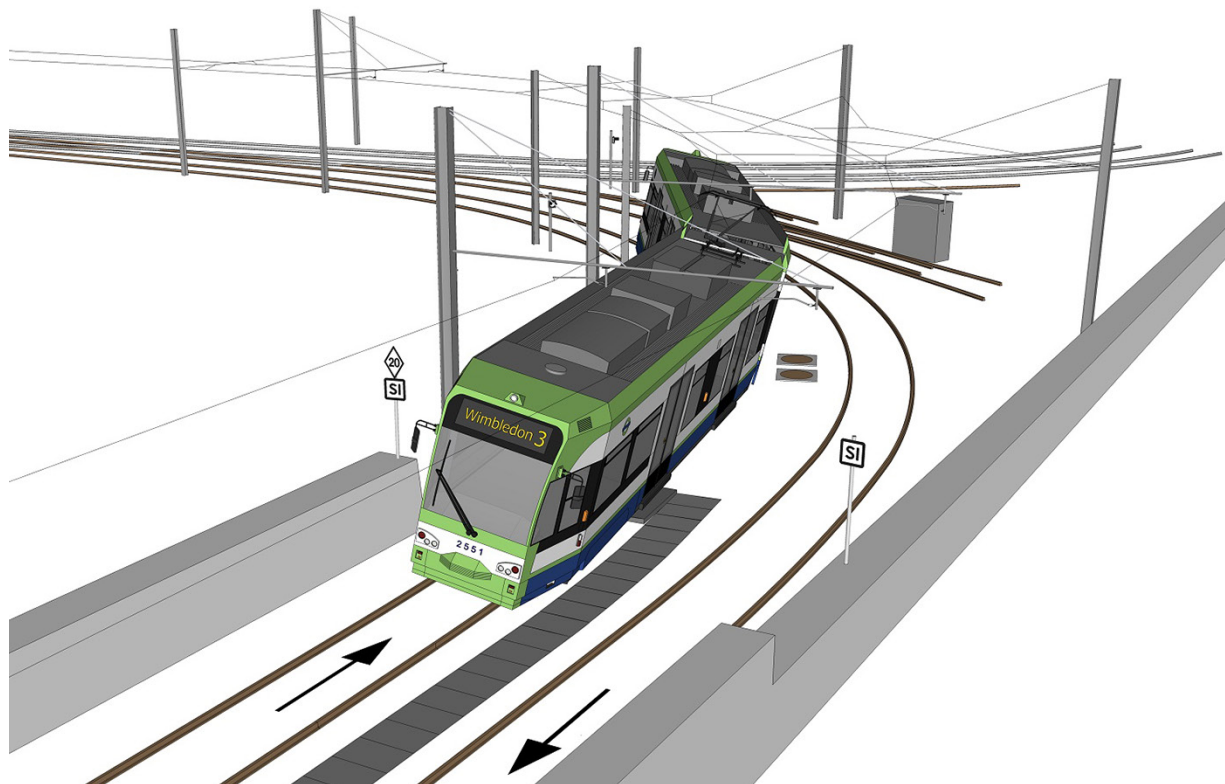
Figure G.1: Overview when front wheels become derailed (point of derailment). Tram is tilting over at about 10°. Note: the flexible connections between the sections of the tram are not shown for clarity.

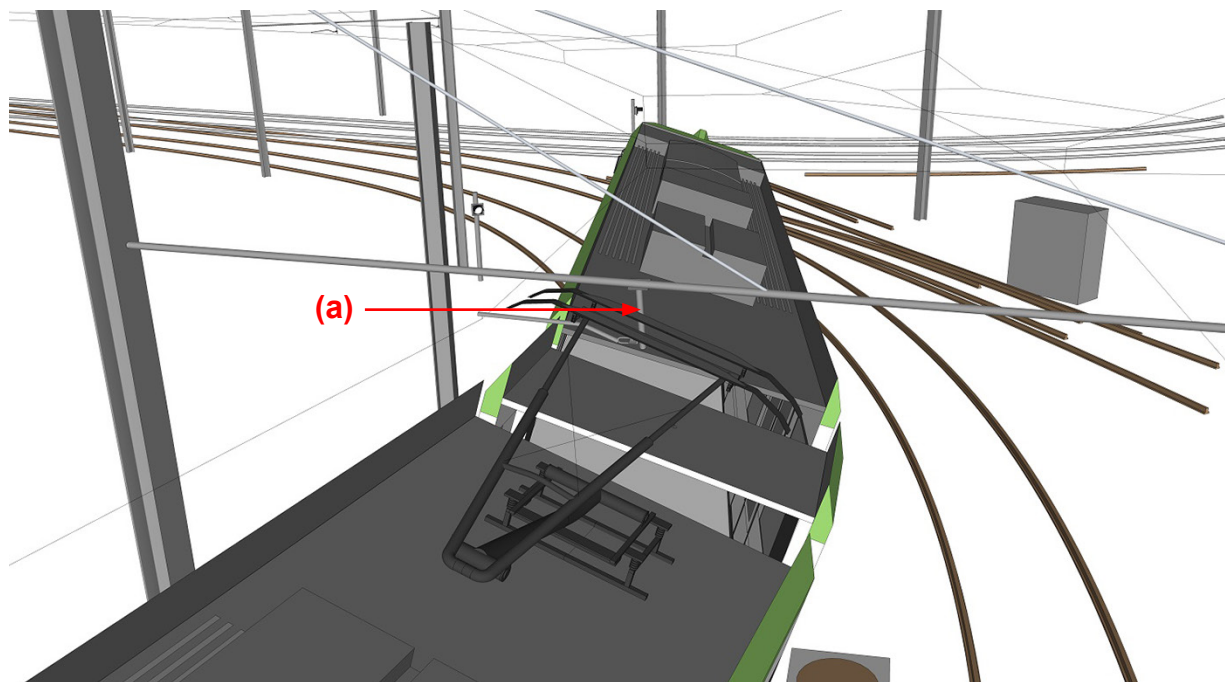
Figure G.2: As tram derails, pantograph strikes overhead line support tube (dropper) (a)

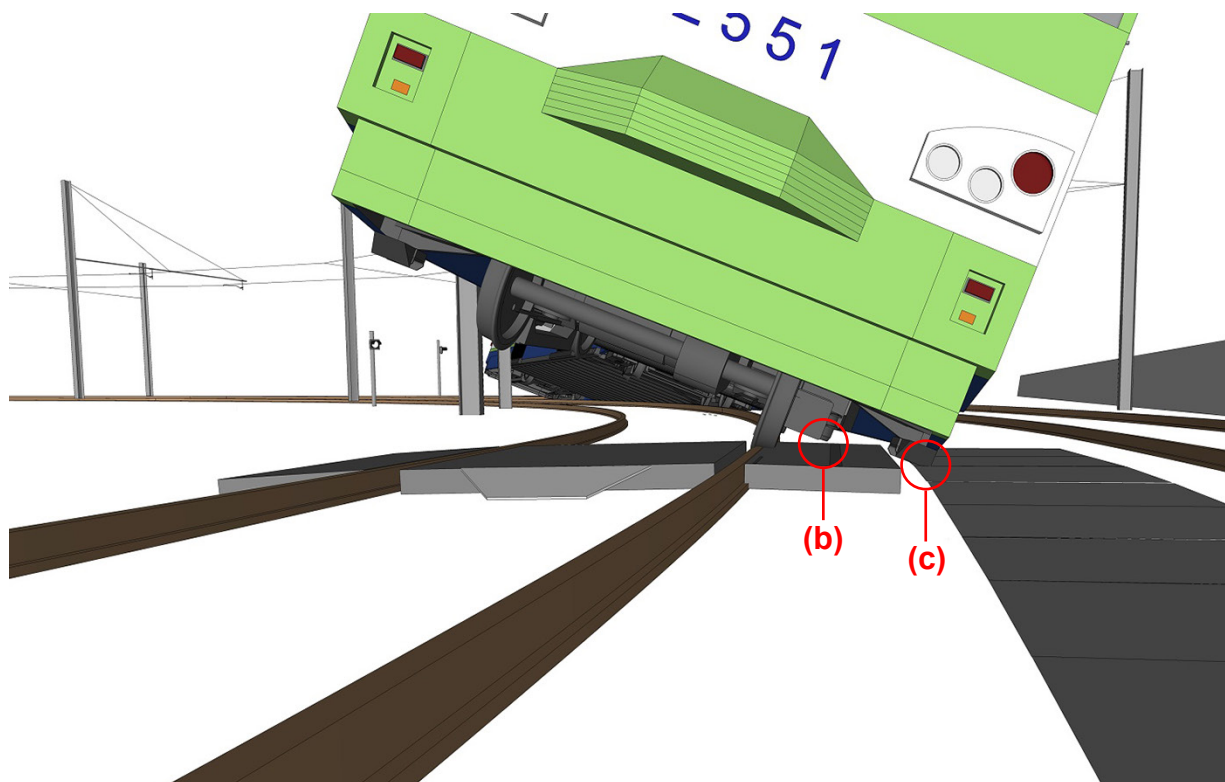
Figure G.3: Rear of tram suspension scuffs track crossing (b) and possibly, the jacking point damages walkway (c)

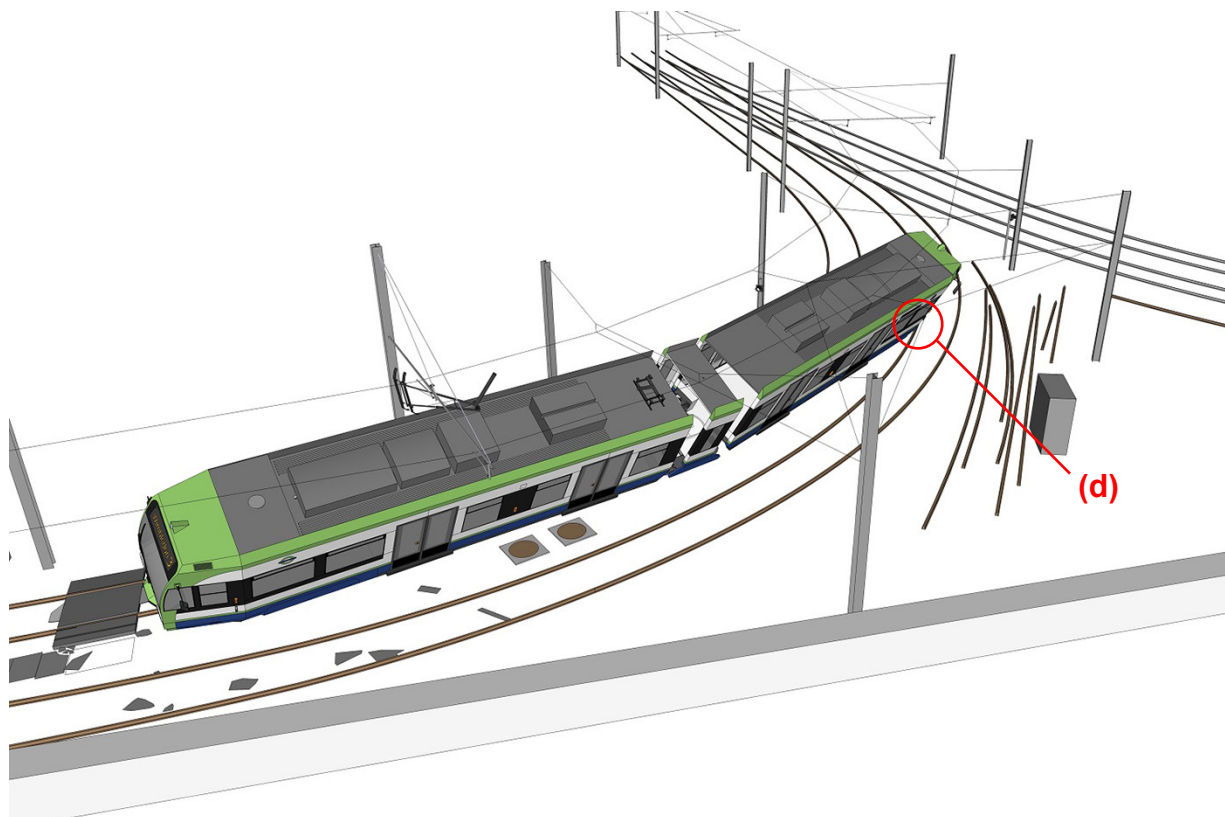
Figure G.4: Front of tram strikes and breaks six-foot rail of outbound line (d)

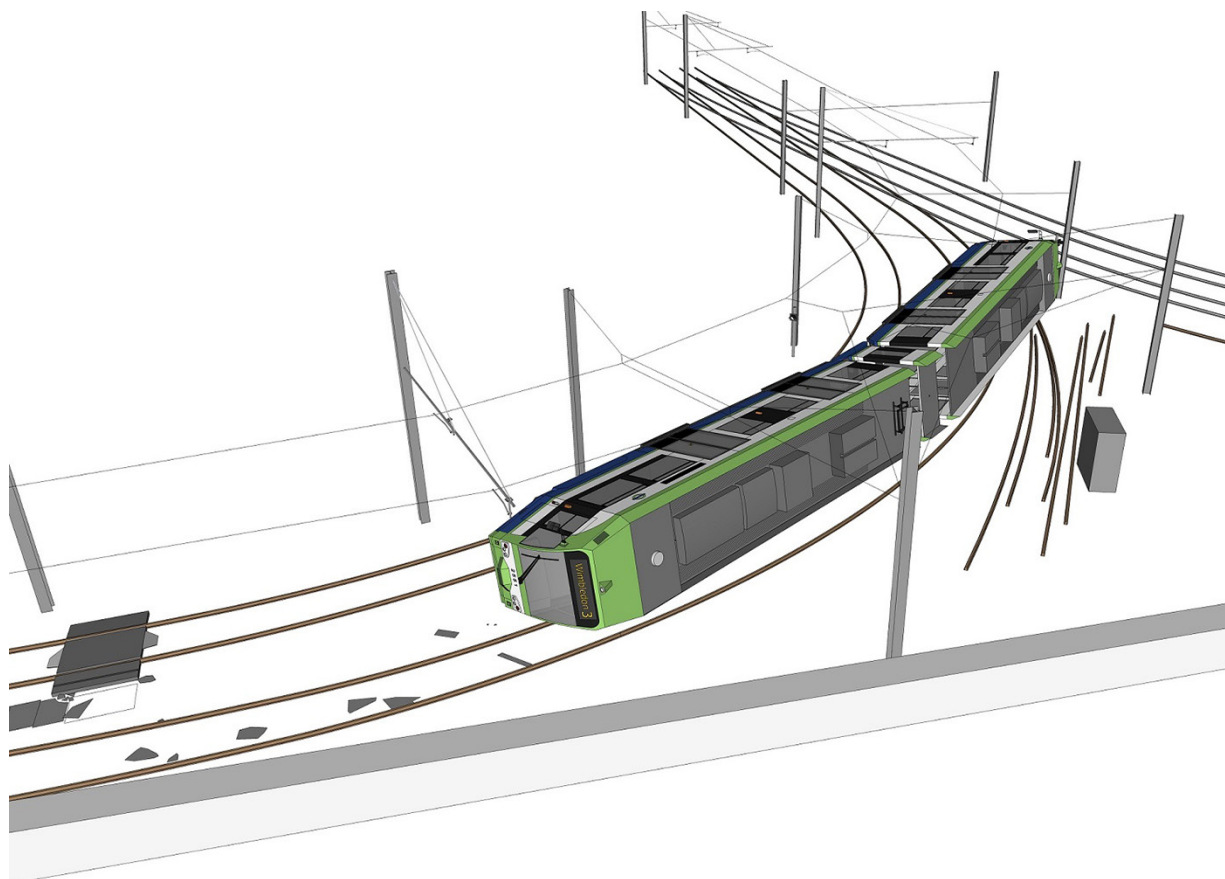
Figure G.5: Side of tram hits ground

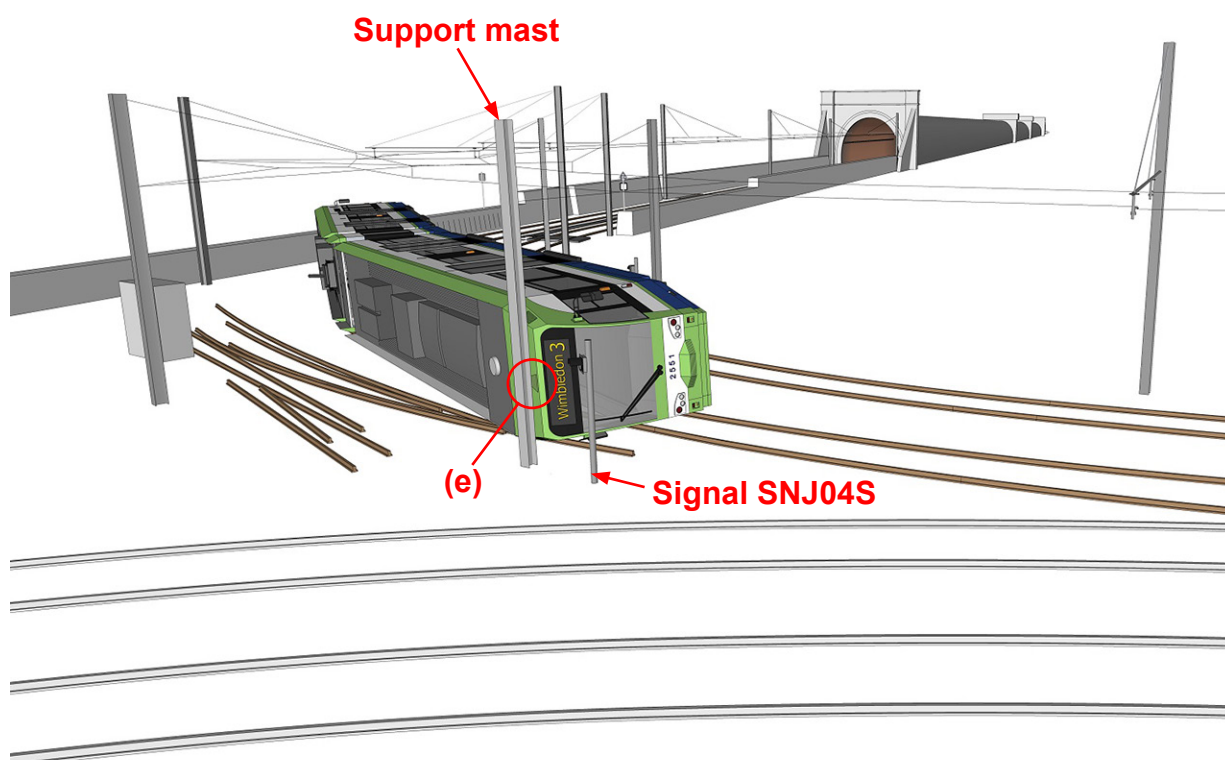
Figure G.6: Roof of tram hits overhead line support mast, displacing headlight from tram roof (e)

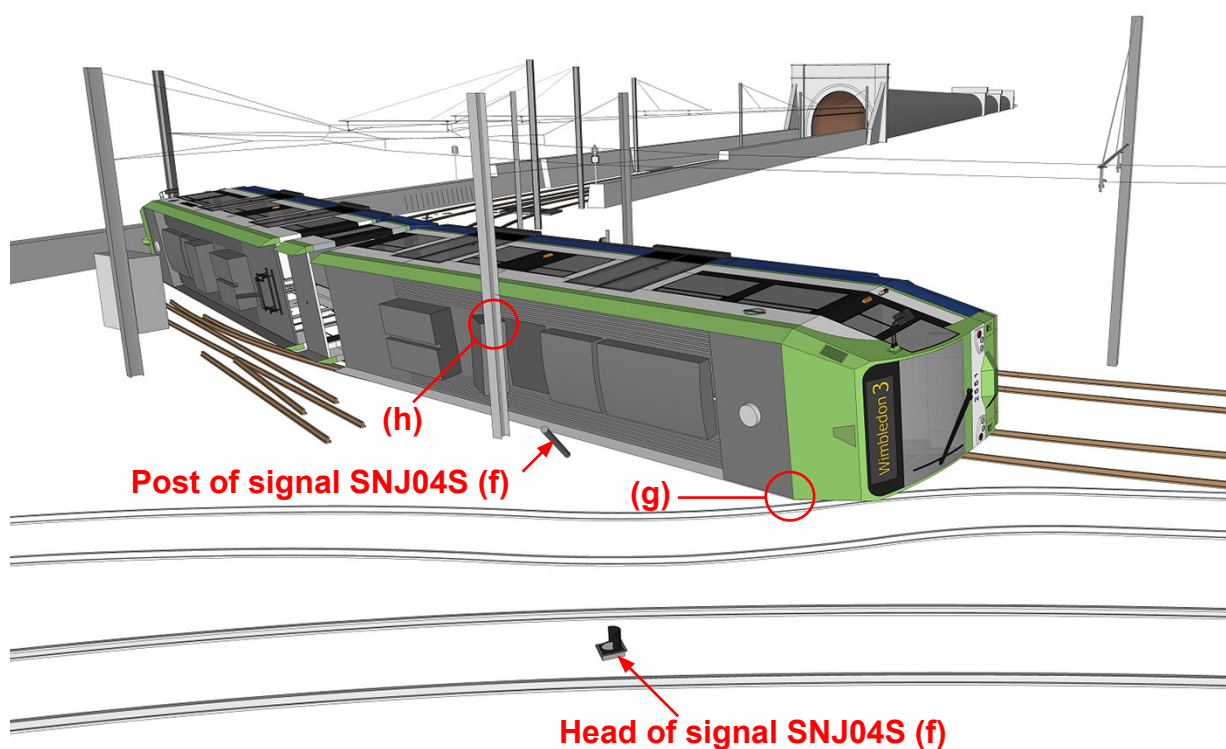
Figure G.7: Front of tram collides with signal (f), then track of inbound Addiscombe line (g). Roof equipment is displaced from tram as it slides against the overhead line support mast (h).

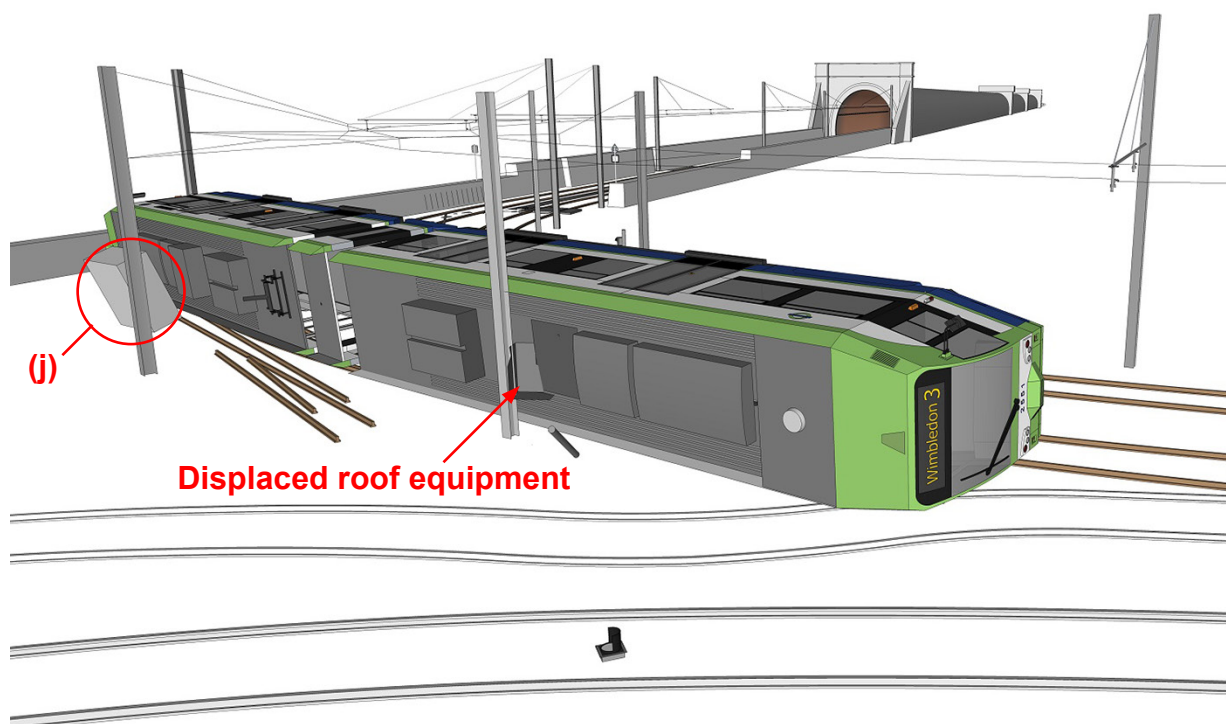
Figure G.8: Rear of tram collides with electrical equipment cabinet (j)

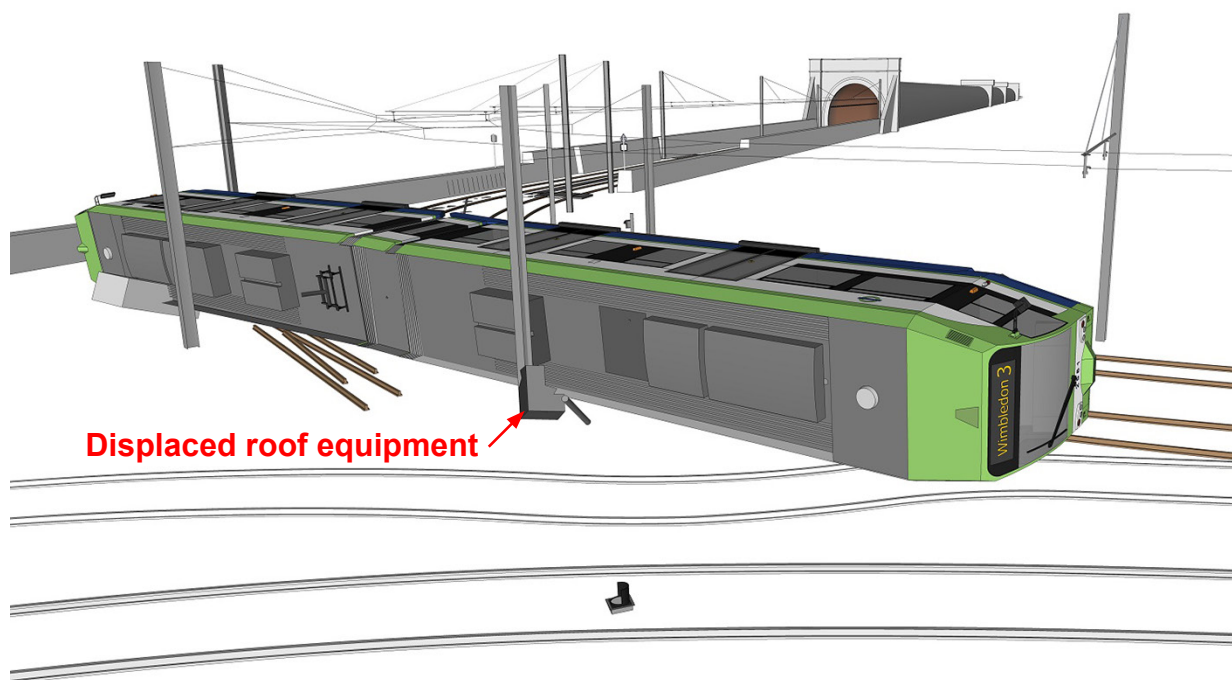
Figure G.9: Tram comes to rest
