Rail Accident Report

Passenger trapped and dragged under a train at West Wickham 10 April 2015

Report 03/2016
February 2016

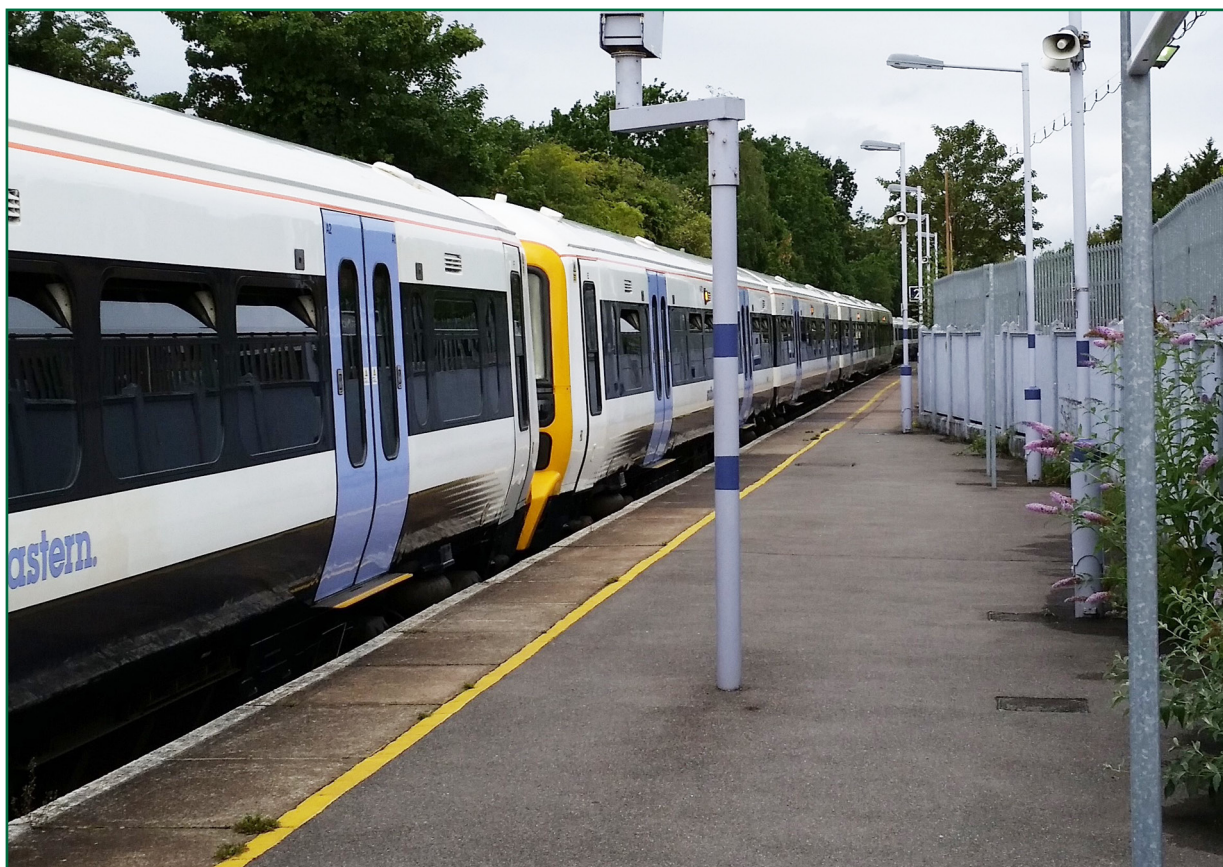
Figure 3: Platform 2 at West Wickham station

- 5 West Wickham station lies around 4.3 miles (7 km) east of Croydon in the London borough of Bromley (figure 1). It is around 12.5 miles (20 km) measured along the route from London Cannon Street to Hayes in Kent (figure 2). The station has two platforms and the accident occurred on platform 2 (figure 3).

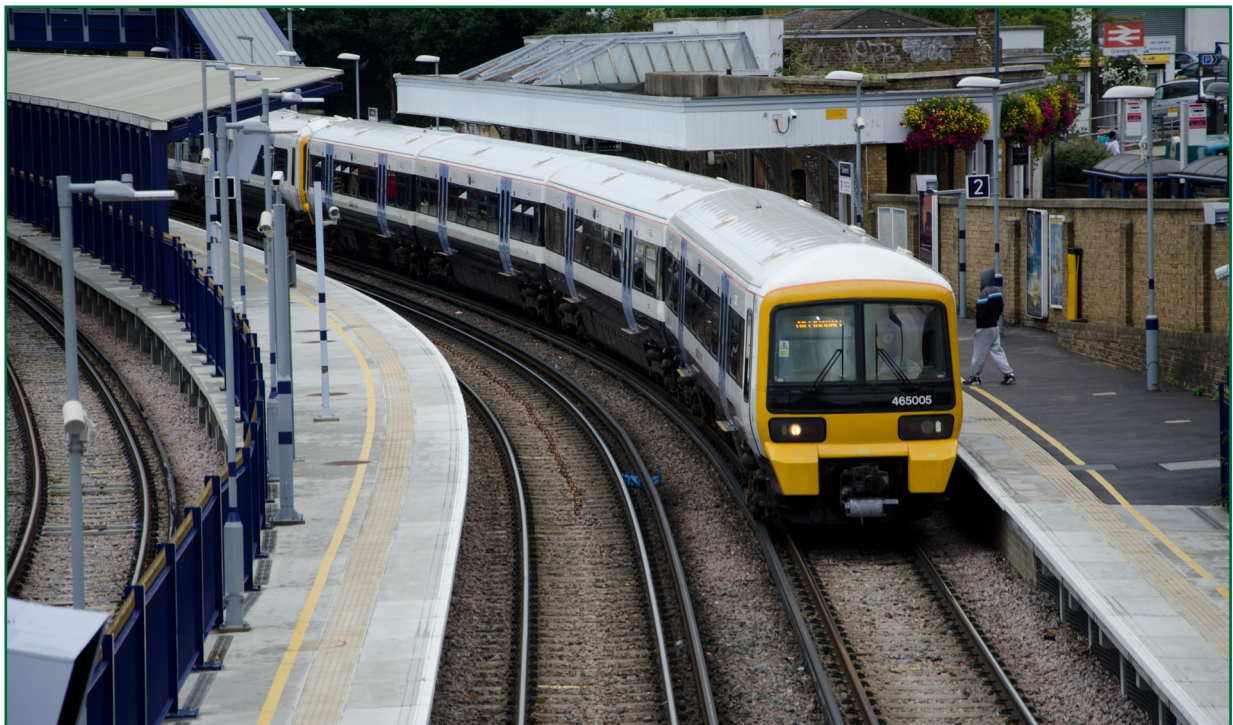
Figure 4: A class 465 train

- 13 The train involved in the accident was formed of two four-vehicle class 465 units (figure 4), often referred to as 'Networker' trains². The leading unit was number 465184 and the rear unit was number 465047. The passenger involved in the accident was travelling in the fourth vehicle of the eight-vehicle train (ie the rear vehicle of the leading unit) which was vehicle number 65880.

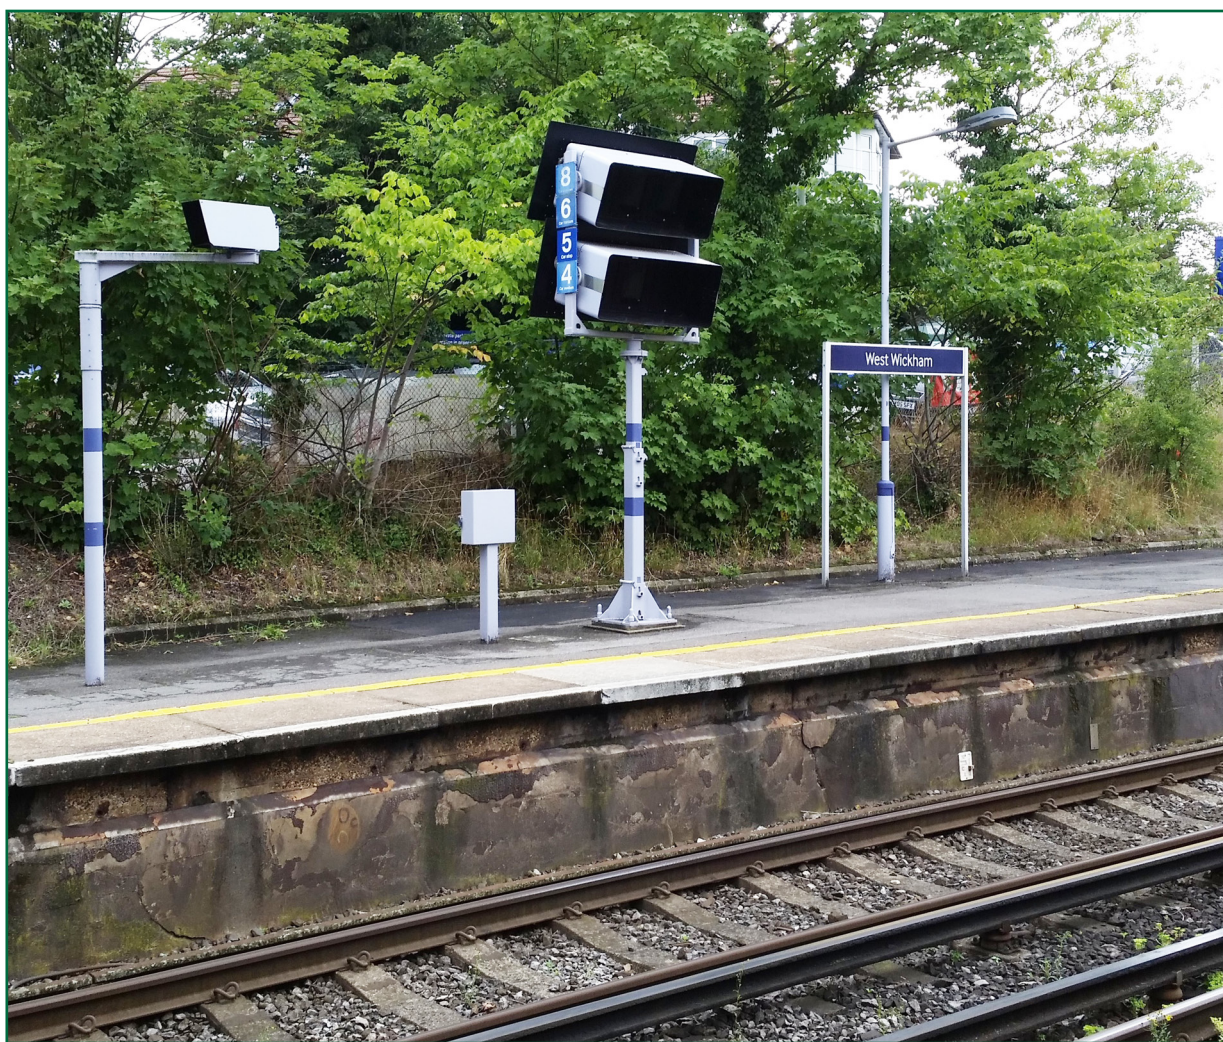
Figure 6: The eight vehicle monitor bank at West Wickham platform 2

- 18 Two banks of DOO monitors are provided at the eastern end of platform 2 at West Wickham station. The monitor bank relevant to the accident is provided for trains comprising up to eight vehicles, and is located around 70 metres from the end of the platform (figure 6).

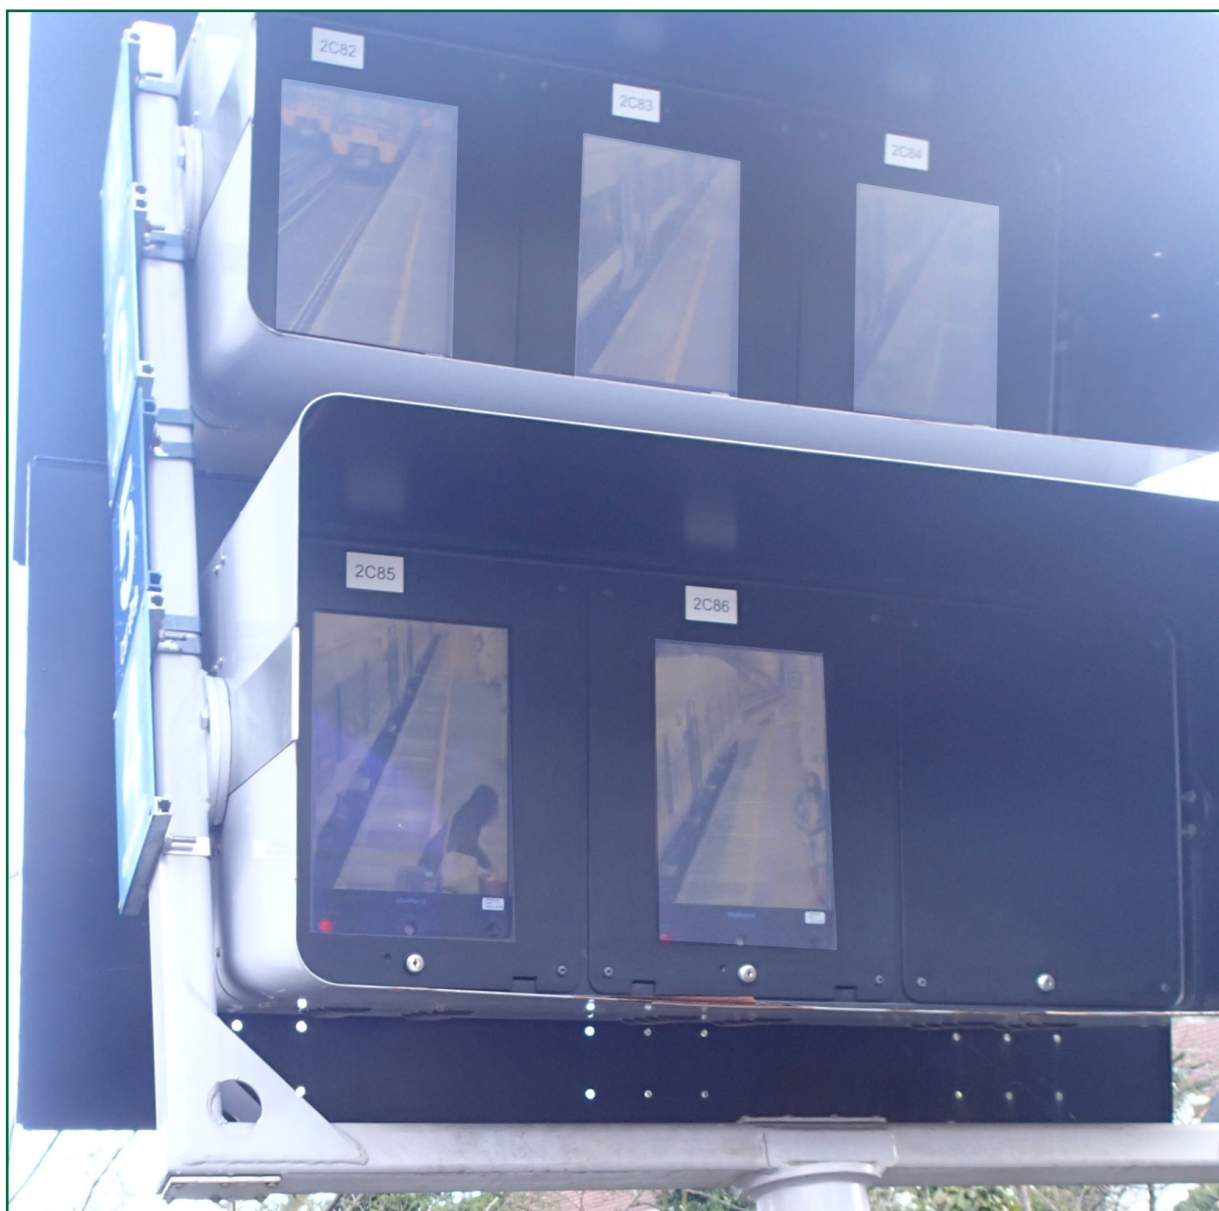
Figure 7: View of a train displayed at the eight-vehicle monitor bank at West Wickham platform 2 (note: the monitor bank images are clearer when seen with the naked eye)

- 19 The eight-vehicle monitor bank houses five *thin-film transistor* (TFT) type monitor screens, each measuring 15 inches (381 mm) diagonally. Each screen is linked to a single CCTV camera. The monitor bank provides train drivers with a colour view of the side of the train and all the passenger doorways (figure 7).

- 20 The DOO monitors and CCTV equipment on platform 2 were installed in July 2011. They are maintained at three monthly intervals and the last maintenance inspection before the accident was completed on 10 February 2015. At this time, the DOO monitors were cleaned, and the CCTV camera angles checked.
- 21 On the day of the accident, no train drivers had reported any problems with the images displayed at the eight-vehicle monitor bank. The RAIB has found no evidence that the performance of the monitors at West Wickham was a factor in the accident.
