# Rail Accident Report

**Collision between a train and tractor at  
Hockham Road user worked crossing, near  
Thetford  
10 April 2016**

Report 04/2017  
March 2017

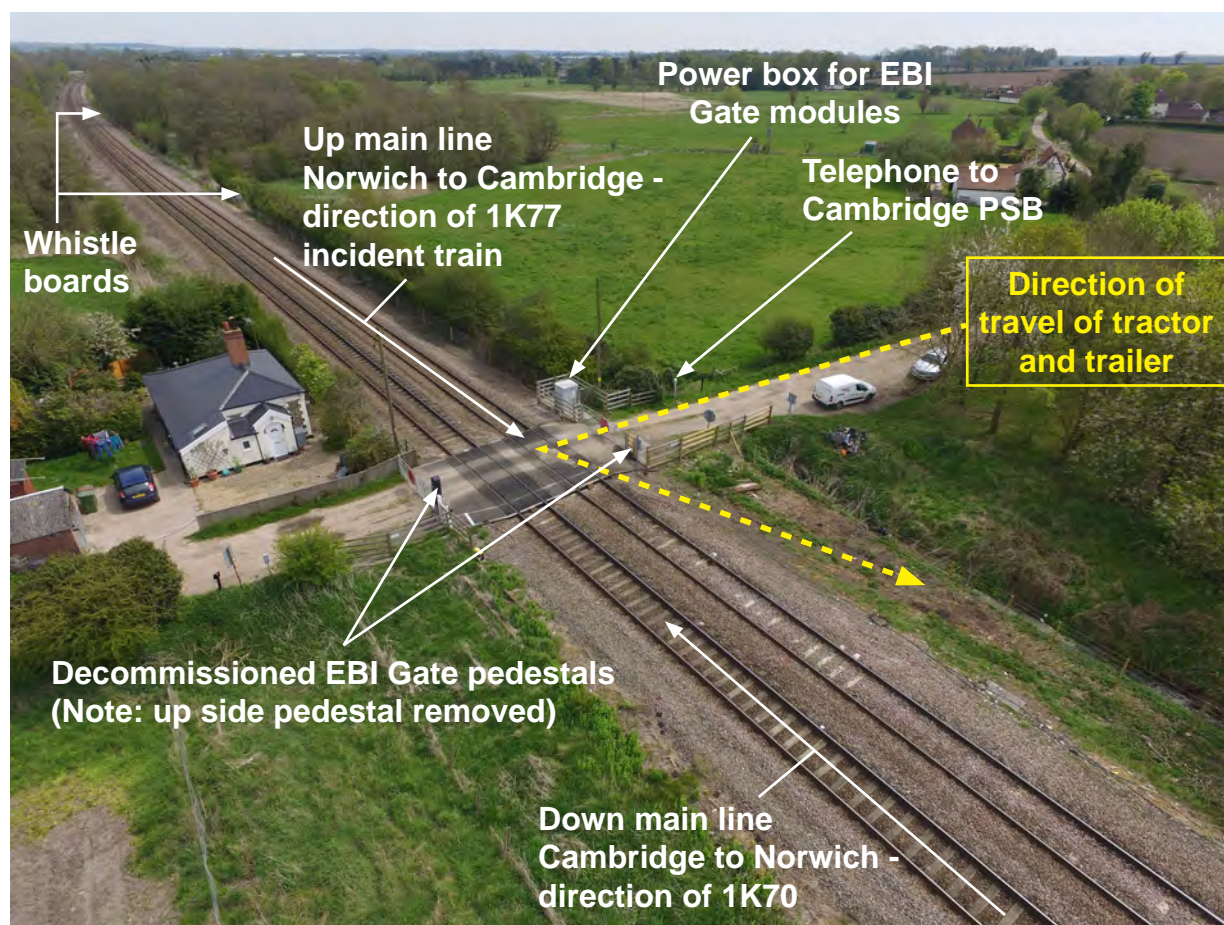
- 6 Hockham Road UWC (figure 3) is located at 99 miles 67 chains on the double track railway between Ely and Norwich, which is known as the Thetford line. The signalling system, which is controlled from Cambridge *Power Signal Box* (PSB), is operated under the regulations for *track circuit block* with train detection by means of *axle counters*.
- 7 The road which crosses the railway at this point is classed as a restricted byway<sup>2</sup>. The level crossing has one *authorised user*<sup>3</sup>, who is permitted to use the crossing with farm vehicles, horses and pedestrians. The road also serves fields and one house. It is also used as an unauthorised access route to and from the A11, the main road between Thetford and Norwich, and a paintballing outdoor activity centre (see paragraph 42). There is a public footpath level crossing alongside the road crossing.

Figure 3: Hockham Road UWC from the north-west

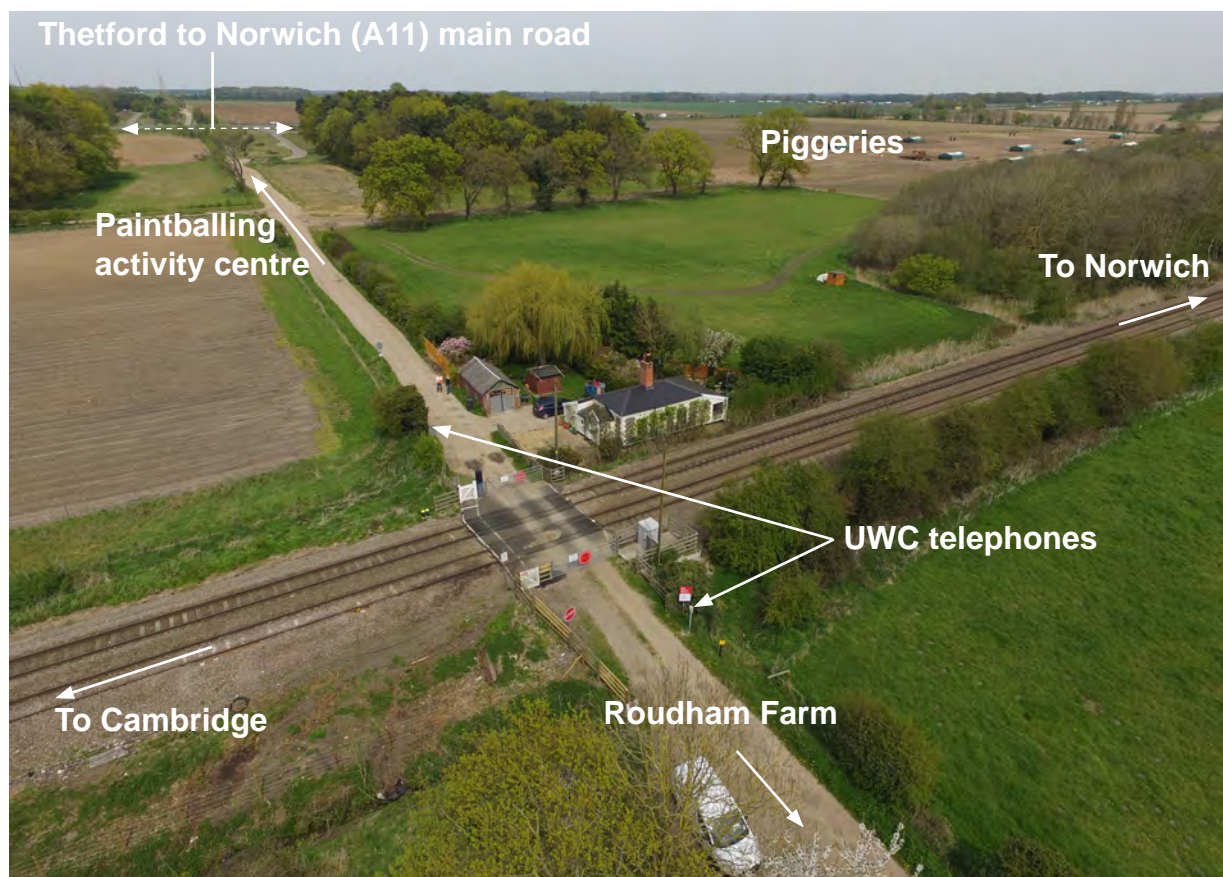
Figure 4: Hockham Road UWC from the south-west

- 42 Network Rail's records show that from 2002 to 2012 Hockham Road crossing had four reported near miss incidents with some users being misdirected across the railway by satellite navigation systems, and persistently suffered from misuse (15 incidents reported between 2009 and 2012) with users not contacting the signaller to ask for permission to cross, or not closing the gates after they had crossed (this is less safe because subsequent users may drive over the crossing without stopping if they come across the open gates and happen not to observe the signage). Witness evidence indicates that some incidents arose from people using the road to reach a site on the north side of the railway which is used for paintballing activity, and for which the normal access is directly off the A11 road (figure 4).

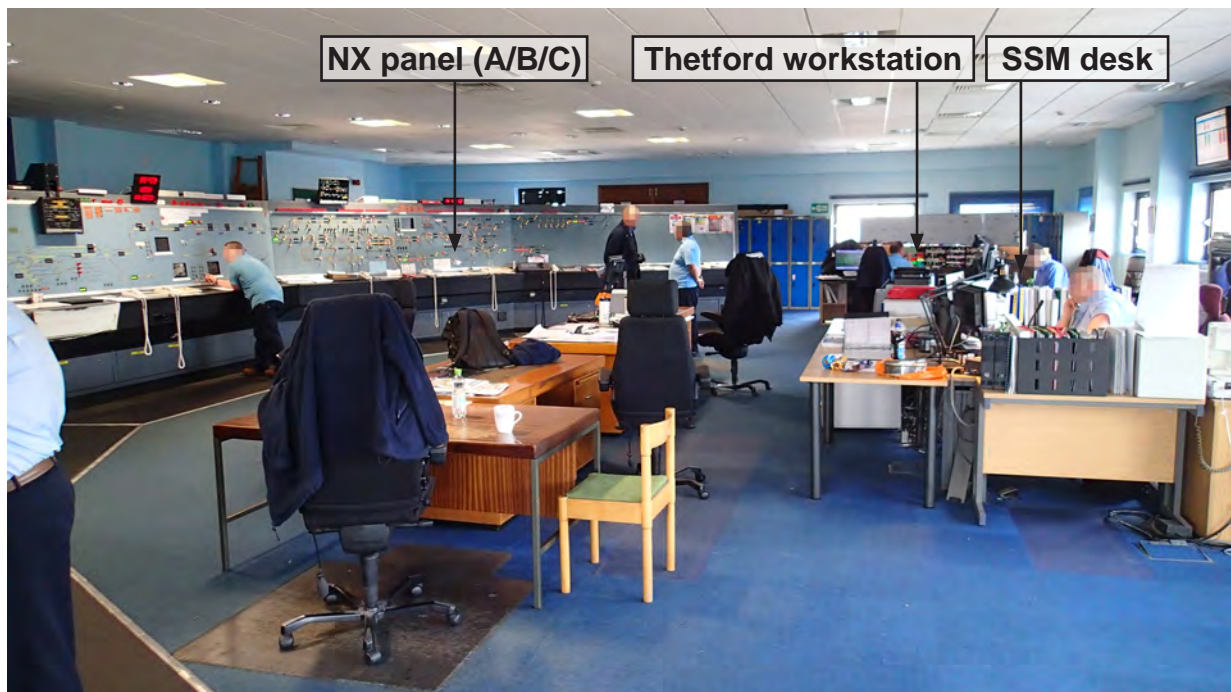
- 22 Between 10:00 hrs and 11.30 hrs, while the signaller was working on the NX panels, he became aware that his colleague working on the Thetford workstation was dealing with technical problems at Brandon level crossing. Signalling technicians had been sent to Brandon and the problem was rectified a short time later (see paragraph 63). From 12:00 hrs the signaller took over the Thetford workstation, monitoring the movement of the trains and dealing with any requests to cross the railway from the 22 UWCs that, at the time of the accident, were equipped with telephones (figures 5 and 6).

Figure 5: Cambridge PSB operating floor showing the location of the three NX panels (A, B and C), the Thetford VDU workstation and the Signalling Shift Manager

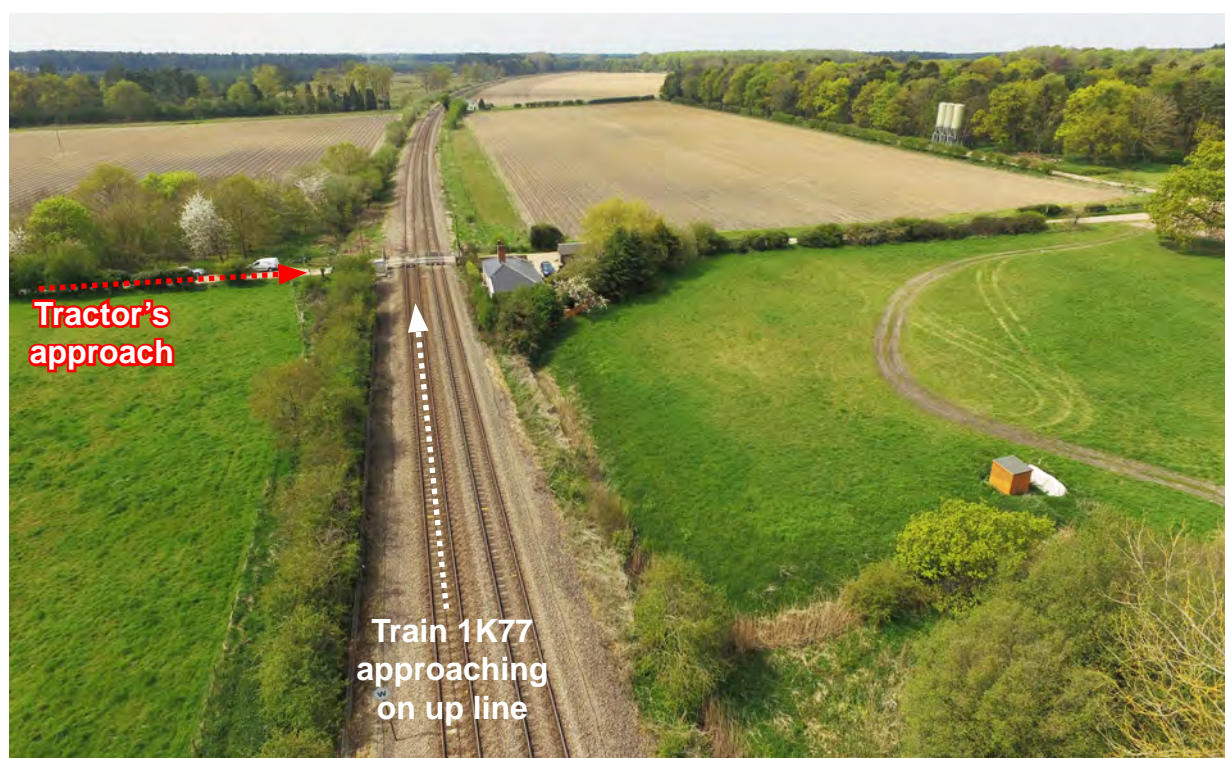
- 29 At 12.29.56 hrs the driver of train 1K77, which was approaching Hockham Road, travelling at 87 mph (140 km/h), sounded his horn once on the approach to the whistle boards for Hockham Road and Drove Road footpath crossing (which is 318 metres beyond Hockham Road). The train driver then saw the raised bucket attachment of a tractor on the left (Roudham Farm) side of Hockham Road crossing, but due to the vegetation and left-hand curvature of the track he could not see the tractor itself, or tell if the gates of the crossing had been opened. The train driver then saw the raised bucket attachment of the tractor continue to move slowly forward towards the crossing.

Figure 9: View looking towards Hockham Road UWC for trains approaching in the up direction

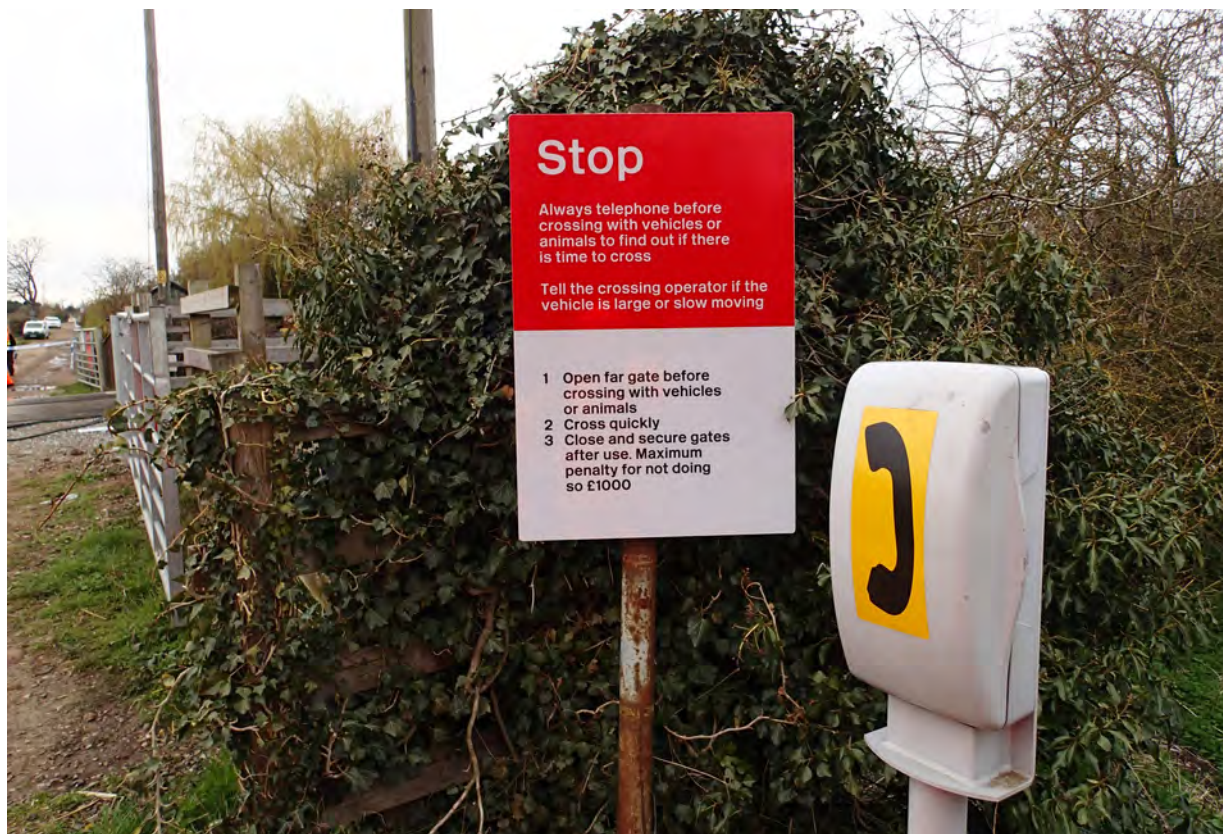
- 36 The emergency services arrived at the crossing a short time later and the tractor driver was transferred to hospital. Four passengers on board were treated at the scene.
- 37 Under the supervision of the RAIB, Network Rail tested the telephones at the level crossing. No faults were found (figures 18 and 19). One of the two decommissioned EBI Gate 200 pedestals, which had been partially covered up (both pedestals were still in situ) was destroyed as a result of the accident (figure 19). British Transport Police (BTP) subsequently examined the remains of the tractor and reported to the RAIB that there was no evidence of any faults with the tractor that could have contributed to the accident.
- 38 The RAIB attended the site to record and obtain evidence. Repairs were made to damaged equipment and the road surface, and the line was reopened the following day.

Figure 18: Signage and telephone on the up side at Hockham Road UWC

- 40 Hockham Road crossing has existed since the opening of the Ely to Norwich railway in 1845, when it was provided for the use of occupiers of Roudham Farm. It currently has metal five-bar gates for vehicle access, and separate smaller gates for the adjacent public footpath and restricted byway crossing. As a result of the line speed of 90 mph (144 km/h) and the curvature of the track, the distance at which approaching trains come into sight gives limited warning time, and whistle boards are provided to warn pedestrians of the imminent arrival of a train. Notices instruct people using the crossing with a vehicle or animals to use the telephones either side of the crossing (which were first installed in 1963) to contact the signaller to obtain permission to cross. The user should tell the signaller if they are crossing with a large or slow moving vehicle (although no definition of this is provided). The signage instructs the user to open the far gate before crossing with a vehicle or animals, cross quickly and then to close and secure the gates after use (figure 18).

120 The signs at a UWC do not specify whether a user should open the gates before or after getting permission to cross from the signaller (figure 18). As there is neither a requirement for the user to tell the signaller whether the gates are already open, nor for the signaller required to ask if they are, the user's estimation of the time required to cross, and the signaller's perception of the situation can vary significantly. It is therefore vital that the user and the signaller come to a clear understanding. This can be difficult, as the user, a member of the public, may not fully understand the limitations of the information available to the signaller.

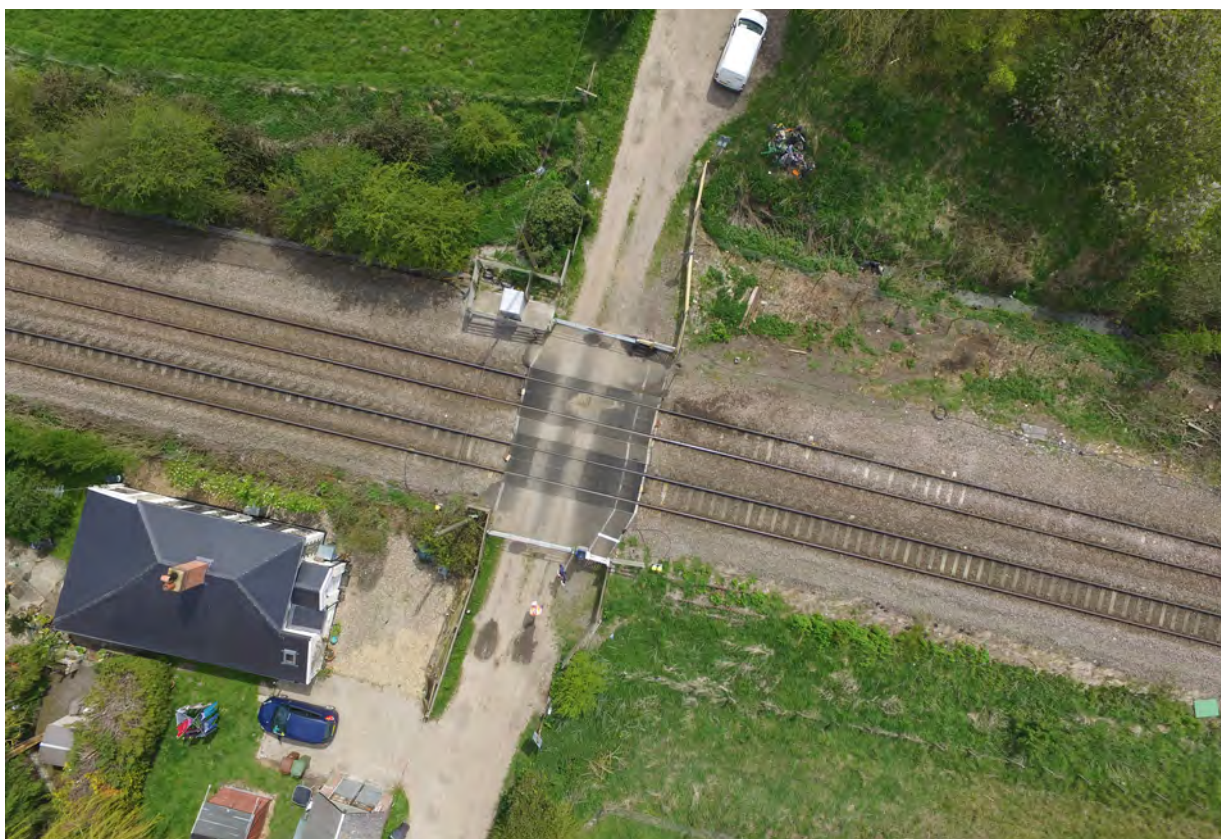
Figure 20: Layout of Hockham Road UWC
