# Rail Accident Report

## **Parting of the live overhead wire at Walkergate station, Tyne and Wear Metro 11 August 2014**

Report 09/2015  
July 2015

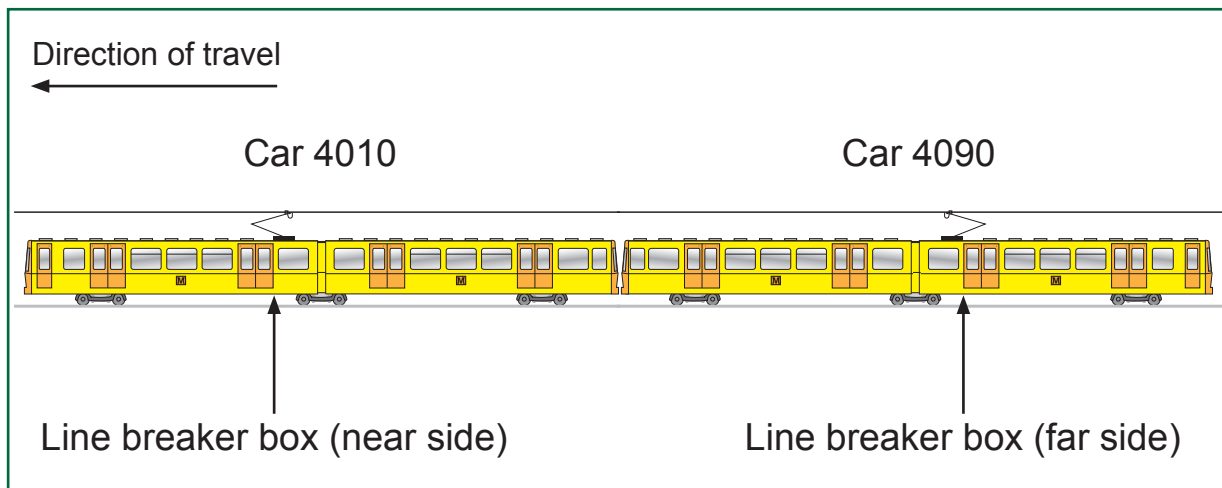
Figure 3: Arrangement of the train looking from the platform side

- 14 The train, reporting number 130, consisted of two cars, each made up of a two-section articulated unit (figure 3). The leading car was number 4010 and the trailing car, on which the electrical fire occurred, was 4090. These cars were built between 1978 and 1981 by Metro-Cammell, in Birmingham.

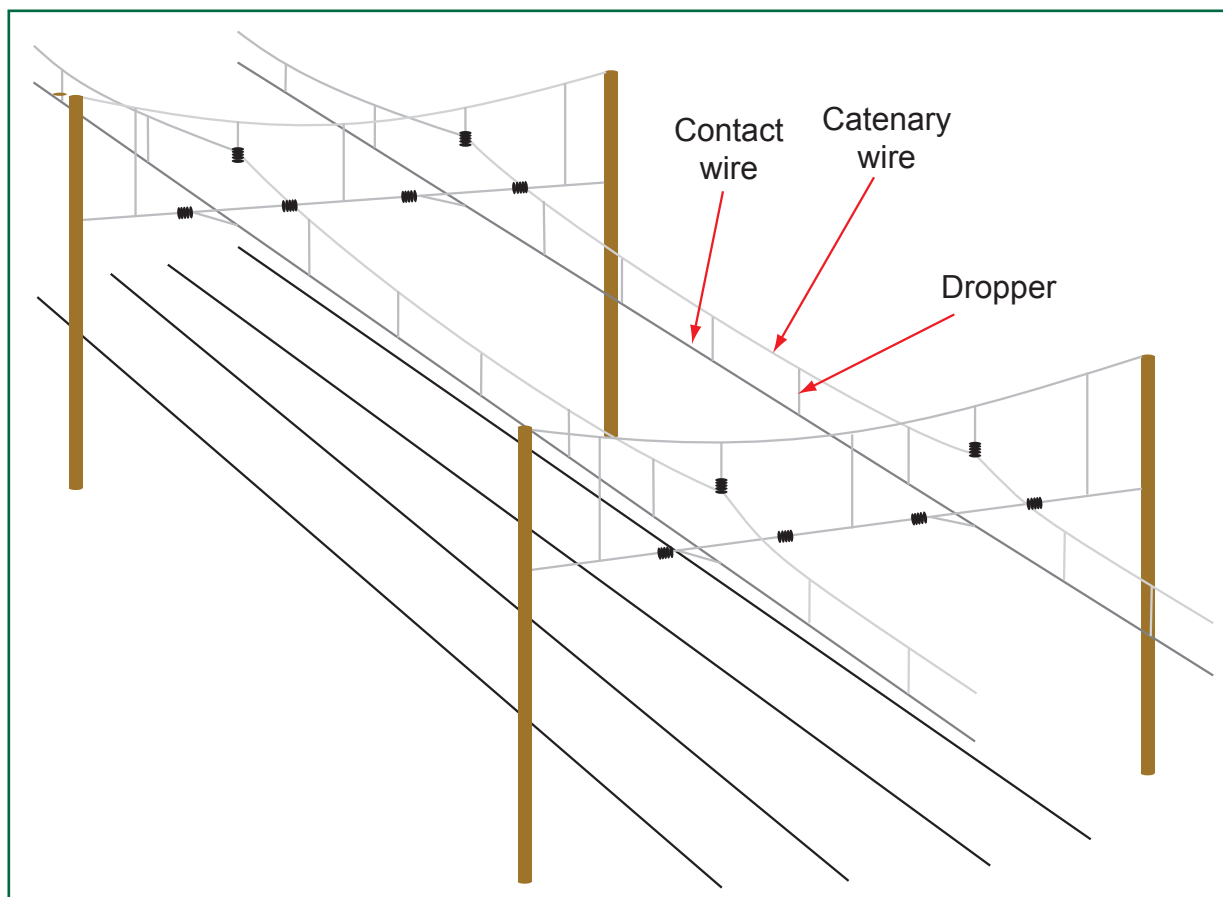
Figure 4: Generalised arrangement of overhead line equipment

- 16 Trains operating on the Metro system are supplied with 1500 Volt direct current (DC) traction power through overhead contact wires. There is a separate contact wire for each track, suspended at intervals by *droppers* from a catenary wire (figure 4). Trains draw traction current from the contact wire through pantographs mounted on the roof of each car and current is returned to the substations via the train's wheels and the running rails.
- 17 The section of overhead line which includes Walkergate station is supplied with traction power at each end of the electrical section from substations at Percy Main and Byker (figure 2). This is known as being 'double-end fed'. There is a separate feed for each of the two tracks. The Byker to Percy Main electrical section is 6,955 metres long; Walkergate station is 1,364 metres from Byker and 5,591 metres from Percy Main (figure 5).

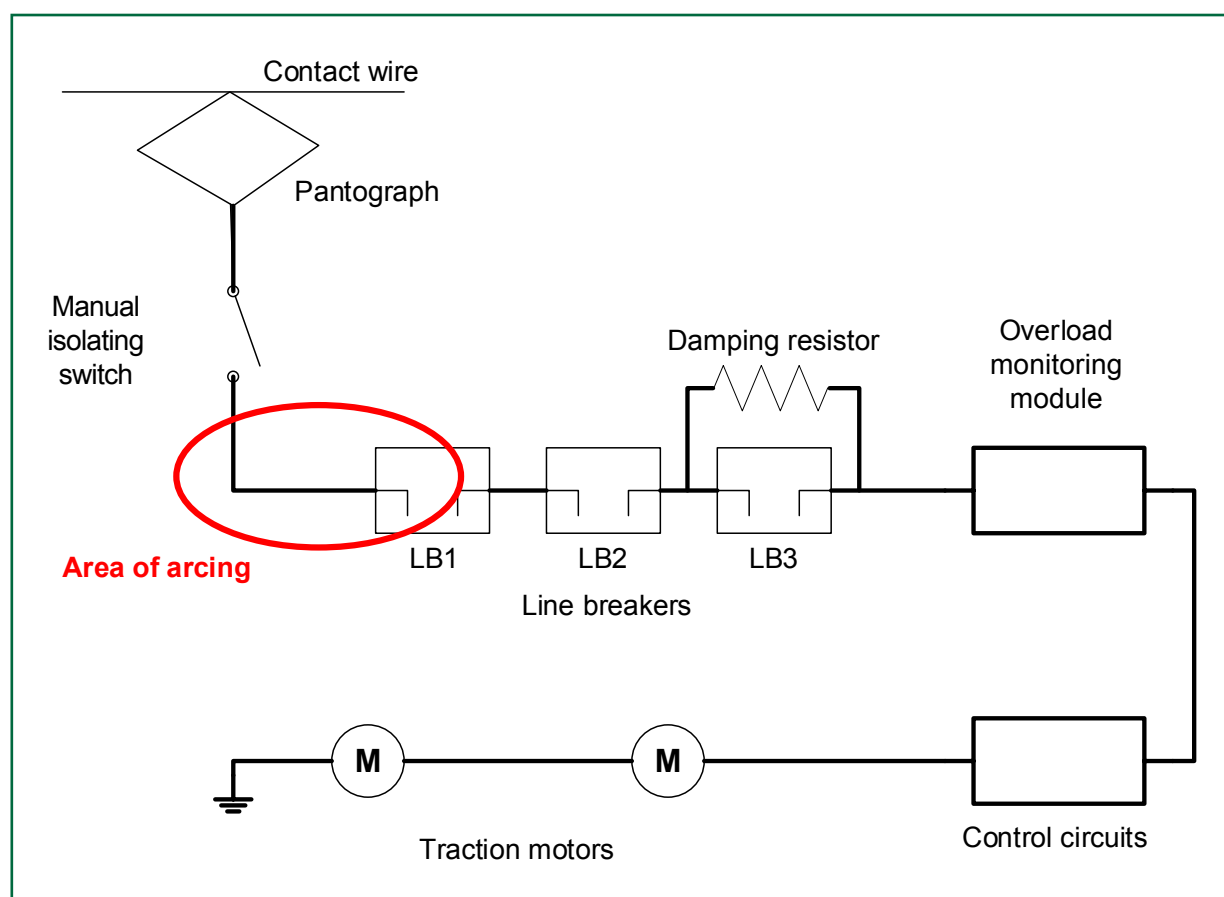
Figure 6: Metro car traction power circuit

- 23 Traction power is fed from the pantographs via a cable to a line breaker box (one on each car) containing three line breakers identified as LB1 to LB3<sup>4</sup> (figure 6). The line breaker box is mounted below the floor of the car, directly under the pantograph (figure 3).
- 24 The function of line breakers is to control the power supply to the traction circuit of the car. The electrical contacts of the line breakers are only closed when the train is drawing traction power (figures 6 and 7). When the train is standing in a station, for example, the line breakers' contacts are open. However, LB1 remains live on the pantograph side of its open contacts.

<sup>4</sup> There are three line breakers arranged in series. When commanded to open, LB3 opens first and puts a damping resistance into the circuit. LB1 and LB2 then open, disconnecting power to the downstream equipment. This arrangement is designed to limit and share the voltages that are developed across the line breakers when the contacts open.
