# Rail Accident Report

## Fatal accident at Frampton level crossing 11 May 2014

# Fatal accident at Frampton level crossing, 11 May 2014

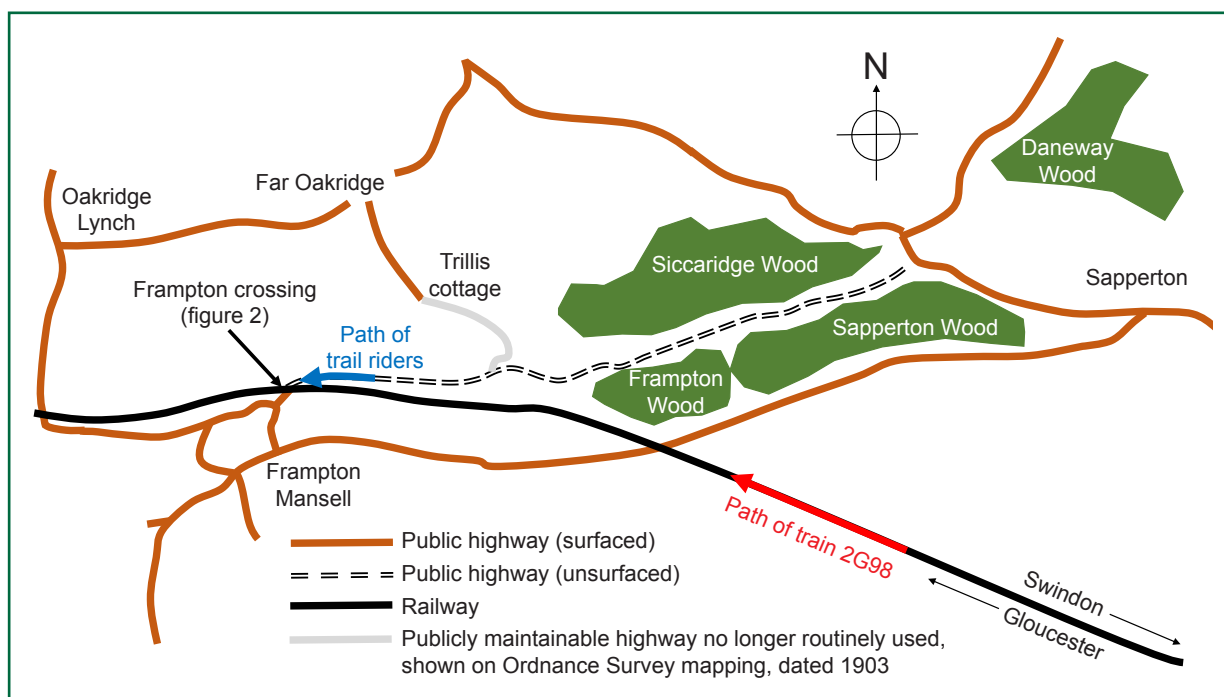
Figure 7: Frampton crossing context

- 14 The northern approach to Frampton level crossing comprises an unsurfaced track leading from a minor road near the village of Sapperton (figure 7). The southern approach comprises a partly surfaced track leading from a minor road near the village of Frampton Mansell (figure 7). Both approaches are shown as a 'highway maintainable at public expense' on Gloucestershire County Council's *Highway Record*. Except where legal restrictions have been imposed, the public are generally entitled to use highways shown on this record for the purpose of passing and repassing on foot, on horseback, with animals or with vehicles. Gloucestershire County Council has stated that it is not aware of any legal restrictions applying to the Frampton level crossing approaches.

- 35 The level crossing was provided for people, animals, and vehicles using the local highways linking Frampton Mansell, Far Oakridge, and Sapperton (figure 7). In response to a British Railways proposal to withdraw the crossing keeper at this location, a letter dated 9 December 1968 from the office of Gloucestershire County Council's County Surveyor, indicated that public vehicular traffic had not used the route over the level crossing for an estimated 20 to 30 years.

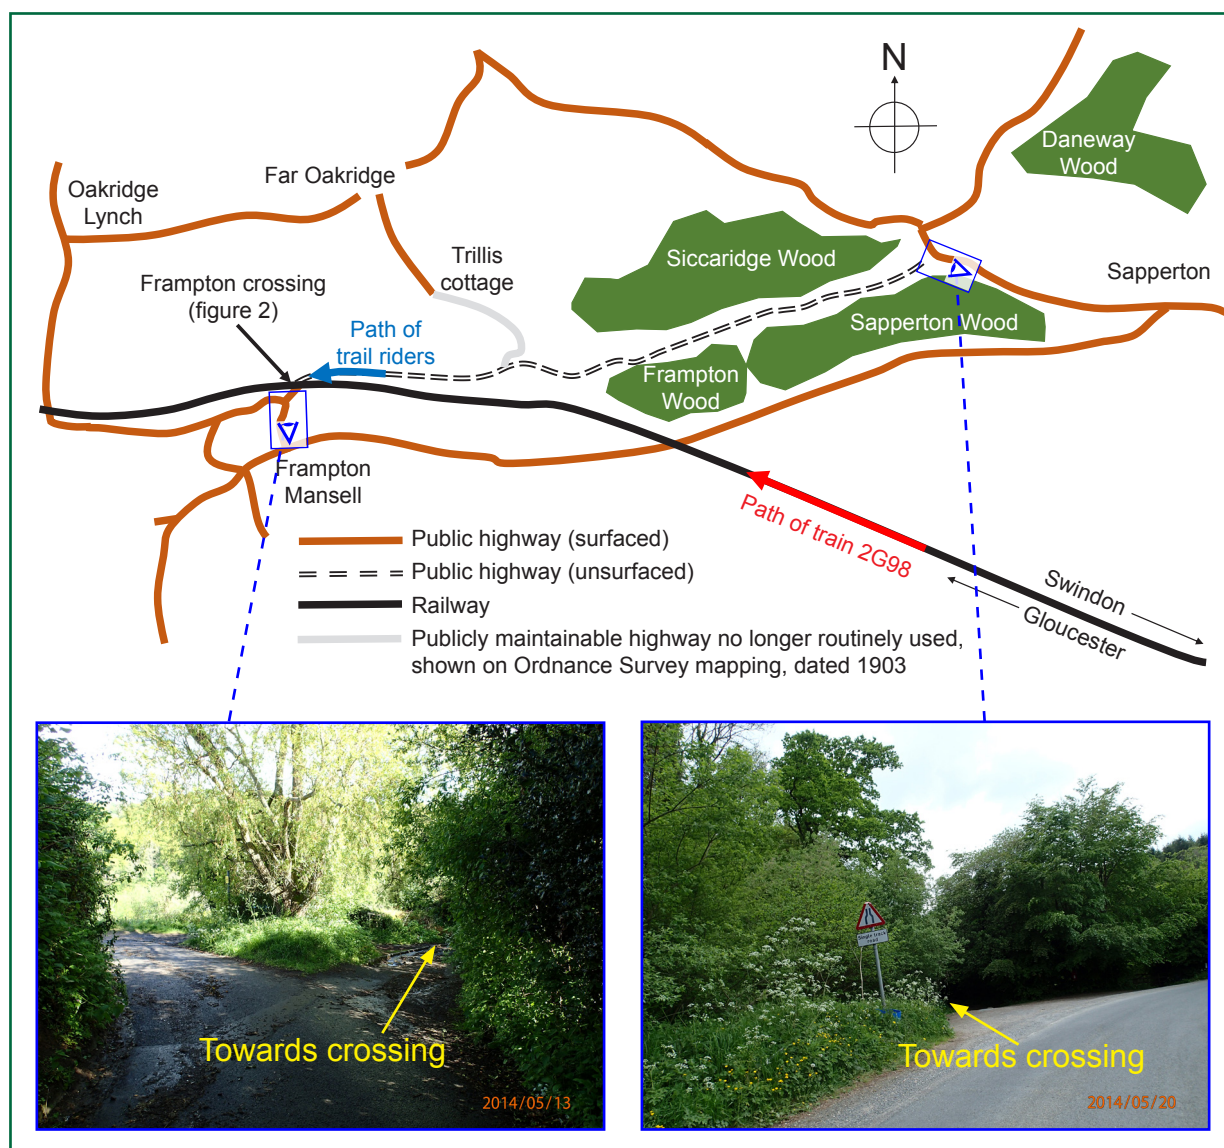
Figure 11: Highways leading to Frampton level crossing

- 82 The route over the level crossing could be accessed from the village of Frampton Mansell, or from the road that leads out of Sapperton village (paragraph 14). There were no road signs on either approach to indicate that the general public were not permitted to take vehicles over the level crossing (figure 11).

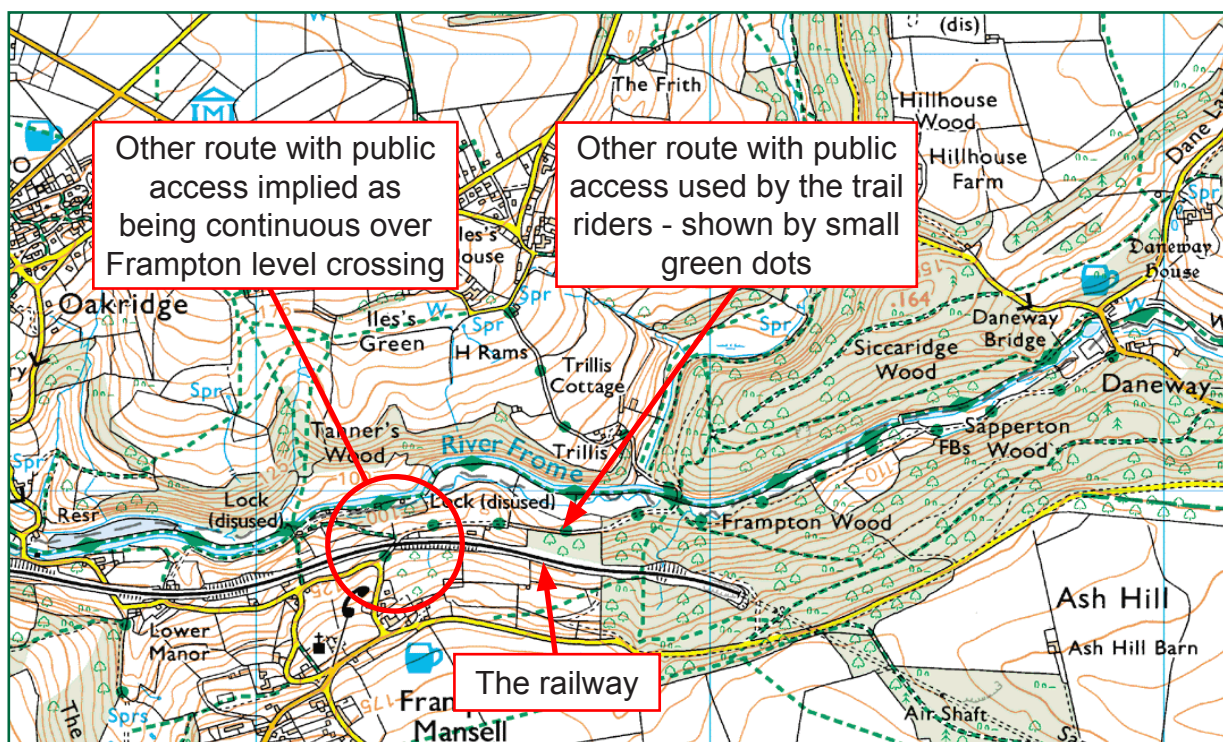
Figure 13: Ordnance survey map (scale 1:25,000) indicating 'other route with public access' (indicated by small green dots)

85 Ordnance Survey mapping showed the route as an 'other route with public access' (figure 13). The route is implied as running continuously over the railway. Readers of these maps are informed that the exact nature of this type of route, and the existence of any restrictions, may be checked with the local highway authority. A post-accident enquiry by the RAIB to Gloucestershire County Council (the local highway authority), showed that reference to their records would have provided the information given in the previous paragraph.
