Rail Accident Report

Overspeed at Fletton Junction, Peterborough 11 September 2015

Report 14/2016
August 2016

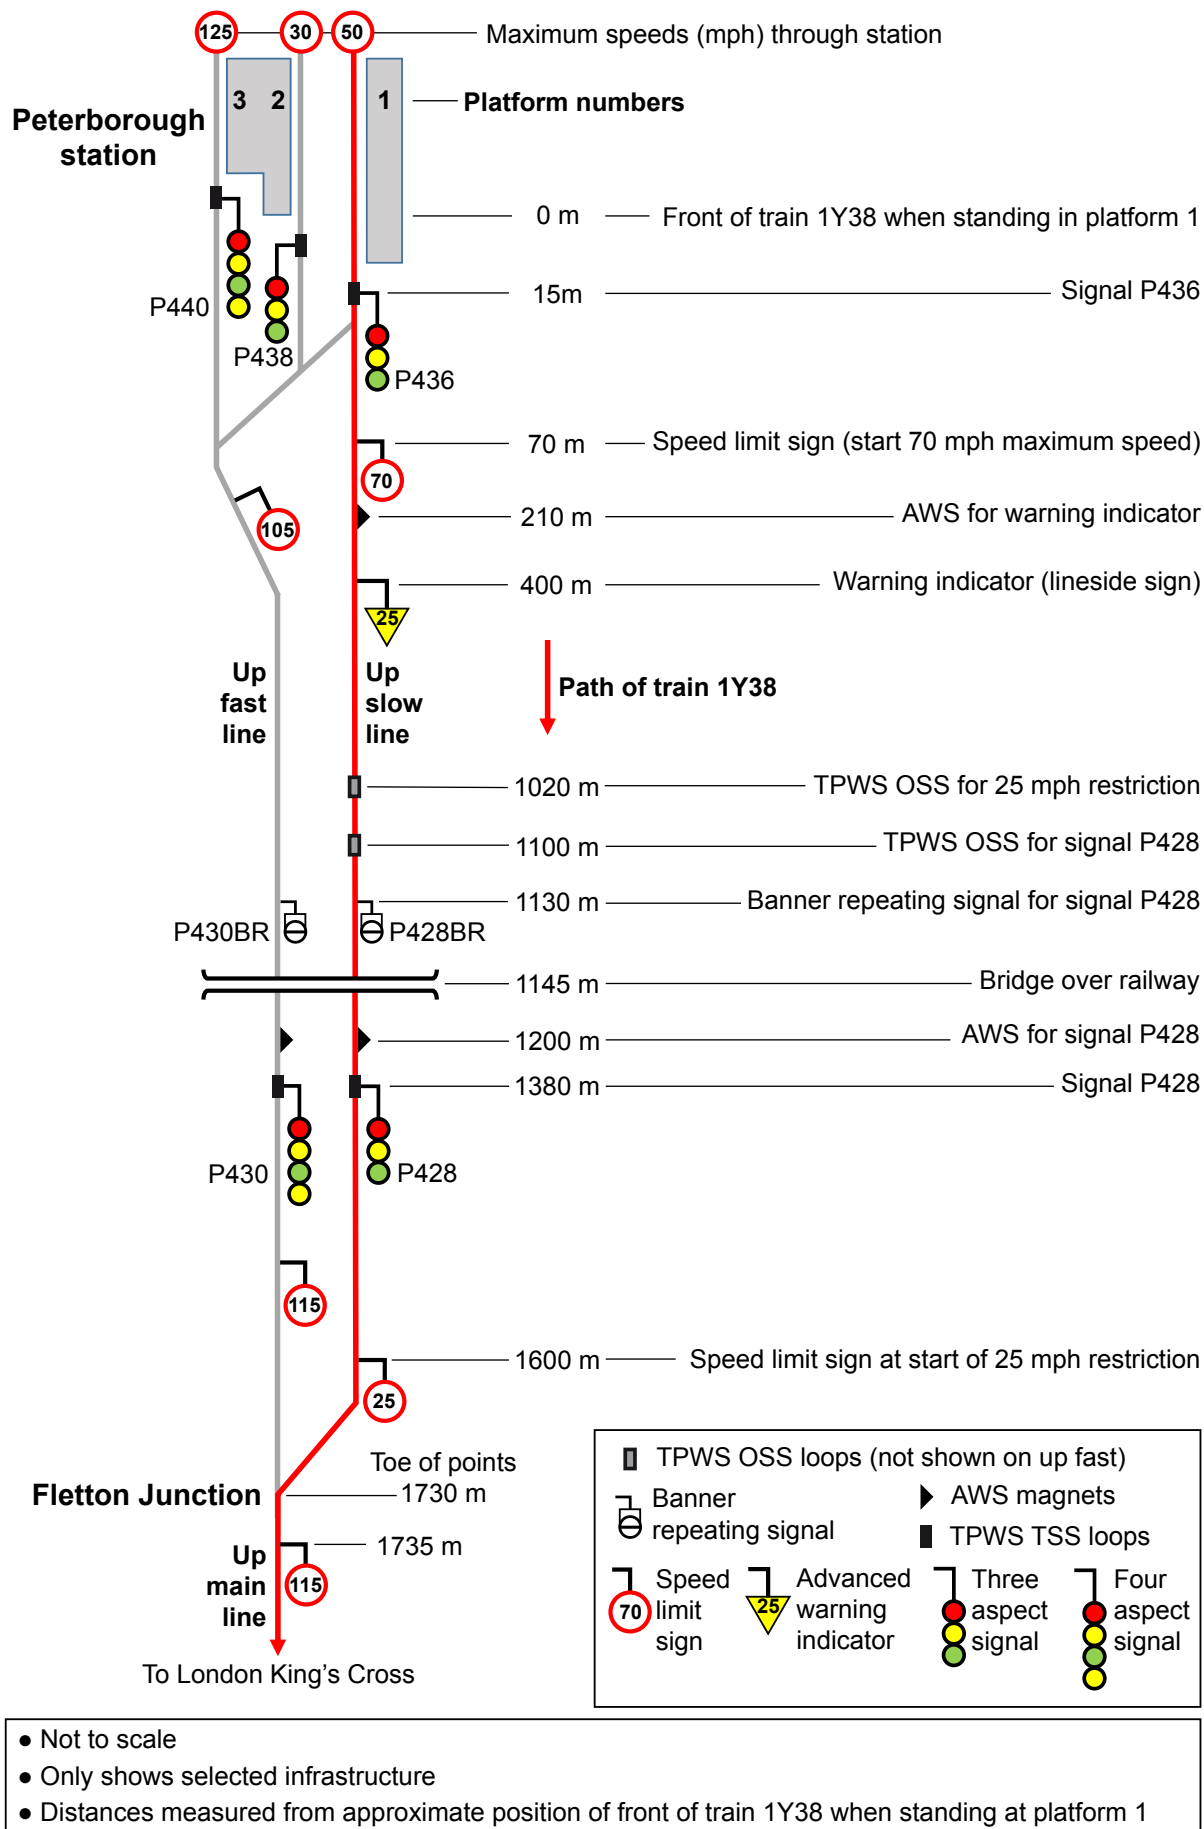
- 6 Fletton Junction is on the East Coast main line around 1.25 miles (2 km) south of Peterborough station and 75 miles and 2 chains¹ from King's Cross station. At this junction, the *up* slow and *up* fast lines merge to become the *up* main line (figure 2).
- 7 These lines carry trains travelling south from Peterborough. The *up* slow line passes through platform 1 at Peterborough station and the *up* fast passes through platform 3. Southbound trains departing from platform 1 can be routed onto the *up* fast line at a *crossover* immediately south of the station, or continue along the *up* slow line to Fletton Junction.

Figure 2: Infrastructure between Peterborough station and Fletton Junction (simplified)

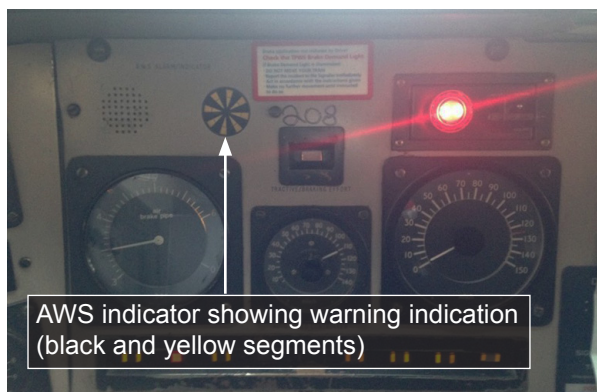
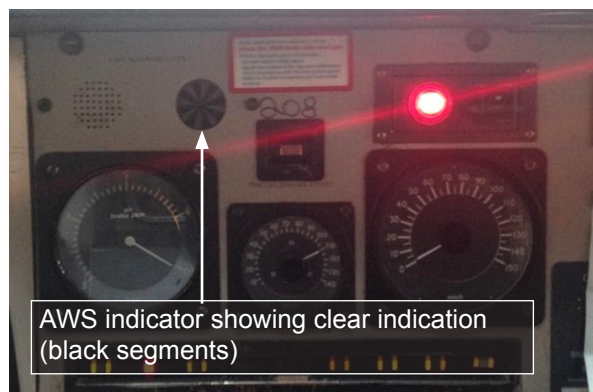
- 14 Train 1Y38 was being driven from the driving van trailer (number 82223) at the front of the train. Equipment fitted to this vehicle included:
- An *automatic warning system* (AWS) receiver which responds to magnets fixed to the track between the rails. A single permanent magnet is provided at locations where the AWS is always required to provide a warning. At other locations, an electro-magnet is added and energised when a clear indication is required. If a warning is given, a horn sounds in the driving cab, and if the driver does not acknowledge this warning within about 2 seconds⁶, the train's brakes will automatically apply to stop the train. If a clear indication is given, an electronic bell sounds in the driver's cab and the driver is not required to take any action. An *AWS visual indicator* in the driving cab, sometimes known as a 'sunflower', displays alternate black and yellow segments as a visual reminder to the driver if a warning was acknowledged at the last AWS location. In other circumstances it shows an all-black indication and this is the normal indication after passing an AWS location associated with a signal displaying a green aspect (figure 3).

Figure 3: AWS visual indicator

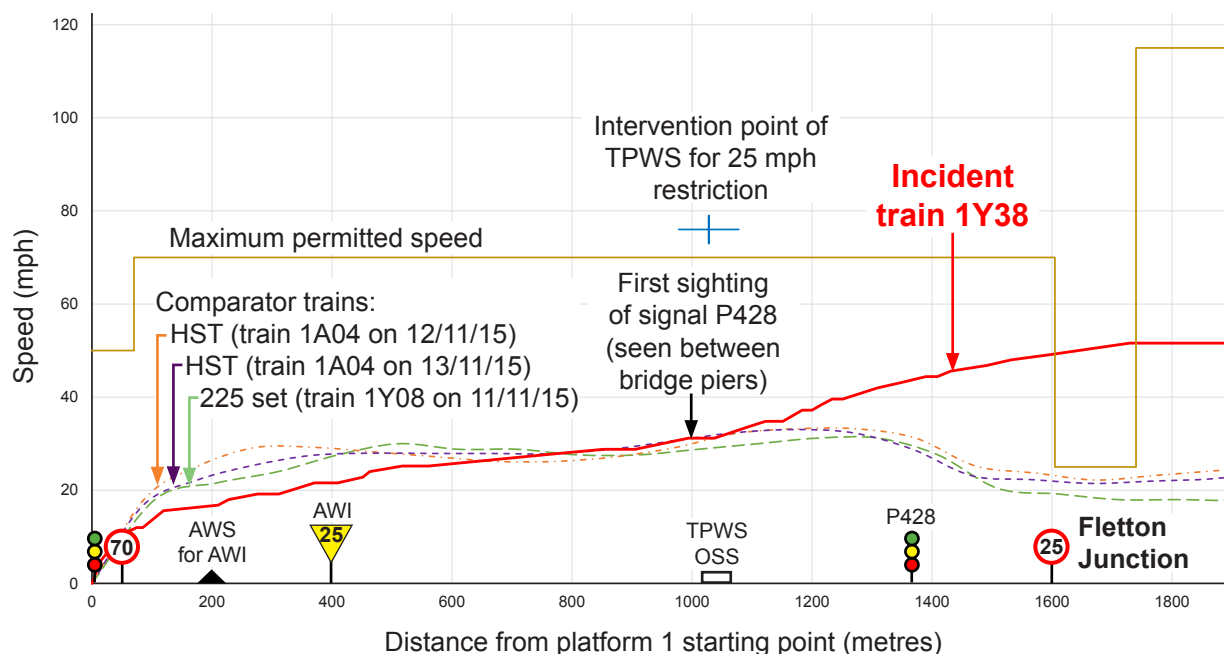
Figure 7: Speed profiles for trains on up slow line

- TPWS is not effective for trains which accelerate after they have passed the OSS loops. This is a normal condition for trains which start from platform 1 as demonstrated on figure 7 which shows that train 1Y38 and the sample of other trains were both accelerating as they passed the OSS.

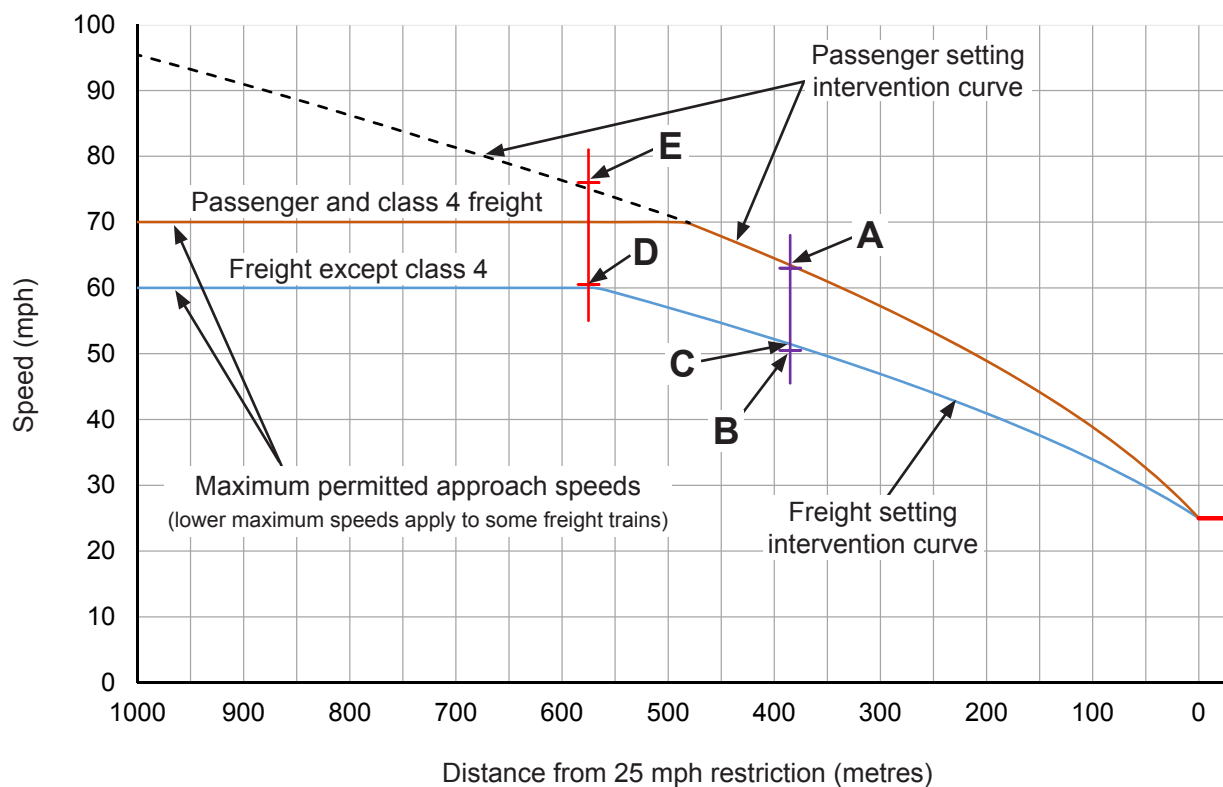
- 8 It would be possible to increase the likelihood of TPWS preventing a significant overspeeding event at Fletton Junction by restricting the approach speed of trains using the freight setting and by adding additional OSS loops intended to stop trains which accelerate inappropriately after passing over earlier OSS loops. The first could be opposed by the freight operating companies and the second would be a non-standard arrangement which, if justified at Fletton Junction, would also be justified at similar locations elsewhere on the rail network. The difficulty of configuring TPWS to prevent all overspeeding events at speed restrictions is probably because TPWS was originally developed to reduce the likelihood of serious accidents caused by trains passing signals displaying a stop indication.

Figure D1: Positioning TPWS OSS for permanent speed reduction at Fletton Junction
