Rail Accident Report

**Fatal collision between a tram and a pedestrian,
near Saughton tram stop, Edinburgh
11 September 2018**

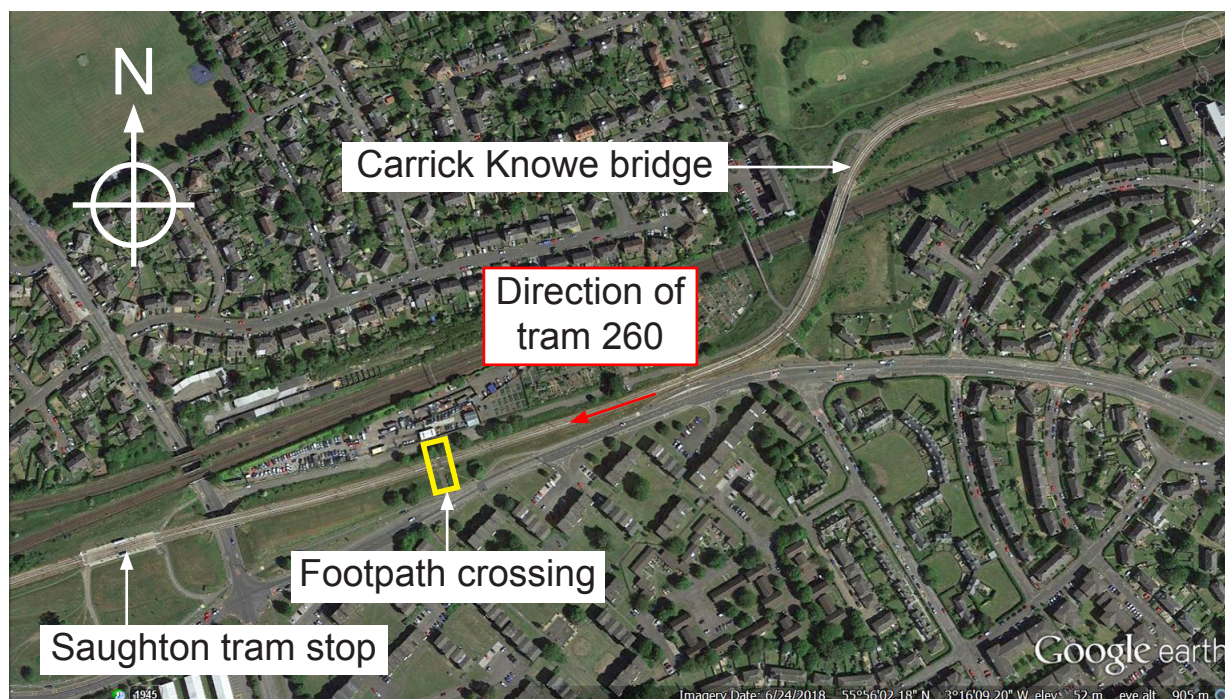
Figure 2: The location of the footpath crossing

- 4 The footpath crossing is located between Balgreen tram stop to the east and Saughton tram stop to the west. It is the most westerly of three crossings on this section of the line and links Stenhouse Drive to the south and Saughton Mains Street to the north (figure 2).

- 24 Tram 260 left Balgreen tram stop at around 12:08 hrs heading west towards the airport. Before it reached the section running parallel to Stenhouse Drive, the driver slowed the tram on the approach to the Carrick Knowe bridge (figure 2), which passes over the mainline railway. Shortly after the bridge, as the tram track straightens, the maximum permitted speed increases from 40 km/h (25 mph) to 70 km/h (44 mph). The data recorder indicates that the tram reached a maximum speed of 66 km/h (41 mph) on this stretch of track.
