Rail Accident Report

Passenger trapped in train doors and dragged at Clapham South station 12 March 2015

Report 04/2016
March 2016

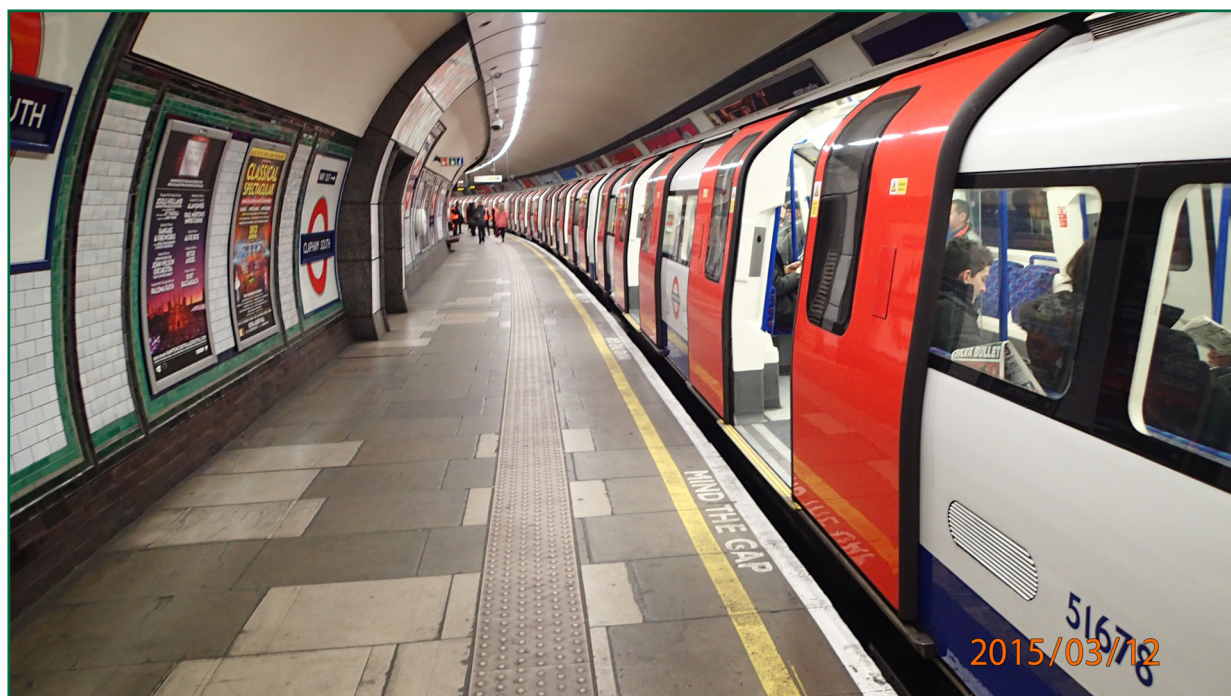
Figure 3: Northbound platform at Clapham South station

- 7 The northbound platform is positioned on the right-hand side of the track, relative to the normal direction of train movement, and is in a single track tunnel. There is a right-hand curve along the entire length of the platform (figure 3).

- 17 A yellow line had been painted along the platform 300 mm from the platform edge, as specified in London Underground standard S1131 (Premises - Station Platforms), to provide passengers with an indication of the distance they should stay back from the platform edge unless boarding or alighting from trains (figure 3). Alternative markings have been applied to the platform since the accident (paragraph 115g).

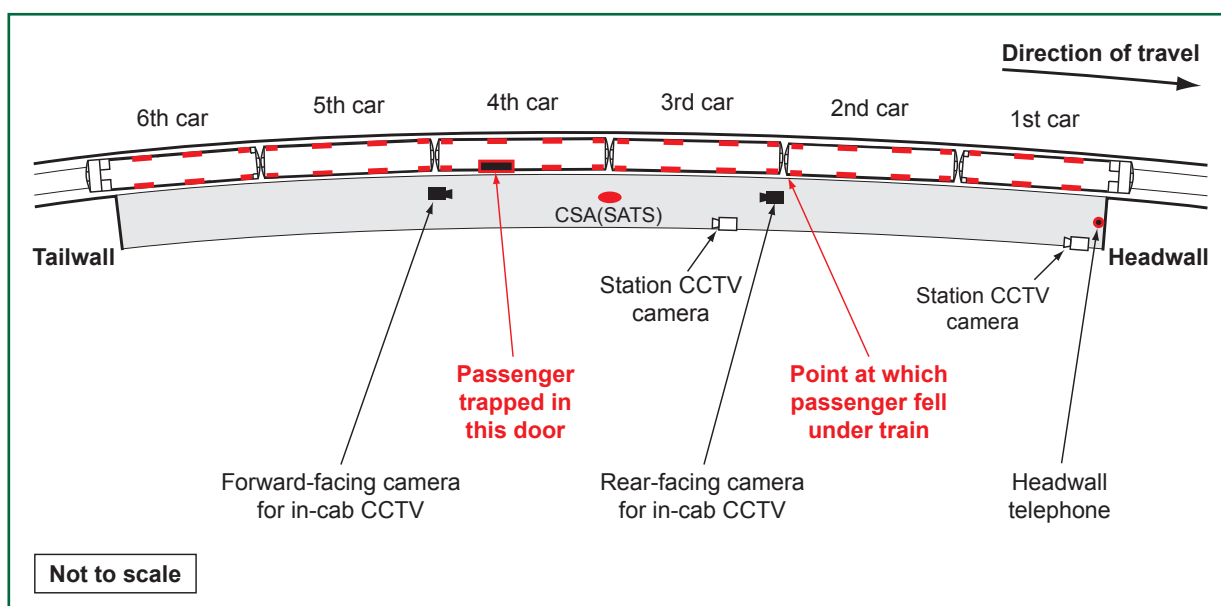
Figure 5: Layout of northbound platform

- 89 When the train departed, the CSA was standing with his baton raised in the central part of the platform, about midway along the train (figure 5). This was within the area where London Underground expect staff to stand when carrying out SATS duties on the northbound platform at Clapham South. He was approximately 10 metres from the door where the passenger had become trapped but could not see that she was in difficulty because his view of her was obscured by people on the platform who had been unable to board the train.

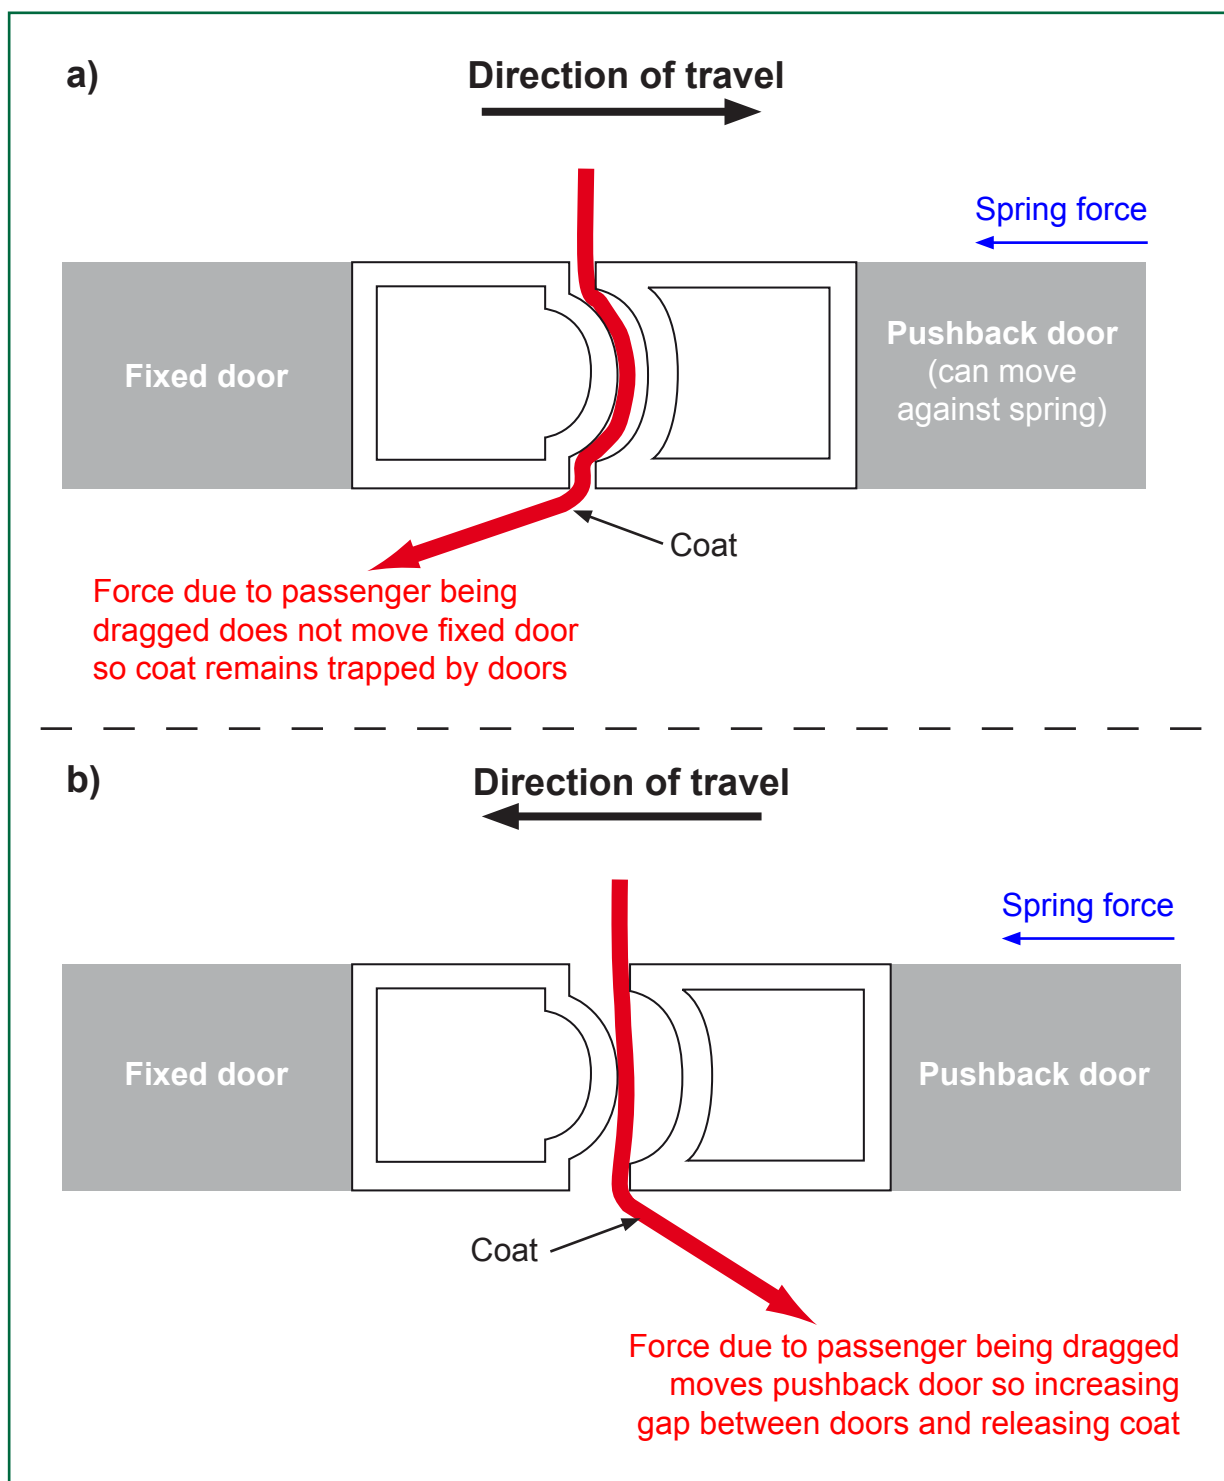
Figure 9: Effect of fixed door trailing

- 46 The configuration at the time of the accident meant that, as the passenger was being dragged, the coat was pulling against the fixed leaf which was unable to move to allow the coat to be released (figure 9a). If the train had been moving in the opposite direction, then the coat would have been pulling against the pushback leaf which would probably have opened slightly and released the coat (figure 9b).

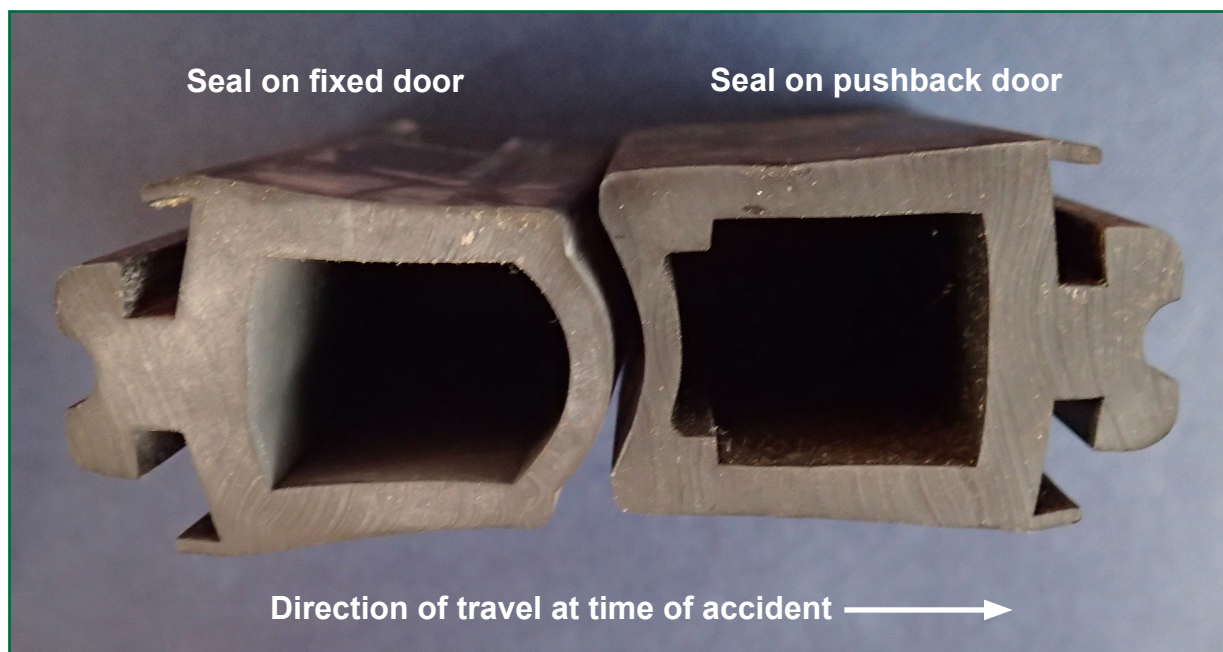
Figure 10: Door seal cross-sections

- 47 This door design is used on the majority of London Underground's trains, although the most recently built trains use different designs.
- 48 The door seals consist of hollow rubber extrusions, with the fixed leaf seal having a convex cross-section and the pushback leaf seal a concave cross-section (figure 10). The seals reduce draughts, water ingress and noise. They are able to compress around small objects when the doors close, but are intended to have sufficient flexibility, when combined with the pushback mechanism, to allow some trapped objects to be withdrawn. Door seal characteristics, particularly shape and flexibility, affect the ease with which trapped objects can be withdrawn from doors. The potential to modify sealing arrangements is discussed at paragraph 101.

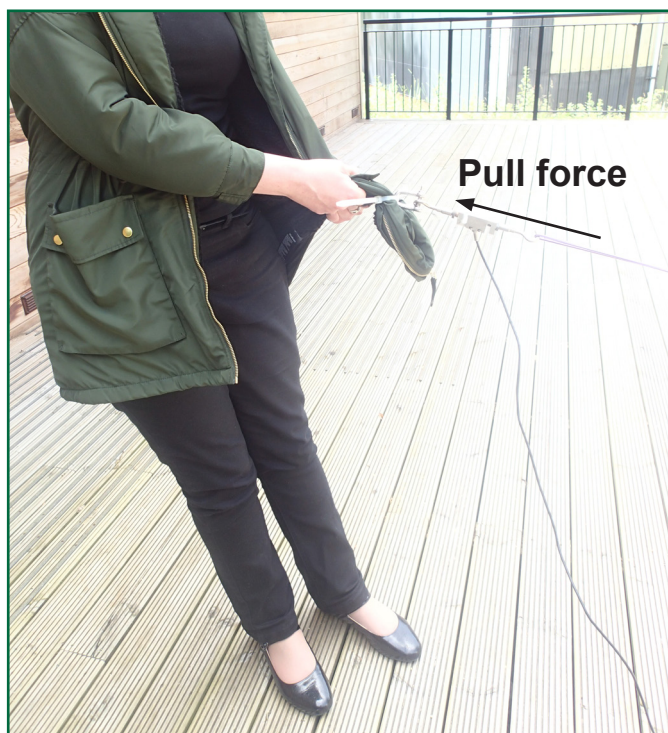
Figure 12: Testing pull-out force applied by person wearing incident coat

- 50 RAIB tests showed that a female of similar build to the passenger, and wearing a coat of the same type, could pull on the coat corner with a force of up to about 350 N (figure 12)⁴. However, the passenger only had a limited time (less than 5 seconds) to recognise her predicament before the train started to move and, until then, did not realise that the train would move with her still trapped. The force she could apply was probably limited because she was physically constrained to remain in the small space between the train and the passengers standing along the yellow line.

- 51 As a result, it is likely that, when standing beside the stationary train, and when walking and running beside the moving train, the passenger would have applied a force of less than 350 N. The force applied as the train started to drag the passenger and after she began falling to the ground is uncertain, but would have ceased after she slipped out of her coat.

- 59 The RAIB has compared these pull-out test results with the 350 N maximum force that the passenger was likely to have applied as established by RAIB tests (paragraph 50). A force greater than the passenger could reasonably have applied in good conditions was required to remove the coat when pulling at an angle backwards from the direction of travel (ie pulling against the fixed leaf), even if there was nothing in the pocket. When pulling perpendicular to the door with the test object in the pocket, the force required to pull the coat out was still higher than 350 N. Without the object in the pocket, the required force was smaller and it would have been feasible, but not easy in the cramped conditions and short time available, for the coat to be pulled out. All of the pulls at an angle forward of the direction of travel required much smaller forces to pull the coat out, regardless of whether the test object was in the pocket or not. This is because the pull was against the pushback leaf, which was able to move.

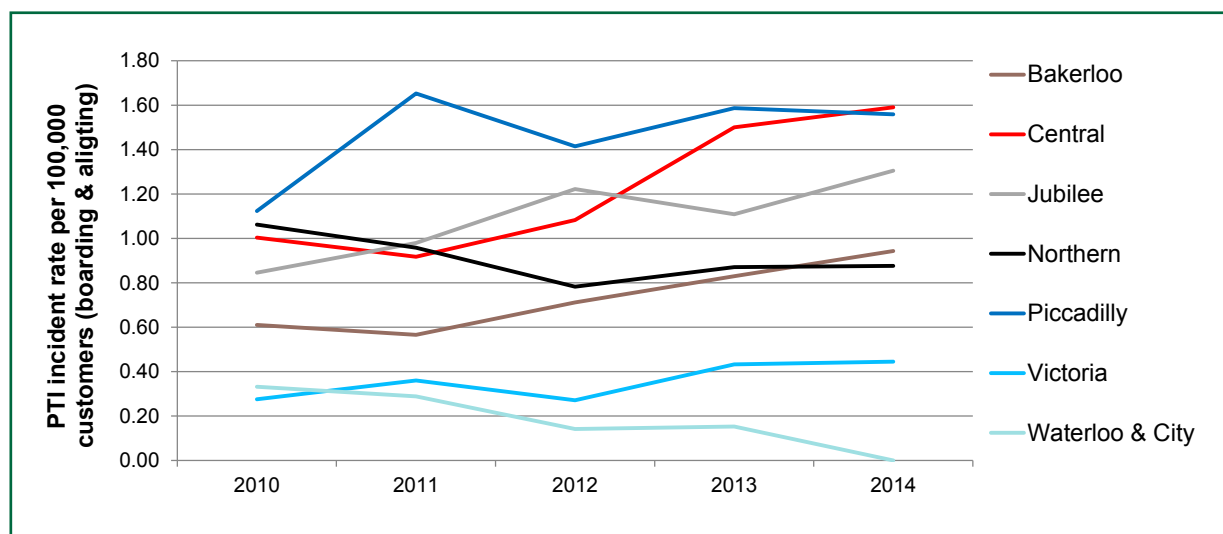
Figure 18: Normalised PTI incident rate on London Underground's tube network line

- 83 The statistics show that the PTI incident rate on the Northern line has slightly decreased since 2010, and has been relatively stable since 2012. It also shows that the PTI incident rate for the Northern line is similar or better than that for other comparable London Underground lines (figure 18).
