Rail Accident Report

Tram collision with pedestrian near Market Street tram stop, Manchester 12 May 2015

Tram collision with pedestrian near Market Street tram stop, Manchester, 12 May 2015

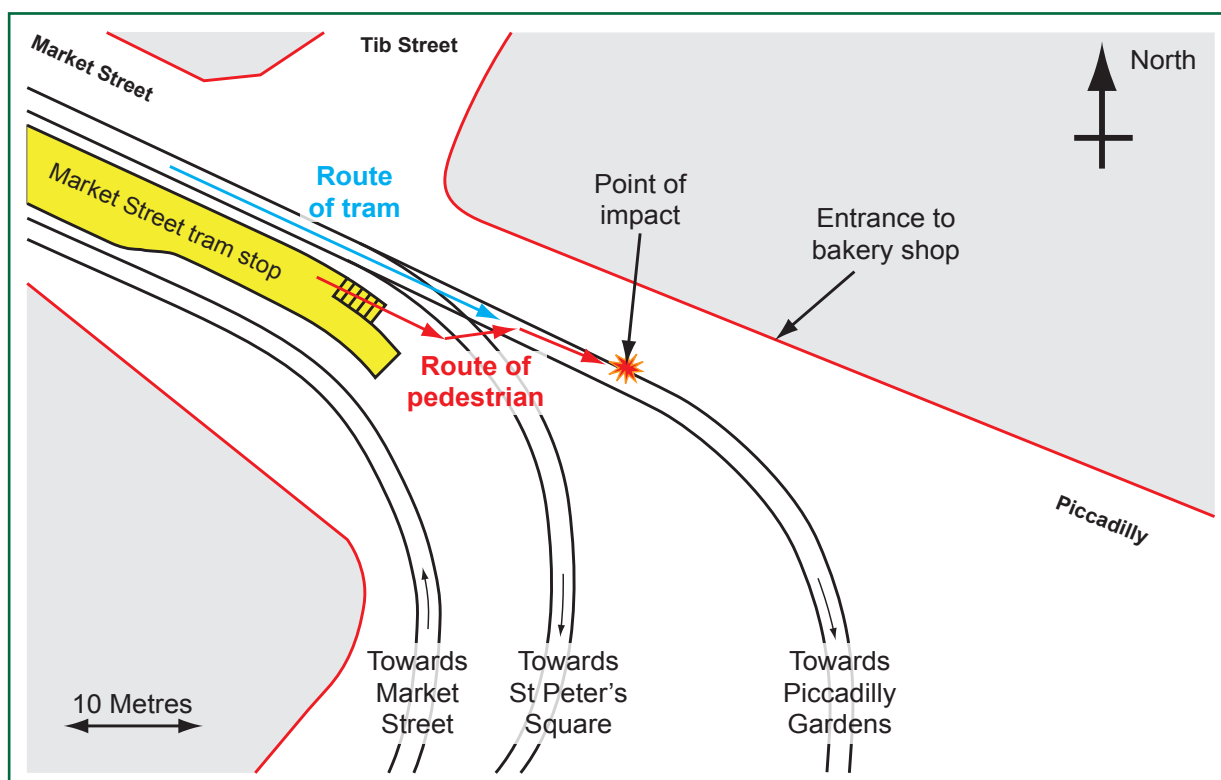
Figure 3: Plan view of Market Street

- 4 The pedestrian had alighted from the same tram at the Market Street stop and was walking along the track towards Piccadilly (figures 2 and 3). He suffered serious injuries as a result of the collision; no-one else was injured.
- 5 Tram services were suspended for approximately 45 minutes following the accident.

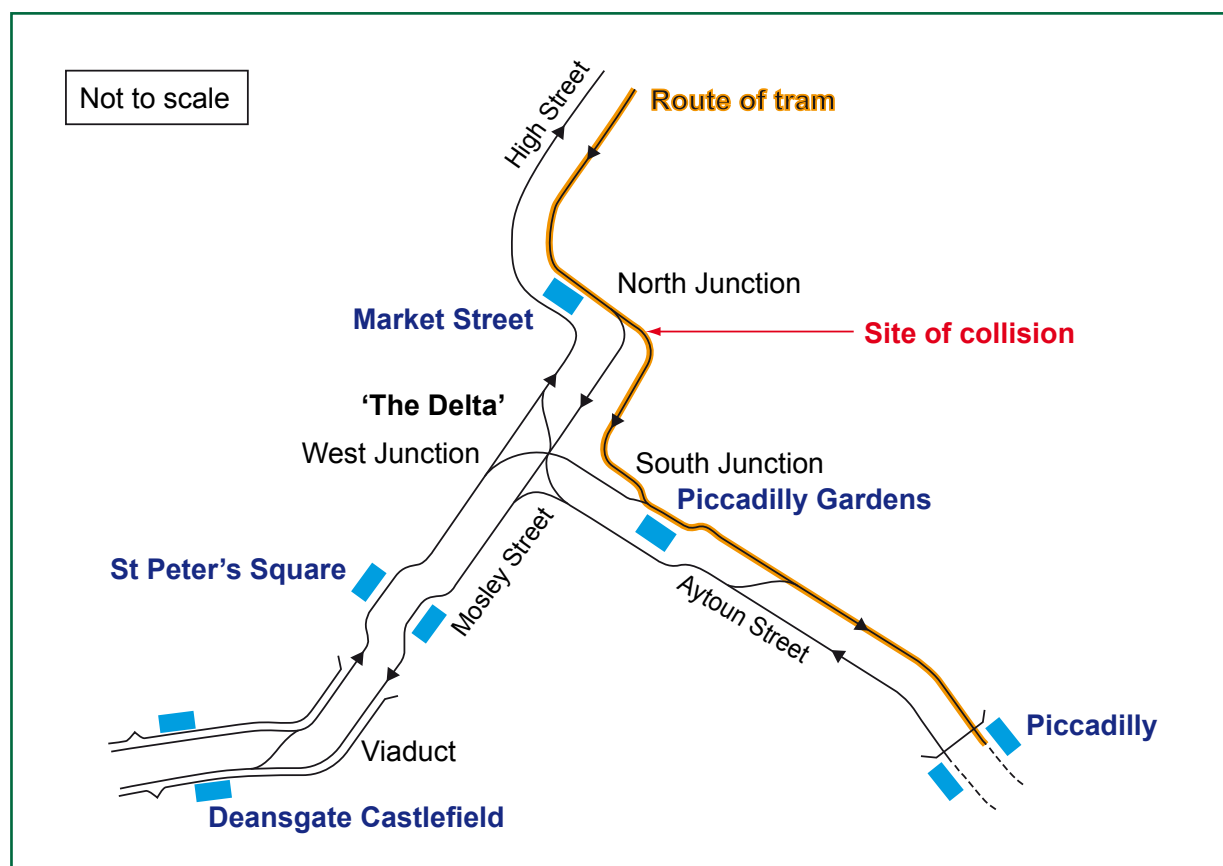
Figure 4: Track layout, Central Manchester, showing diverging routes at North Junction

- 6 The Piccadilly Gardens area in Central Manchester is at the hub of the Metrolink system¹. Tramway infrastructure in this area includes North, South and West junctions, the 'Delta' and the Market Street and Piccadilly Gardens tram stops (figure 4). Piccadilly Gardens and the section of Market Street in which the tram stop is situated in a pedestrianised area (closed to motor traffic except trams and vehicles requiring access).

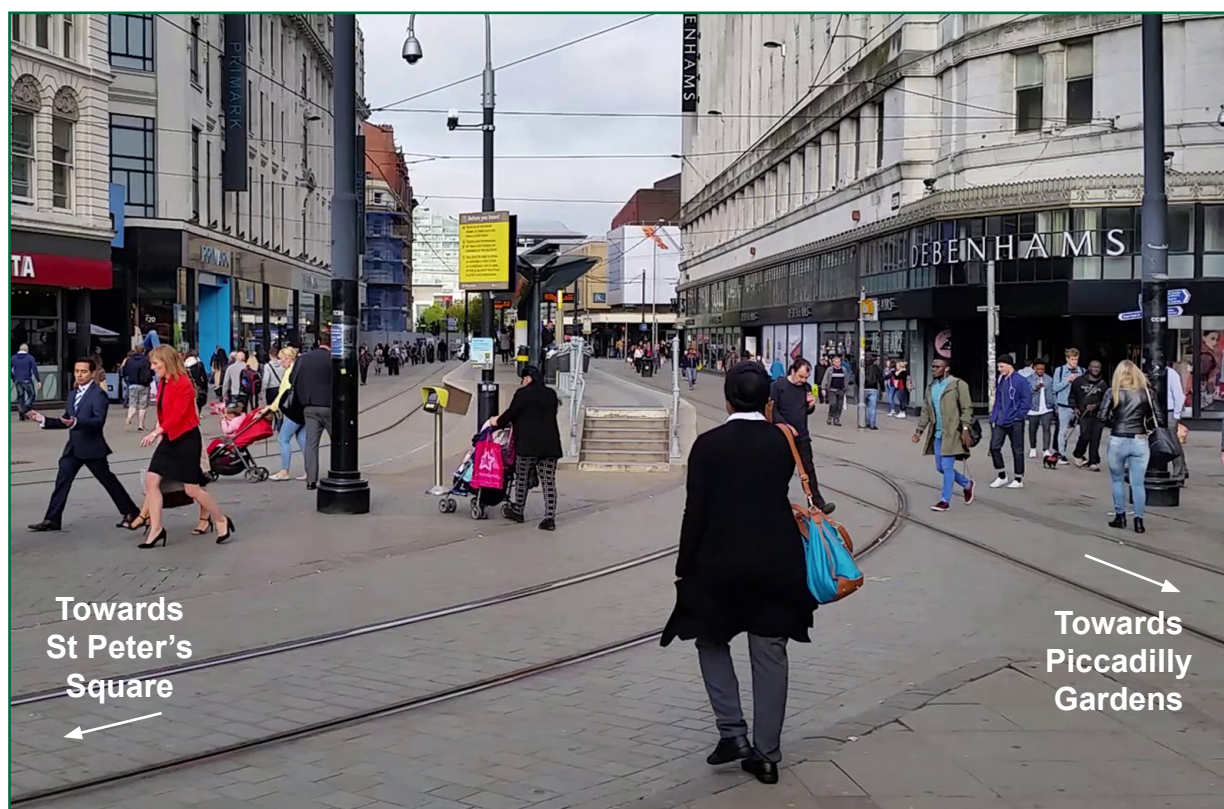
Figure 5: View along Market Street towards High Street, with Market Street tram stop in the centre

- 7 The tram involved in the accident had passed from an *off-street tramway* into an *on-street tramway* at Manchester Victoria station. After travelling south along High Street, which is classed as a segregated on-street tramway (see appendix D), the tram turned left into Market Street. This area is classed as an integrated on-street tramway as, although other road vehicles are not normally present, the surface in which the rails are laid is available for use by pedestrians (figure 5).

- a. integrated on-street tramways;
 - b. segregated on-street tramways; and
 - c. off-street tramways⁵.
- 28 The Piccadilly Gardens area in Manchester, including Market Street, is a pedestrianised area in which trams share the space with pedestrians (figure 5). As such, it falls within the definition of an integrated on-street tramway as well as being a form of *shared space*.

- f. may be inattentive to trams due to the use of mobile devices (eg phones or music players) or conversations with other pedestrians;
- g. tend to move freely across and along the tracks (figures 5 and 9), ignoring the areas of tactile paving on either side of the tracks (see paragraph 73);
- h. often do not appear to respond to tram whistles; and
- i. stand close to trams while waiting to cross.
