# Rail Accident Report

## **Collision between a train and a piece of equipment at Barrow-upon-Soar, Leicestershire, 14 February 2016**

Report 21/2016  
October 2016

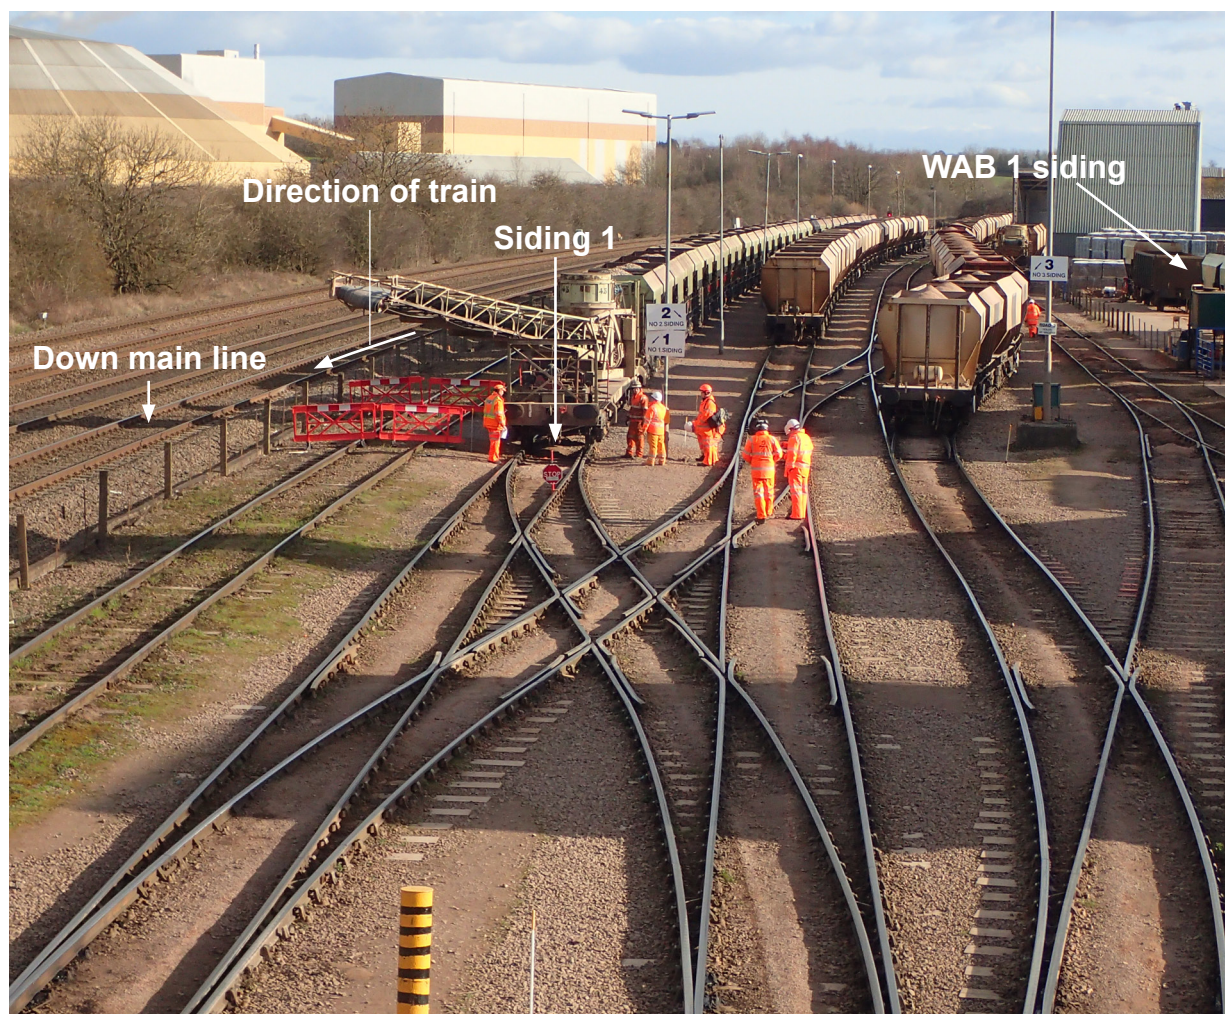
Figure 2: Site of the accident

- 3 At around 10:26 hrs on Sunday 14 February 2016, a passenger train collided with an unloading wagon conveyor boom projecting from an aggregates train standing in Barrow-upon-Soar sidings (figures 1 and 2). The train was travelling at approximately 102 mph (163 km/h). The driver applied the emergency brake and the train stopped approximately 0.72 miles (1.17 km) from the point of impact.

- 25 The Tarmac PIC briefed the locomotive driver and member of groundstaff in the control cabin. The driver and groundstaff then shunted unloading wagon REDA92545 onto the SDT hopper wagons for the Peterborough train which had already been loaded with stone and were in siding 1 (figure 2). This train was scheduled to depart at 05:43 hrs the following day (Monday). The driver and groundstaff then proceeded to shunt other wagons that needed to be moved to make up other trains.

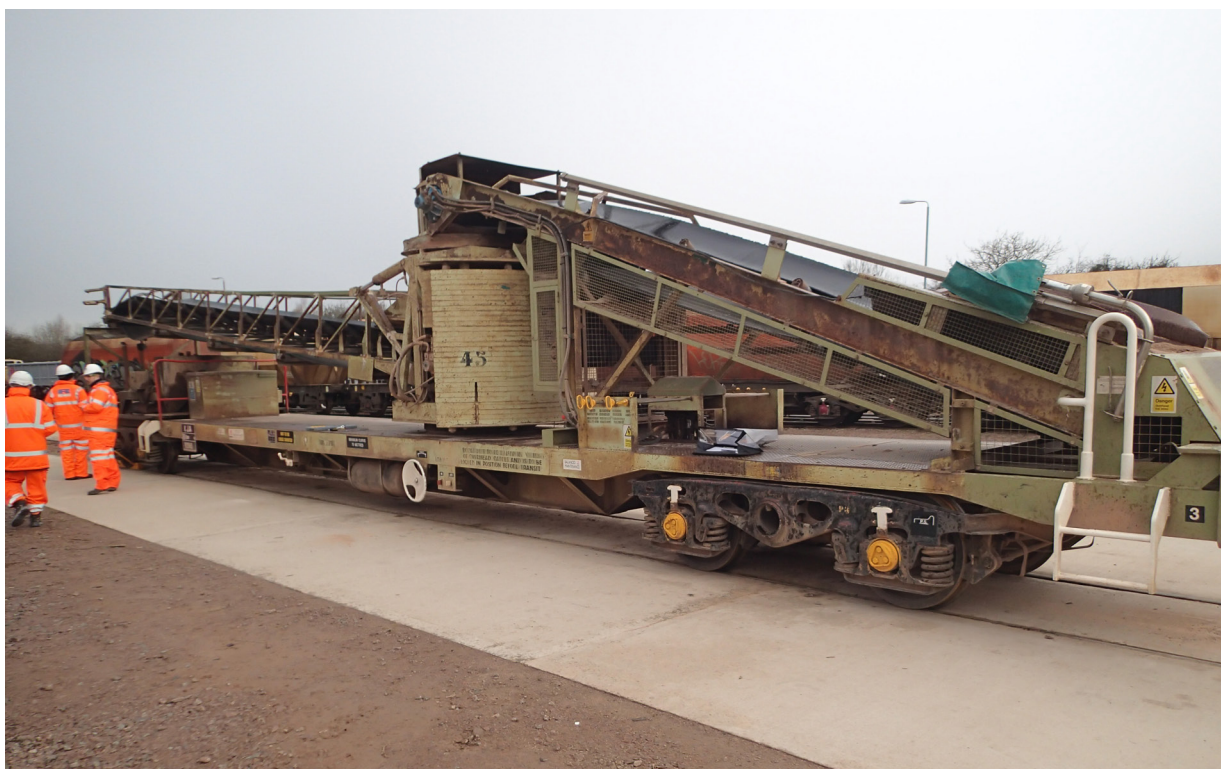
Figure 4: SDT unloading wagon REDA92545

- 16 The train involved was the 10:20 hrs passenger service from Leicester to York, reporting number 1F01. It comprised a 7-car diesel-electric multiple unit, number 222 005.
- 17 The wagon involved (figure 4) was an unloading wagon, number REDA92545, which is part of the self-discharge train (SDT) fleet. The wagon is fitted with a conveyor belt mounted on a boom which can rotate in plan view (figure 5). Its purpose is to provide a means of discharging stone from the hopper wagons which make up most of the SDT fleet. The boom can be rotated to discharge the stone to either side of the wagon.

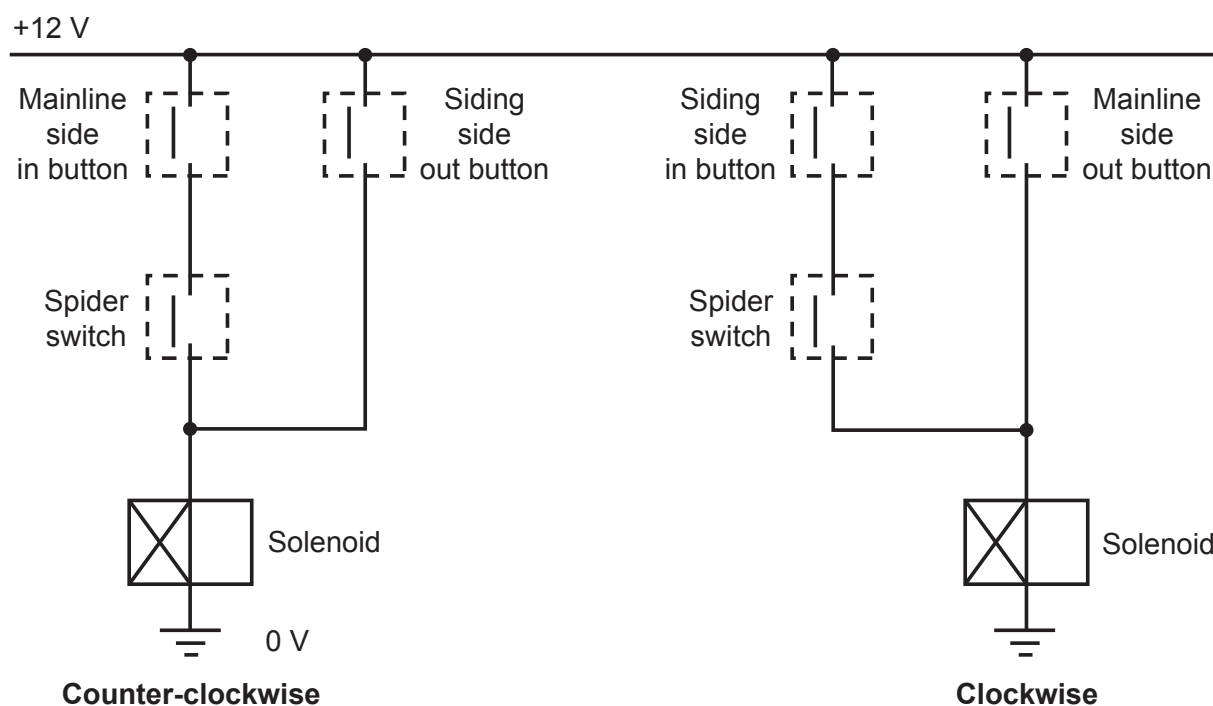
Figure 6: Circuit diagram

- 29 Fitter 1 replaced the switch contact block on (paragraph 49) the inwards slewing push button on the main line side and tested it, but the fault was still present. He then considered that the fault might be with the 'spider' switch which detects which way the boom has slewed. It is mounted in the centre of the wagon behind the slewing turret (figure 5) and has arms which engage with rods attached to the turret. This switch has two pairs of contacts, one of which is wired in series with the 'in' push button on each side, and is arranged such that the 'in' push button only becomes active when the boom is slewed to that side. This means that the boom can only be slewed in towards the centre using the controls on the side that the boom is slewed out over. Figure 6 shows the circuit diagram of the slewing control circuit, as surveyed by the RAIB after the accident.

66 Neither Tarmac nor Wabtec had any written information on the electrical control circuits of the wagon. The RAIB examined a similar unloading wagon, number REDA92546, to derive the slewing control circuit diagram (figure 6). The RAIB then checked that the circuit was same on the incident wagon, REDA92545, and carried out tests of it. During these tests the normally open switch on the out button on the main line side of the wagon was operated a number of times and stuck on one occasion (figure 11). This would have caused the boom to move out of control to the end of its travel, had the solenoids on the hydraulic valve not been disconnected for the test.

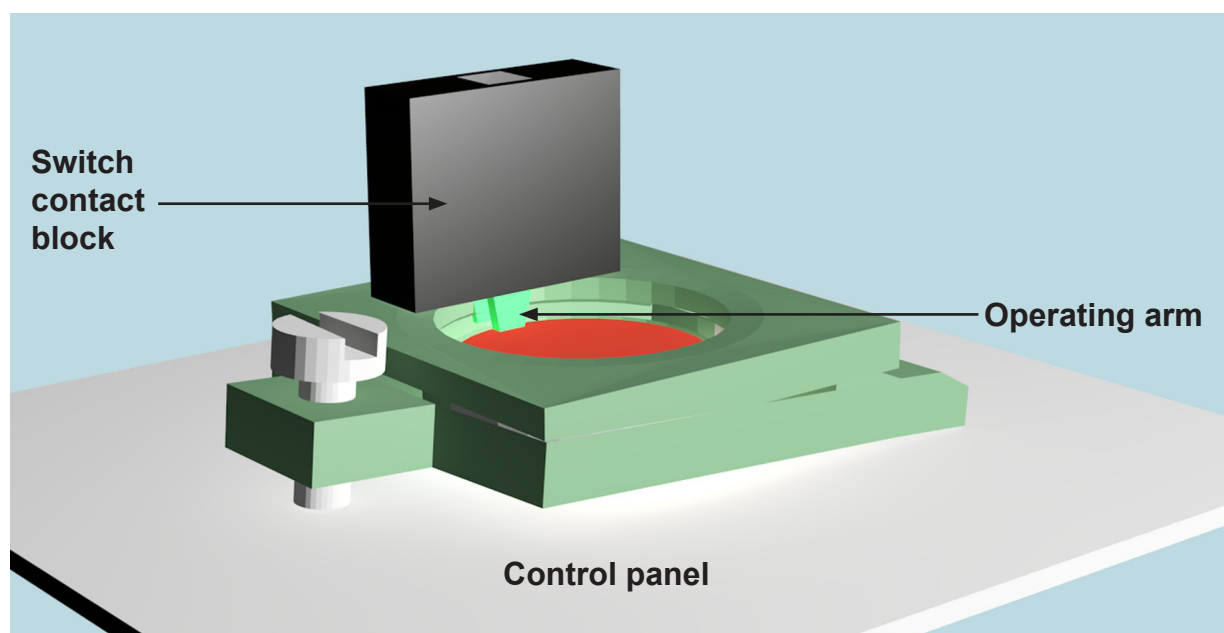
Figure 9: Arrangement of switch and button unit (button coloured red)

- 49 Behind the button unit, within the control panel enclosure, there is a diecast metal bracket (or collar) which secures the button unit and provides a mounting point for one or more switch contact blocks (figure 9). These switch blocks are not rated to be waterproof or dustproof (paragraph 78). Each of these switch blocks is itself sprung and has a protruding operating arm which presses against the back of the push button (coloured red in figure 9). It is possible, when the pushing force is removed, for the button to return to the normal position but the switch block remain in the operated position if the switch block were to stick in that position. If this were to occur, it would not be apparent from the front of the panel, as the button would spring back out.
