Rail Accident Report

Collision between a train and a tractor at Oakwood Farm User Worked Crossing, Knaresborough 14 May 2015

This report is published by the Rail Accident Investigation Branch, Department for Transport.

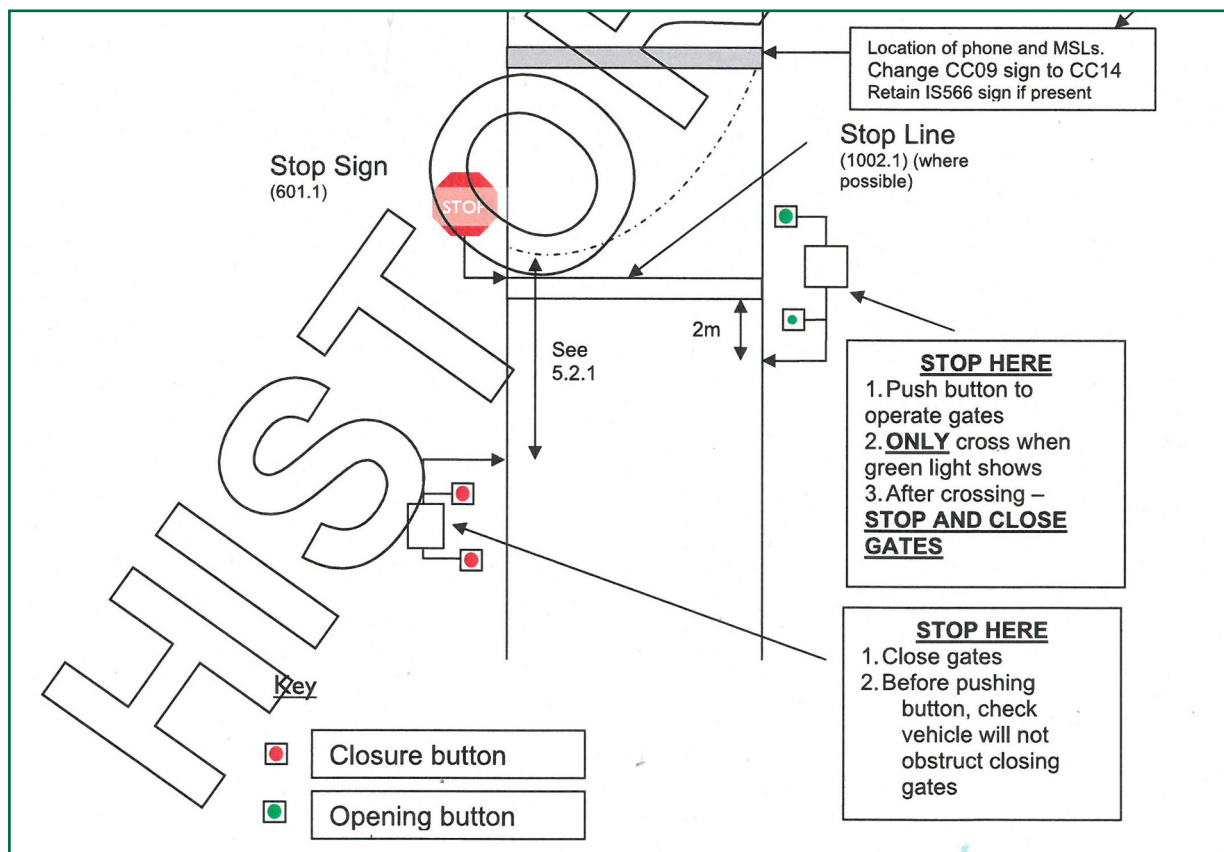
- 74 At the time of the accident, the POGO equipment was the second version that had been fitted for trials at Oakwood Farm UWC. For the first POGO trial, Network Rail created standard NR/L2/SIG/30039 in December 2009. Within this standard was a plan which showed a layout of a typical user worked crossing with MSLs, including the positions of the buttons (figure 12). Buttons located on the right-hand roadside posts (those closest to the gates) were specified as 'opening' buttons. Buttons on the left-hand roadside posts were specified as 'closure' buttons. These 'closure' buttons are located further away from the crossing to allow long vehicles and farm machinery to be clear of the gates when the button is pressed to close the gates. This configuration also allowed drivers of right-hand drive vehicles to reach the buttons without having to leave their vehicles.

Figure 12: Extract from superseded Network Rail standard NR/L2/SIG/30039, Issue 1, December 2009
