Rail Accident Report

Runaway hand trolley at Ramsbottom, East Lancashire Railway 15 March 2018

Report 18/2018
November 2018

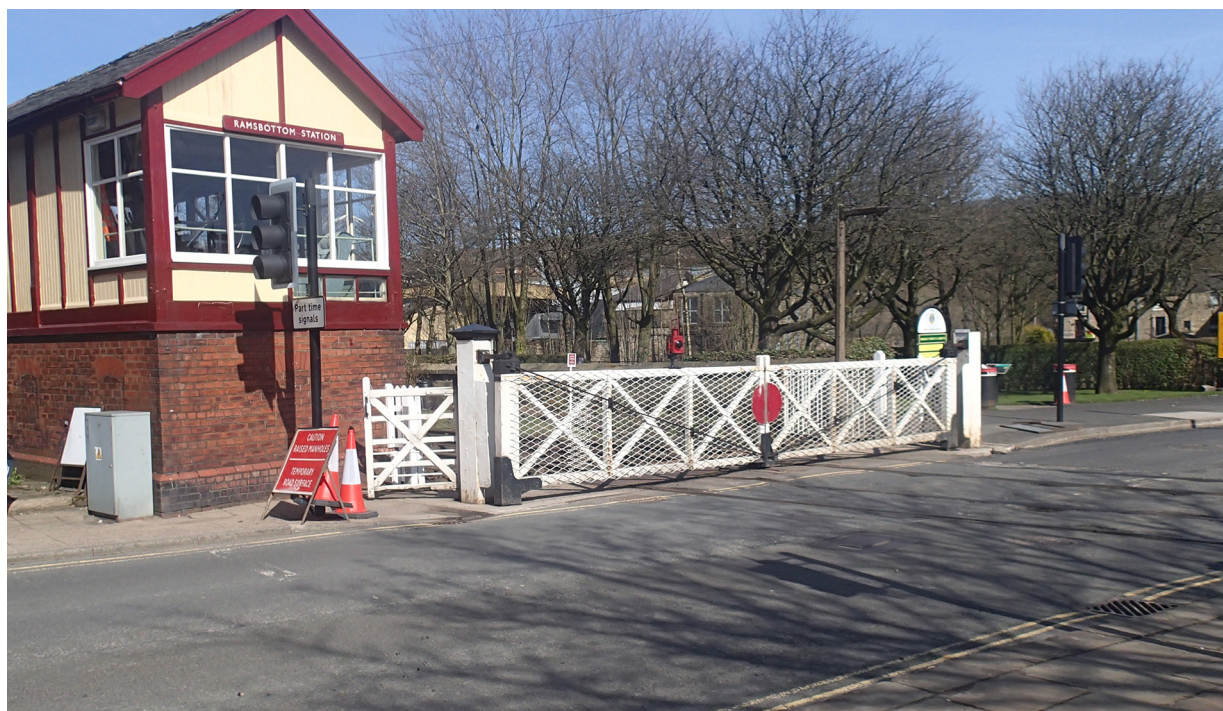
Figure 5: Ramsbottom signal box and level crossing

- 25 The trolley struck the eastern gate on the north side of the crossing. It derailed and some ballast spilled onto the road. The impact damaged the woodwork and the gate mechanism causing the gate to be partially displaced across the road. A passing motorist was forced to alter course to avoid the gate. He stopped briefly and spoke with one of the volunteers.
