Rail Accident Report

Collision at London Waterloo 15 August 2017

Report 19/2018
November 2018

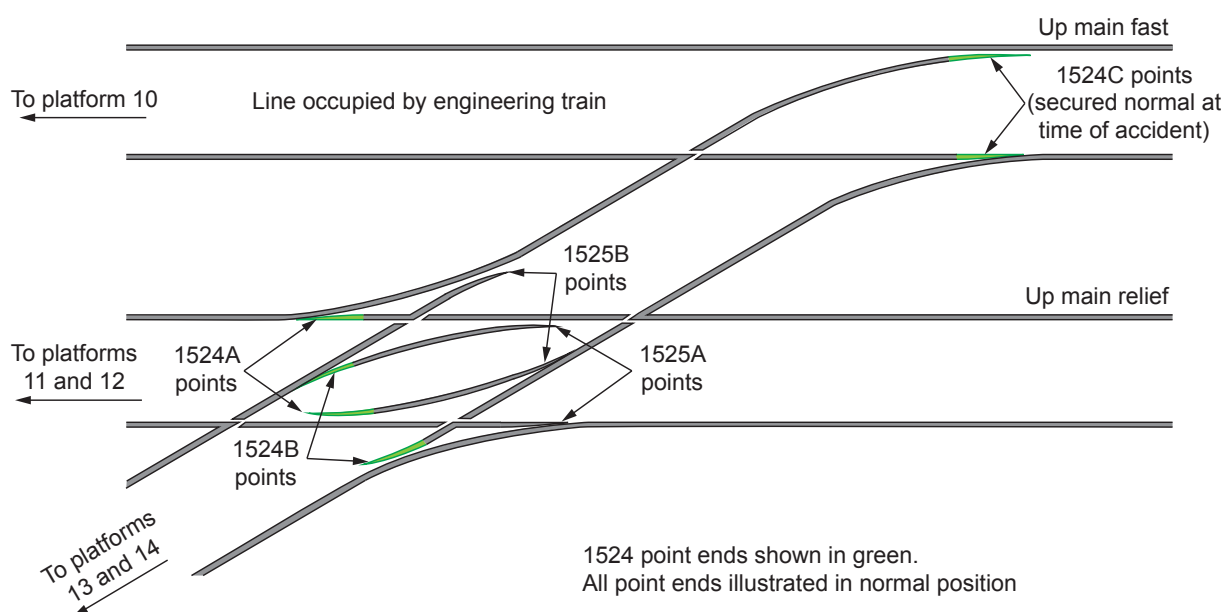
Figure 5: Schematic layout of 1524 points, the accident location

- 22 The three pairs of ends of 1524 points were intended to swing together so that all were in the normal position, or all were in the reverse position. When correctly in the normal or reverse position, the point ends should have been mechanically locked and confirmed to be (ie detected) in this position before a train was permitted to pass over them.

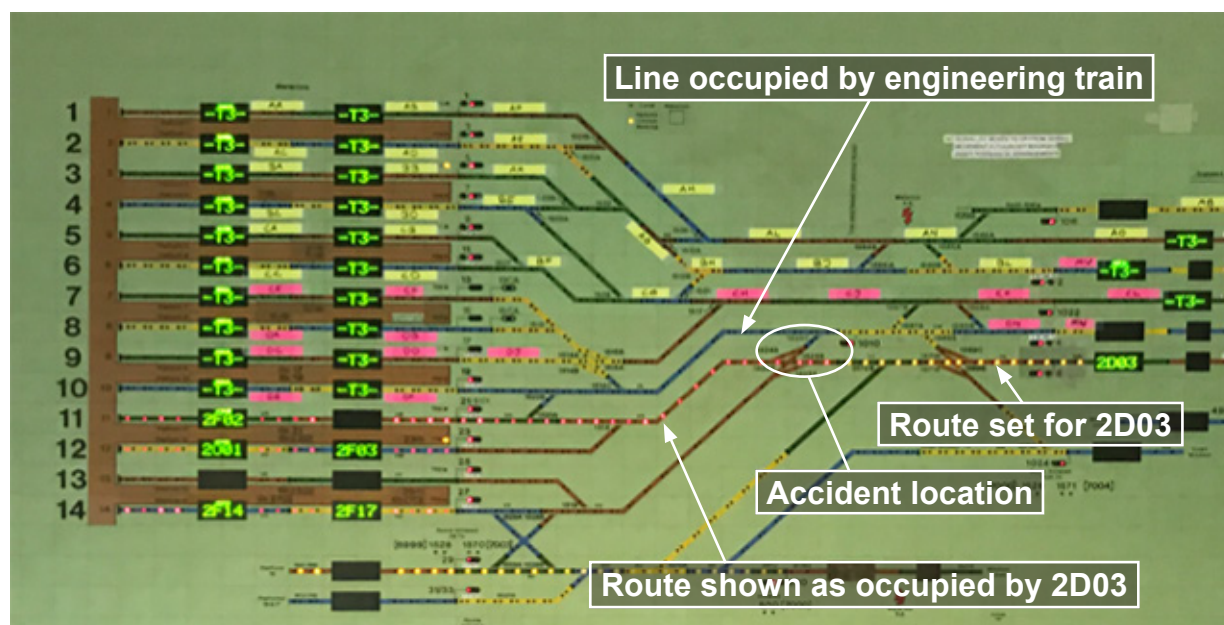
- 29 At 05:40 hrs the signaller set a route for train 2D03 to leave platform 11. The panel display at Wimbledon indicated that it was safe for the train to do this (figure 6). The train driver received a green signal with 'UR' displayed on the adjacent theatre indicator (figure 7). This indicated that it was safe for his train to leave the platform and proceed along the up main relief line. The train departed at 05:41 hrs.

Figure 6: Signaller's panel at Wimbledon showing the route out of platform 11 set for and occupied by train 2D03. (Indicators are not illuminated for the engineering train as inputs were not provided to these indicators during parts of the construction work.)

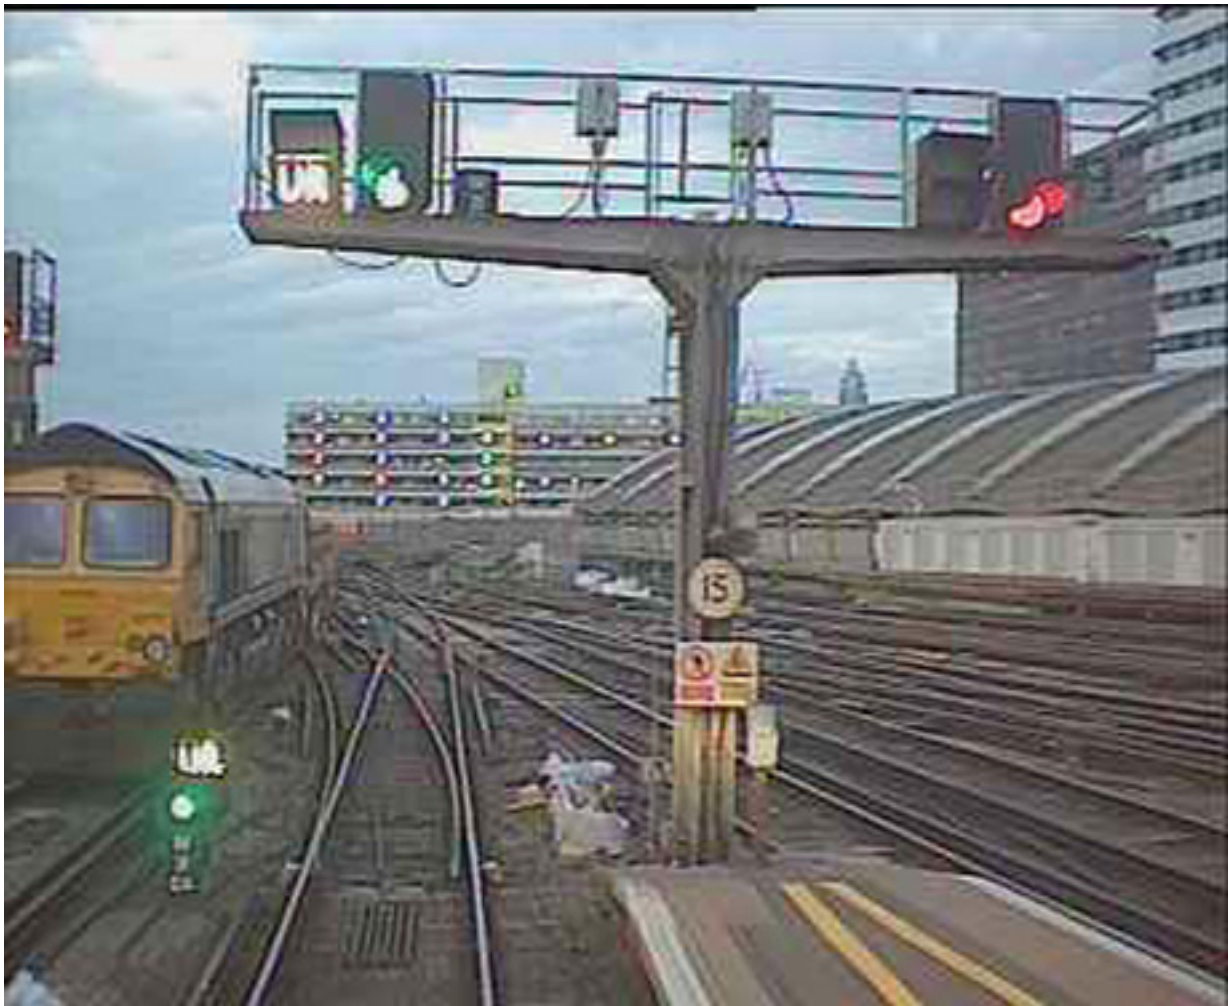
Figure 7: Forward facing CCTV from train 2D03 showing the green signal and 'UR' (up main relief) route indication displayed at high and low levels as it departed from platform 11 (courtesy South Western Railway)

- 84 Images from the passenger train's forward facing CCTV show a green signal with a 'UR' indication displayed adjacent to this (figure 7). This gave the driver authority to proceed out of platform 11 and along the up main relief line, the line running alongside the engineering train. The correct indications for this authority were shown on the signallers' display at Wimbledon area signalling centre (figure 6).
- 85 Less than a minute after the signal turned green, the train was approaching 1524 points and images from the train's CCTV showed the points in an intermediate position between the reverse position and the intended normal position (figure 8).

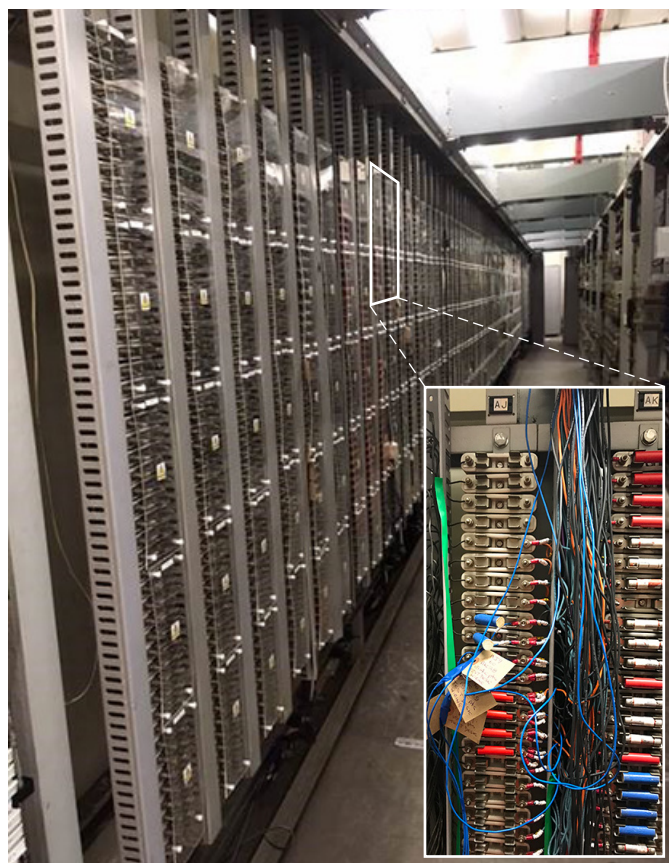
- 57 The detectors on 1524 points are connected by electrical cables to a lineside cabinet (location case W14), and then into the Waterloo relay room (figure 10). Although 1524 points were not physically affected by the upgrade work, the arrangement of the point detection wiring between 1524 points and the relay room was modified when location case W14 was replaced in June 2017 (paragraph 59).

Figure 10: Waterloo relay room with inset including connections from 1524 points and associated fuse holders as detailed in figure 19

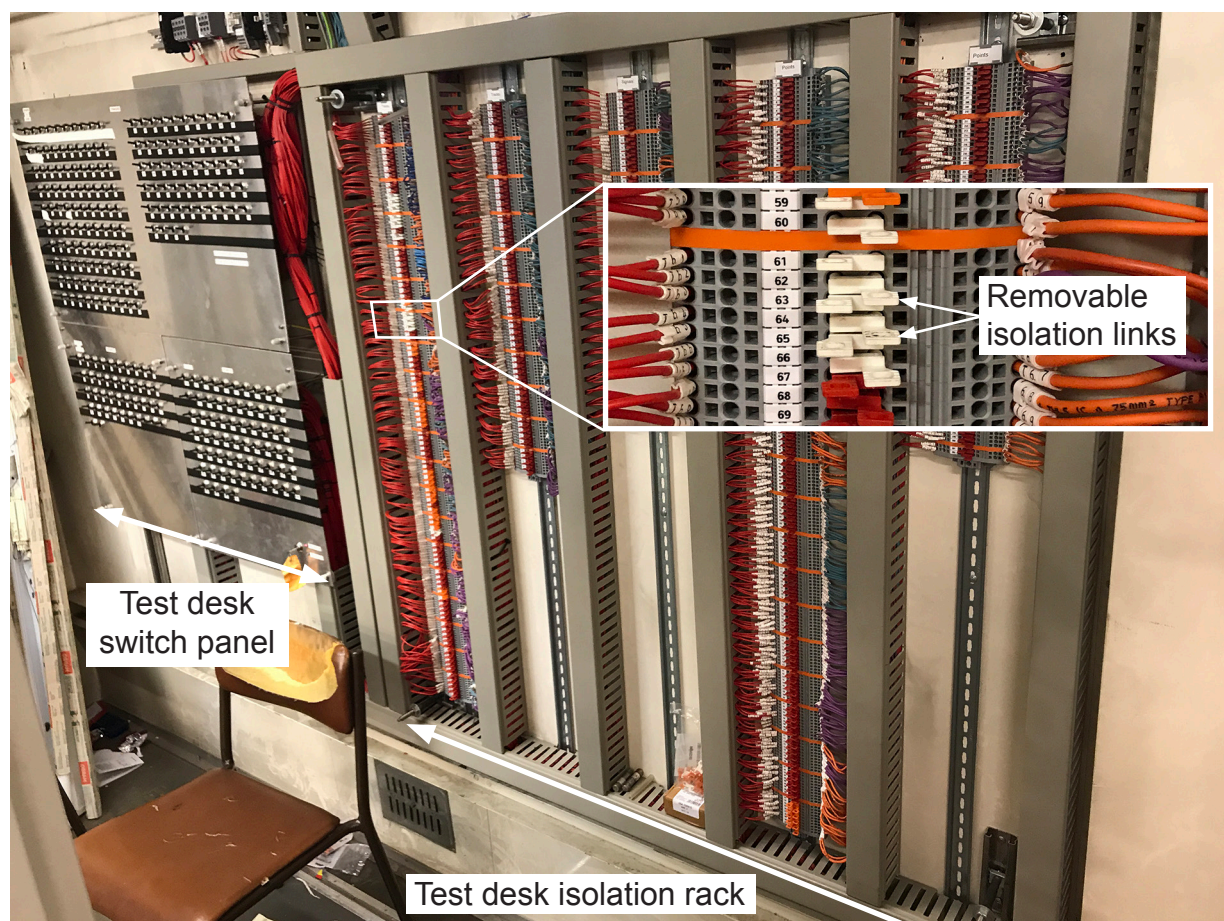
- 67 The spur wires were connected to the interlocking side of fuse holders on circuits linking the interlocking to trackside equipment. These wires remained connected to the interlocking fuse terminals at all times. Testers removed fuses and inserted links in the isolation rack to allow the interlocking to respond to the simulated inputs from the test desk switch panel, and not to trackside equipment. Once testing was complete, removing the links from the isolating rack disconnected the switch panel from the interlocking and re-inserting the fuses caused the interlocking to respond to inputs from trackside equipment.

Figure 12: Test desk switch panel and isolation rack in Waterloo relay room. White links are conductive, red and orange links are dummy (isolating) links which are fitted to prevent unintentional fitting of conductive links.

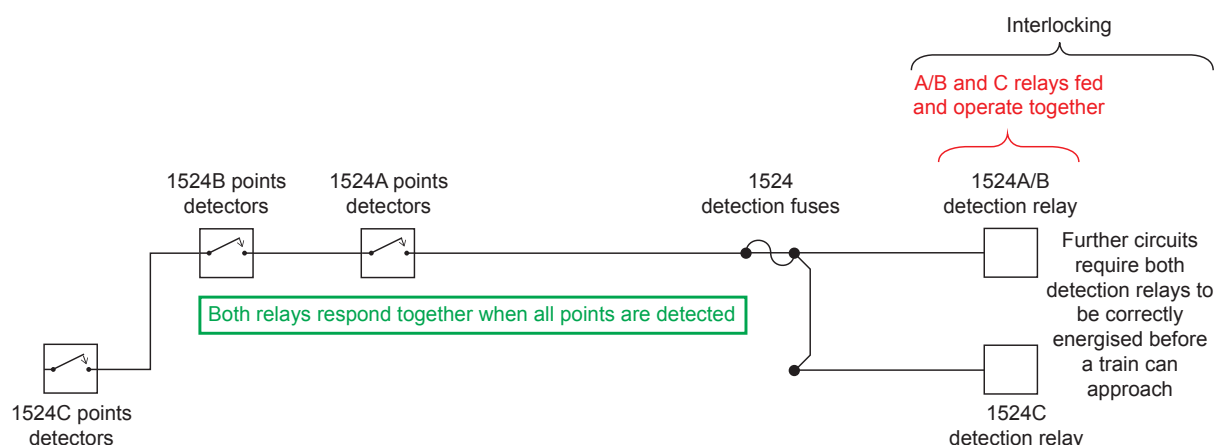
- 91 Before the works began, the point detectors for each of the three ends were wired in series, meaning that all three ends had to be in the same position before any current was returned to the normal or reverse detection relays (figure 13). This current was then used to energise the appropriate relays designated 1524A/B and 1524C. Although designated A/B and C, these relays were fed by detection circuits passing through all three point ends. Further circuitry in the interlocking required the detection relays to be energised before signals could display a proceed aspect to permit trains to approach 1524 points.

Figure 13: 1524 points detection before work began

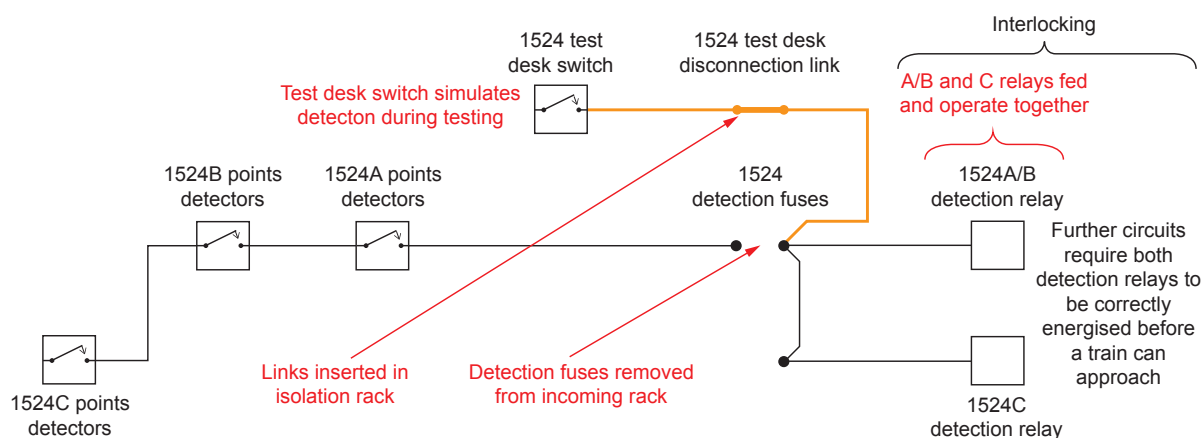
- 92 When the test desk was installed in August 2016, spur wires were attached to the detection fuse terminals which fed both 1524A/B and 1524C detection relays. When used to simulate the operation of 1524 points, the test desk correctly energised these relays (figure 14).

Figure 14: 1524 points in test mode, before location case W14 was replaced

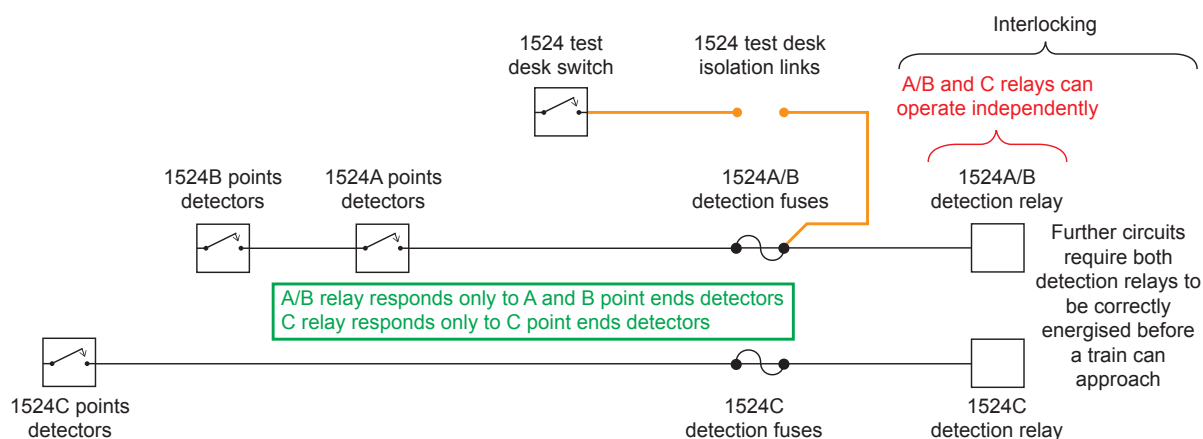
- 93 The detection wiring from 1524 points passed through location case W14. When this was replaced in June 2017 (paragraph 71), the wiring was altered so that A and B detection circuits energised only 1524A/B detection relays and the C end detection circuits energised only 1524C detection relays (figure 15). As before, further circuitry required both detection relays to be energised before trains were permitted to approach 1524 points.

Figure 15: 1524 points detection after location case W14 was replaced (no uncontrolled wiring)

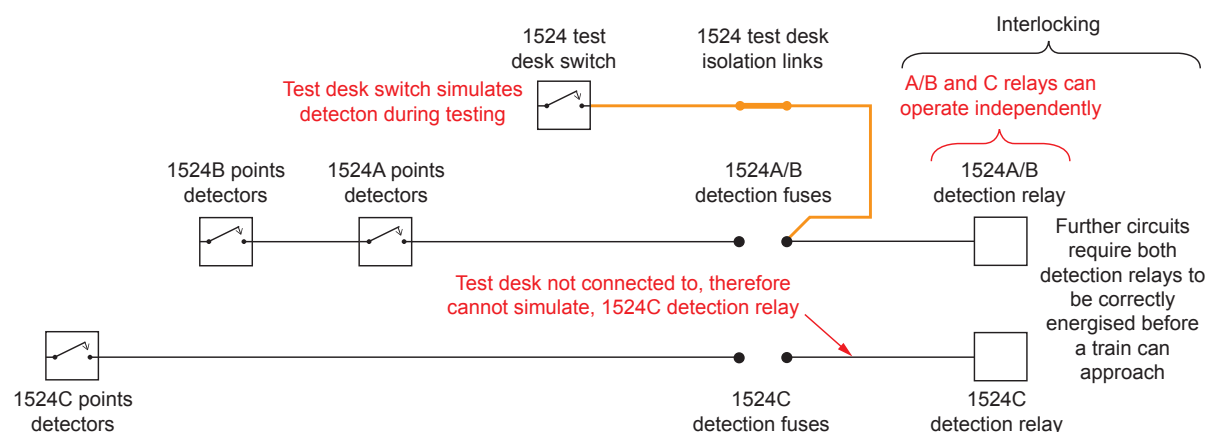
- 94 These modifications to the wiring of 1524 points detection (paragraph 71) did not affect the safety functions provided by the interlocking but did mean that the test desk no longer simulated the detection of 1524 points correctly because 1524C point ends were no longer connected to it (figure 16). This would not be apparent until testers required the test desk to simulate the position of the points.

Figure 16: 1524 points in test mode after replacement of location case W14 (no uncontrolled wiring)
