Rail Accident Report

**Serious operational irregularity at Bagillt user
worked crossing, Flintshire, involving an
abnormally heavy road vehicle
17 August 2018**

Serious operational irregularity at Bagillt user worked crossing, Flintshire, involving an abnormally heavy road vehicle, 17 August 2018

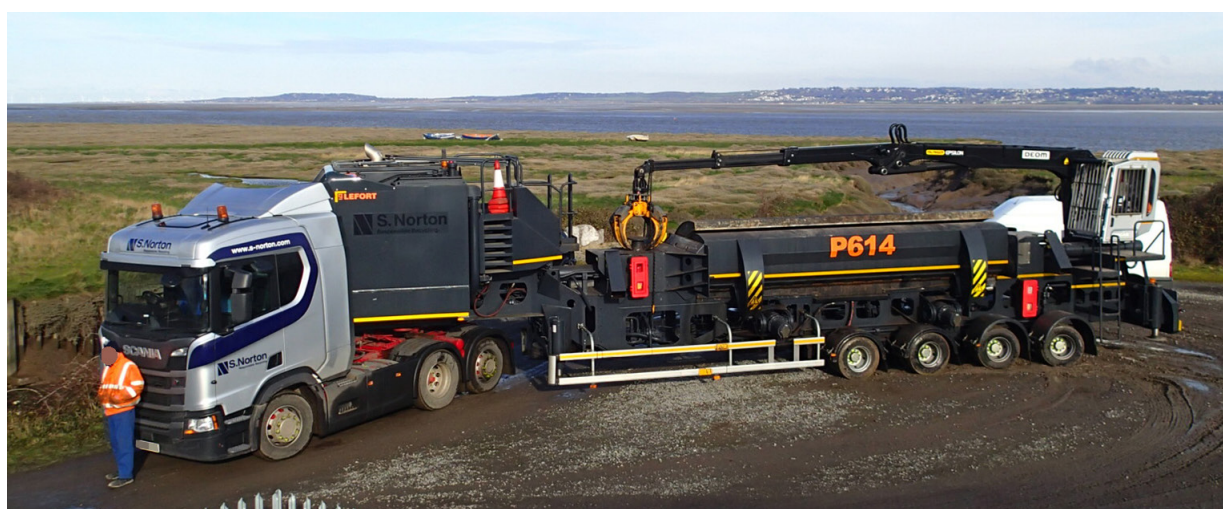
Figure 3: The baler

- 14 The large road vehicle involved in the incident, referred to as the 'baler' in the remainder of this report, is an articulated lorry comprising a tractor unit hauling a semi-trailer equipped with a large ram and loading crane which crushes cars into bales of scrap metal (figure 3).

- 15 The combined tractor unit and semi-trailer is approximately 60.5 tonnes in weight, 19.1 metres long and 2.7 metres wide. Individual vehicles and vehicle combinations permitted to operate without special restrictions on public roads in the UK are usually limited by UK highway legislation to a maximum weight of 44 tonnes, a maximum length of 18.75 metres and a maximum width of 2.55 metres. Vehicles exceeding these criteria are described in this report as 'abnormal vehicles'.

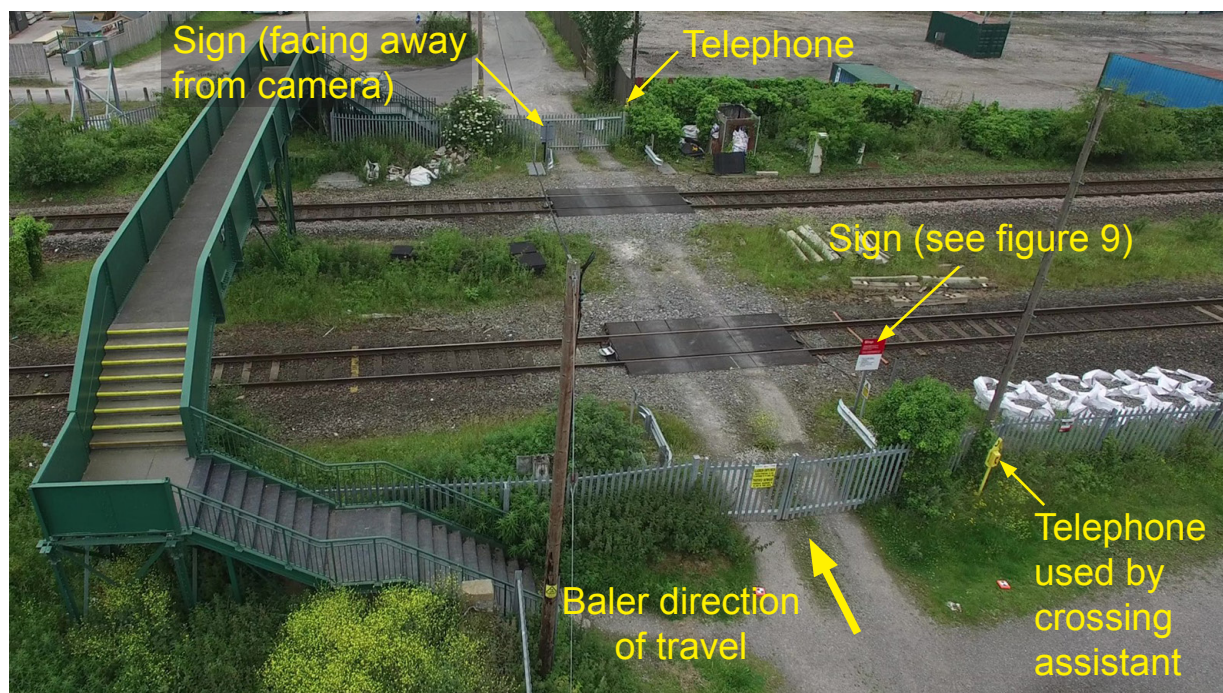
Figure 5: Telephones and signs at Bagillt UWC-T

- 16 Bagillt UWC-T has a pair of gates on each side of the railway situated 24.5 metres apart (figure 4). The crossing is equipped with a telephone outside each pair of gates which connect to the signaller's workstation supervising the crossing (figure 6, paragraph 19). Signs positioned inside the gates on both sides of the crossing tell users with vehicles or animals that they must telephone the signaller to obtain permission before opening the gates, crossing the railway and closing the gates. Vehicle users are required to obtain permission because sighting distances along the railway are not sufficient for users to see trains in time to determine if it is safe to cross.

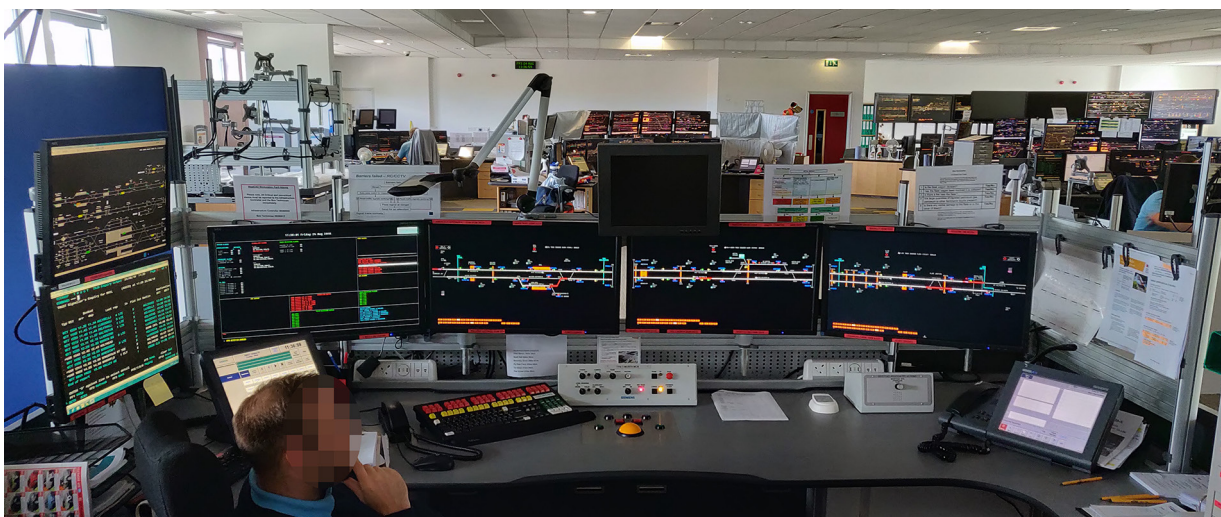
Figure 6: Rhyl workstation

- 19 Bagillt UWC-T is supervised by the signaller at the Rhyl workstation located in the WROC in Cardiff (figure 6). This workstation controls approximately 45 route-kilometres of the Chester to Holyhead railway including Flint station. The signaller controls train movements in both up and down directions by using a pointer to click on symbols in a track layout displayed on display screens. The track layout shows the individual sections of track which change from white to red when occupied by a train (figure 7). The track layout display is not to scale and does not include any indication of distances between features on the display.

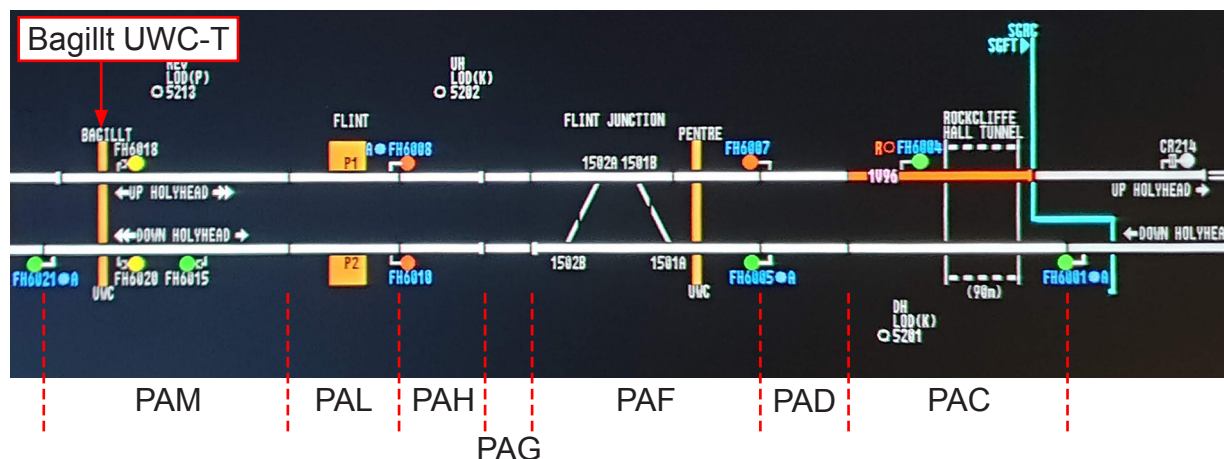
Figure 8: Rhyl workstation display annotated to show track section designations

- 41 It is therefore most likely that the train arrived at the crossing after the crossing assistant locked the north gates and before the signaller answered the second telephone call. On this basis, the rear of the baler had cleared the south end of the crossing between 57 seconds and 1 minute 10 seconds before the train arrived (table 3). This is described as about one minute in this report.
- 42 The time taken by the train to travel to the crossing from each section of track on the approach has been calculated using signalling data. This records the time at which the front of a train occupies, and the time at which the rear leaves, each section of track. The layout and designation of track sections on the down line approaching the crossing Bagillt UWC-T are shown on figure 8.

- 43 On the basis of the most likely sequence of events (table 3), the evidence indicates that the signaller gave the user permission to cross between 2 minutes 30 seconds and 2 minutes 17 seconds before the front of the train arrived at the crossing. Signalling data shows that the first of these times corresponds to the rear of the train being in section PAC and the front in section PAD. The second time corresponds with the entire train being in section PAD.

- 124 During the incident at Bagillt, the crossing user requested two minutes to cross the railway. The signaller stated that his decision point for a down train in these circumstances would be just after the train had entered section PAD (figure 8). This is when a train is approaching signal FH6005 and before it reaches Flint station and then Bagillt UWC-T, which is 3.2 km (2 miles) beyond the station.
