Rail Accident Report

Runaway of a maintenance train near Markinch, Fife 17 October 2017

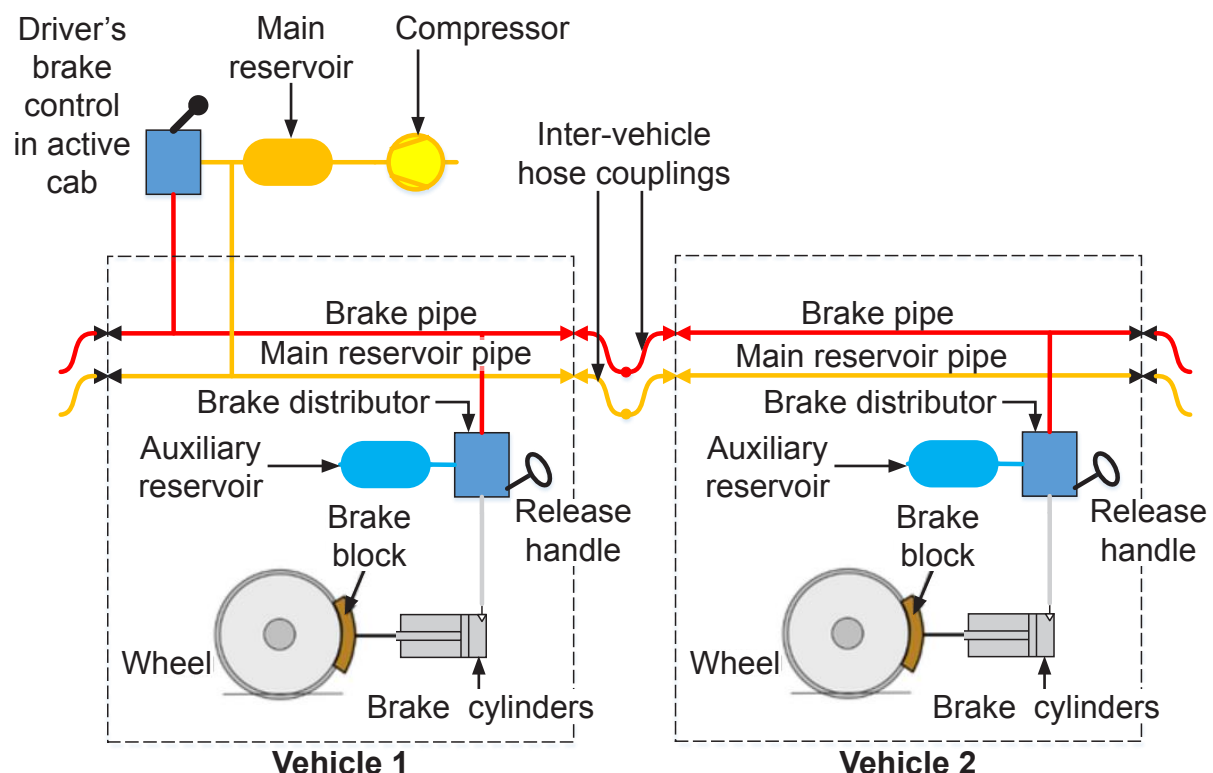
Figure 4: Simplified diagram of MPV braking system (direct brake omitted – see paragraph 22)

- 20 When the brakes are not applied, the brake pipe pressure is at its highest, and this pressure reduces as the driver requests more braking. In an emergency brake application, the brake pipe is vented to atmosphere, so that all the pressure is released.
- 21 The distributor senses the brake pipe pressure and modulates the air pressure applied to the brake cylinders in response. A reduction in the brake pipe pressure results in an increase in the pressure to the brake cylinders, and thus the amount of braking applied. The manual release handle, when pulled, rotates a spindle on the distributor, which releases a control pressure chamber in the distributor, thus venting the brake cylinder pressure, and releasing the brakes (figure 5). The control pressure chamber is re-pressurised from the brake pipe when the release handle is no longer operated, allowing braking to be re-established.

- 24 The accident occurred due to a combination of the following causal factors:
- The brakes were released because the brake distributor release mechanisms were operated on both vehicles by the debris from the tree passing underneath the train (paragraph 29)
 - The driver was unable to reapply the brakes after the debris from the tree had caused all three brake system pipes to be separated between the vehicles (paragraph 33)
- 25 It is likely that the localised wind conditions caused the tree to fall onto the track. Local weather records from the weather station at Leuchars (15 miles/24 km north-east of the collision site) show that wind speeds reached 36 mph (57 km/h), gusting to 49 mph (76 km/h) in the hour before the collision. However, at 01:00 hrs, the recorded wind speed was much lower, at 21 mph (33 km/h).

- 33 **The driver was unable to reapply the brakes after the debris from the tree had caused all three brake system pipes to be separated between the vehicles.**

- 39 The separation of the main reservoir pipe had little effect on the operation of the brakes, as non-return valves in both halves of the coupling caused that pipe to remain pressurised in both vehicles.
