Rail Accident Report

Collision between a train and a collapsed signal post at Newbury 17 November 2014

Report 15/2015
September 2015

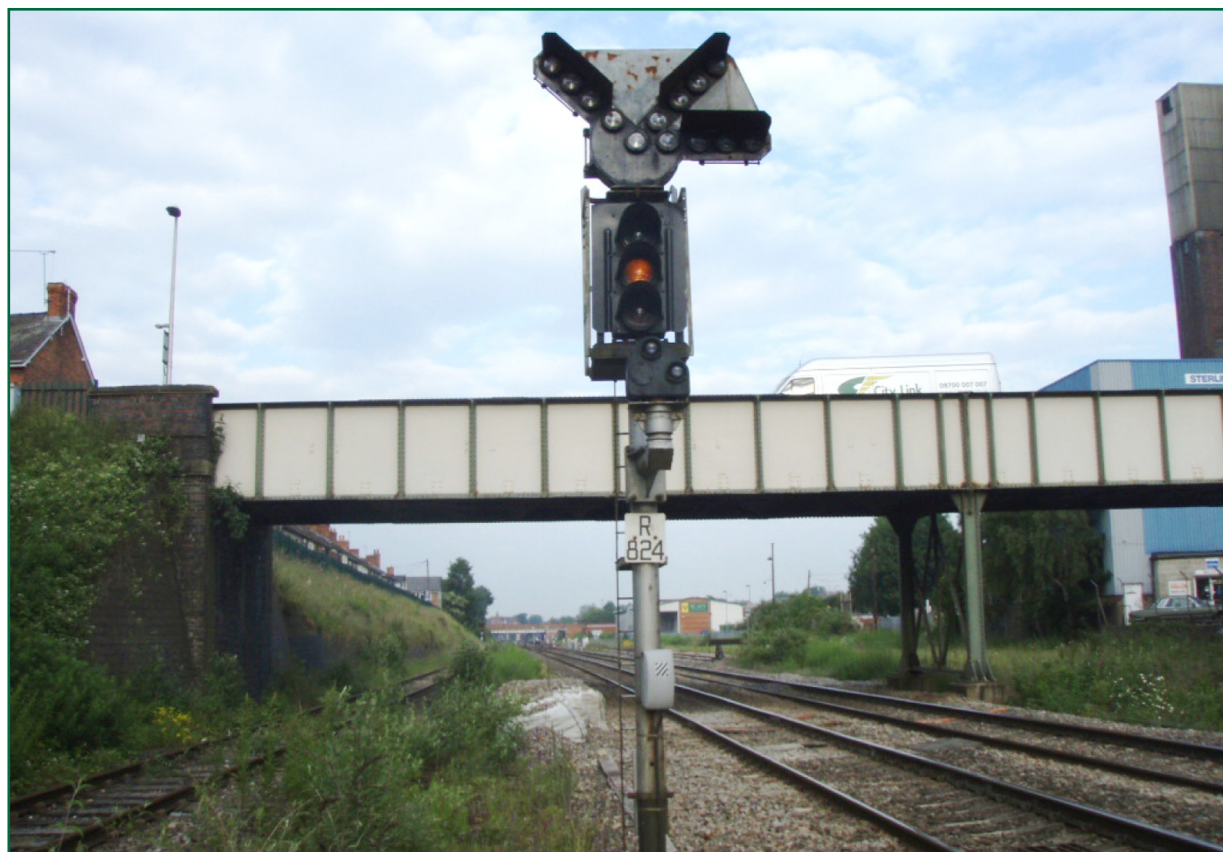
Figure 5: Photograph of the signal from 2009 (prior to the LED signal head being fitted) (courtesy of Amey)

- 14 Signal T2865 is a simple straight post LED type three-*aspect* signal for the Down Westbury line (see Figure 5). It has three junction indicators and a *position light* signal which is used for *call-on* moves into the platforms at Newbury station as well as wrong-direction shunt moves onto the Up Westbury line.
- 15 The signal is located in the *ten-foot* between the Down Westbury and Down Newbury Loop lines.
- 16 The post is of hollow round tubular construction made of carbon steel, with an outside diameter of approximately 168 mm, while the manufactured wall thickness was approximately 6 mm. As a structure, the post is welded into a baseplate assembly which, in turn, is bolted to a concrete foundation (see Figure 6). The signal structure also includes an access ladder which is similarly fixed into the ground.

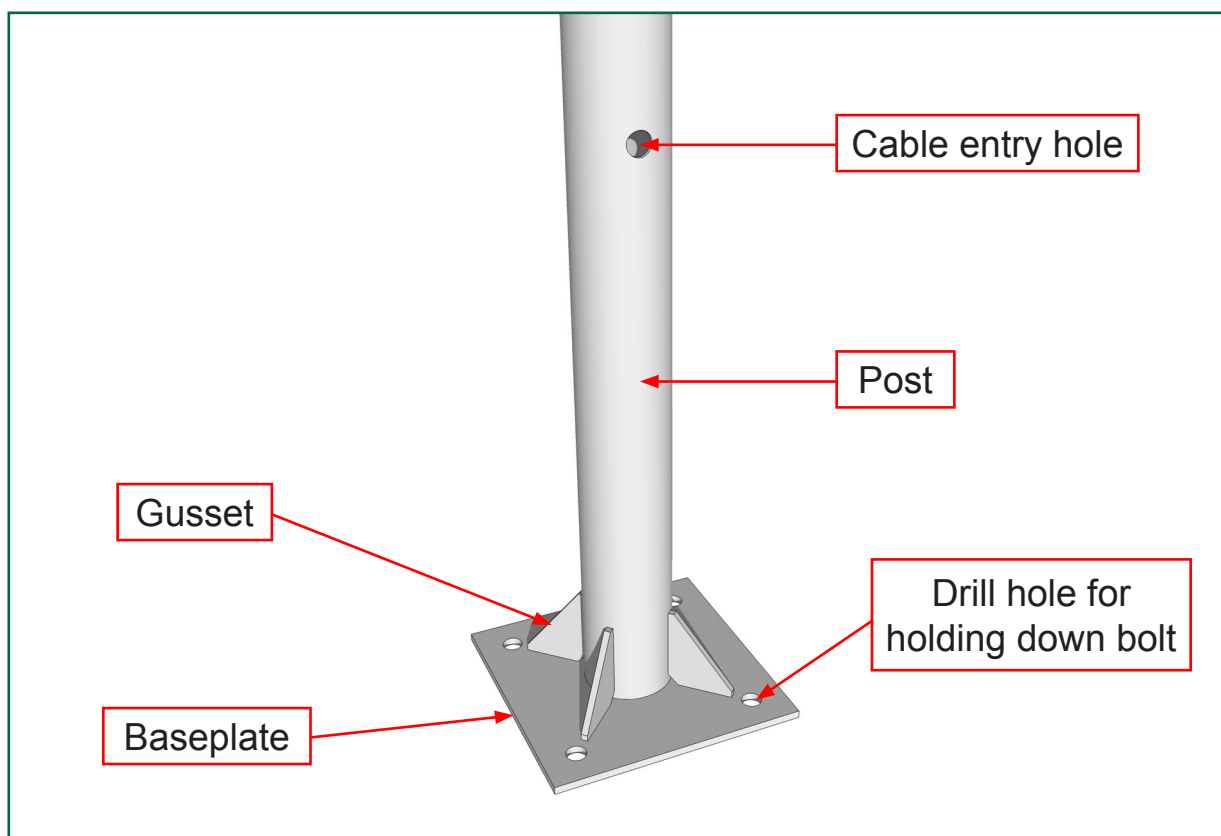
Figure 6: Schematic of post and baseplate assembly (holding-down bolts and concrete foundation not shown)

- 17 The structure is approximately 40 years old. Standard design drawings were first issued in 1974, while Network Rail believes this particular post was installed in 1978. The design drawings do not specify any protective coating, although a version update in 1993 refers to hot dip galvanisation.
- 18 Two weeks before the accident, on 3 November 2014, *axle counters* replaced *track circuits* as the means of train detection as part of a resignalling project in the area, which also replaced the older style incandescent signal lamps with LED technology. The signal was originally numbered R824. It became TR824 in 2010, and was redesignated T2865 after the resignalling was commissioned. Since this report discusses different times throughout the life of the signal, the designation correct for the period of discussion will be used in each case.
