Rail Accident Report

Collision between two road-rail vehicles at Cholmondeston, Cheshire 19 September 2018

Report 08/2019
July 2019

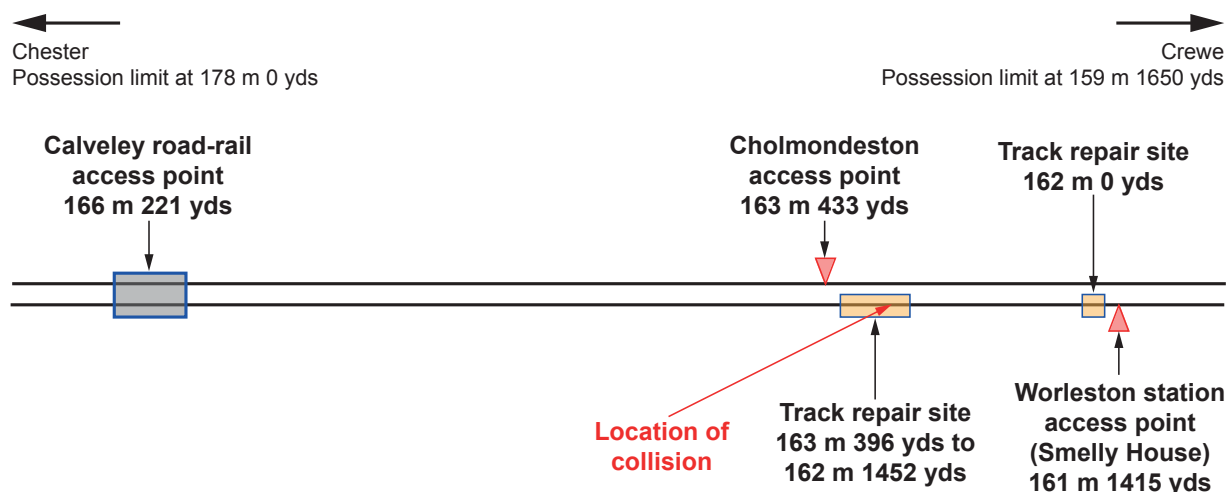
Figure 2: Overview of site showing geographical relationship of key features

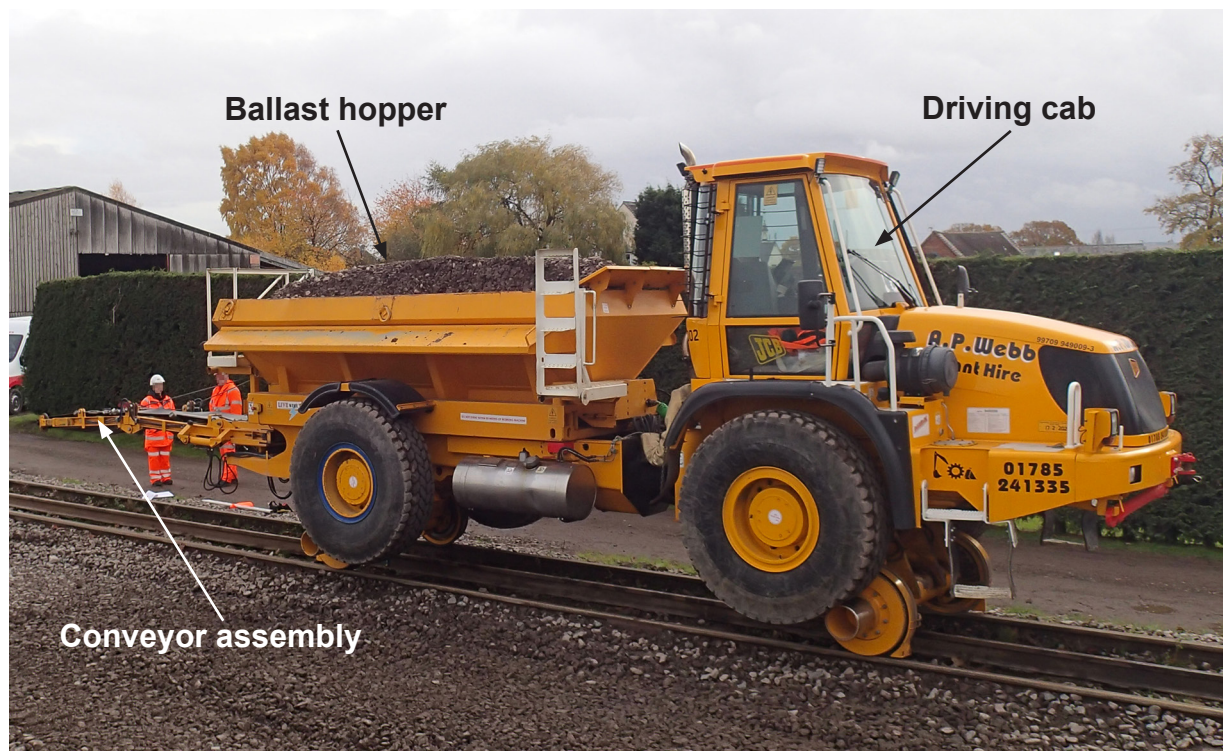
- 13 The ballast distributor RRV (figure 3) is a road based dumper truck, manufactured by JCB, and converted for use on the UK rail network by Railability in 2005. After conversion, the cab of the RRV remained unidirectional, with the operator's seat facing forwards away from the hopper. There is no evidence that JCB played any part in the factors relating to the accident.

Figure 3: The ballast distributor road-rail vehicle

- 14 The vehicle is fitted with a ballast hopper module that has a conveyor belt in the bottom. This conveyor belt extends to the rear of the vehicle and can swing laterally to allow the ballast to be deposited where required on, or beside, the track. The hopper can carry up to 10 tonnes of ballast.

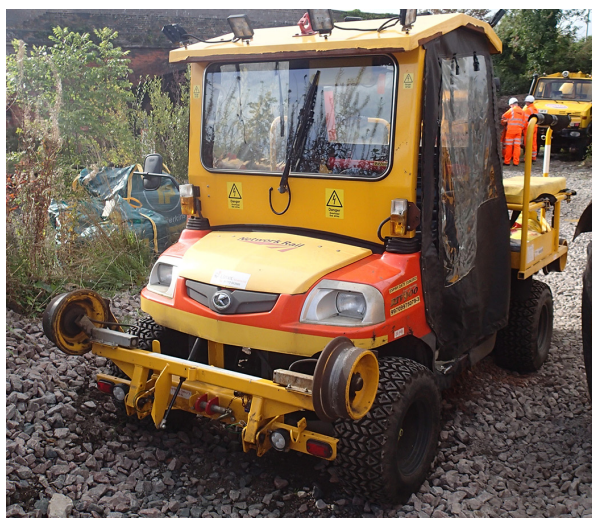
- 16 The personnel carrier RRV was a Permaquip Kubota (figure 4). This is a four-wheeled Kubota all-terrain vehicle that had been converted for use on rail by Permaquip. When on the track, the rail wheels are lowered to provide guidance. The road wheels remain in contact with the rail, taking the weight and providing traction and braking (type 9C⁷).

Figure 4: A 'kubota' personnel carrier RRV, similar to that involved in the accident

- 17 The kubota has seating for two people, including the driver, in the front, as well as space for up to four people and/or equipment in the rear. There is no evidence that the design, construction or conversion of the vehicle for rail use played any part in the cause of the collision.

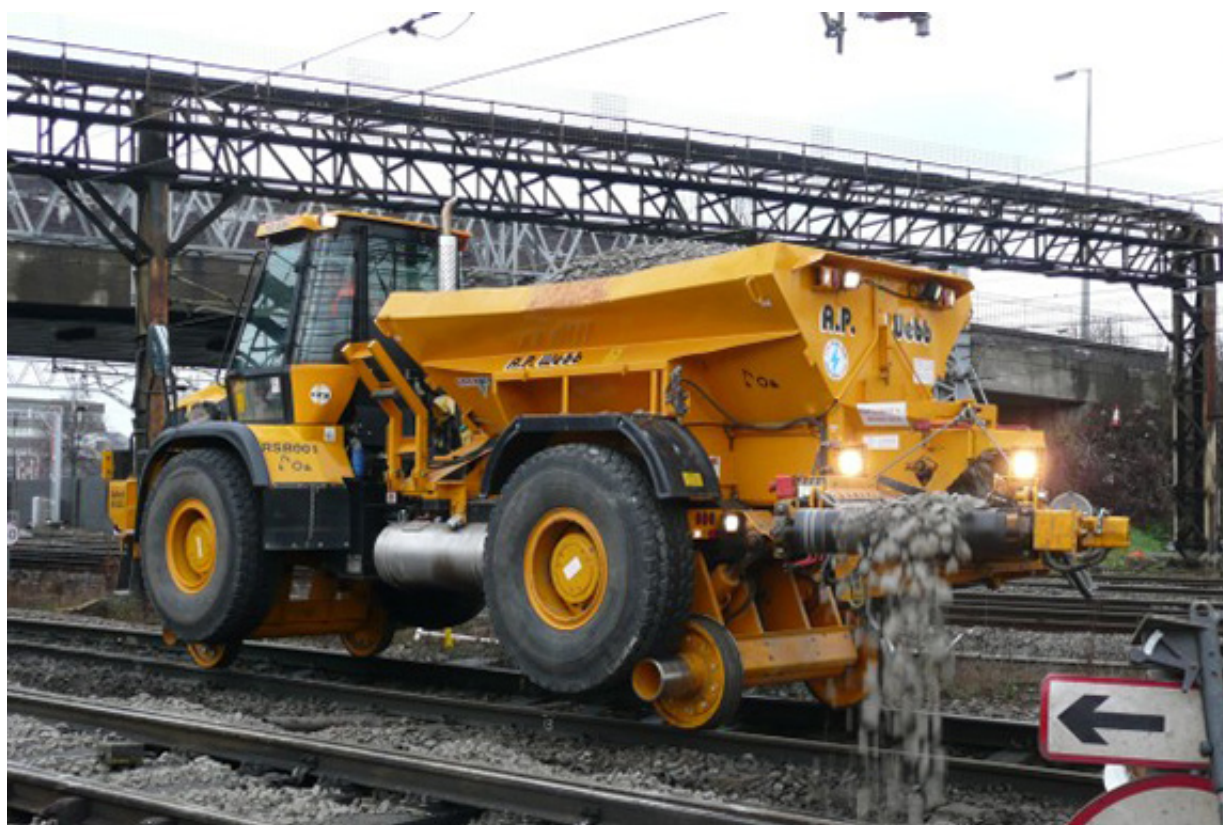
Figure 5: A ballast distributor dropping ballast (courtesy of AP Webb Plant Hire)

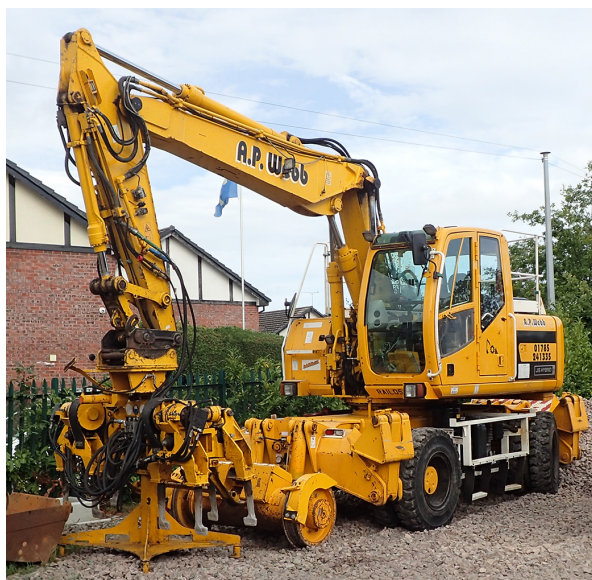
- 34 The track maintenance team then on-tracked their kubota on the down line at the RRAP, followed by a 360 degree excavator type RRV that was fitted with a tamper bank attachment¹³ instead of a bucket (henceforth referred to as the tamper bank RRV - figure 6). The five members of the team then travelled to 162 miles 1450 yards, with the two RRVs, where they were intending to repair a track geometry fault by lifting and tamping the track.

Figure 6: The tamper bank RRV
