Rail Accident Report

**Overspeed at Sandy South Junction,
Bedfordshire
19 October 2018**

Report 10/2019
August 2019

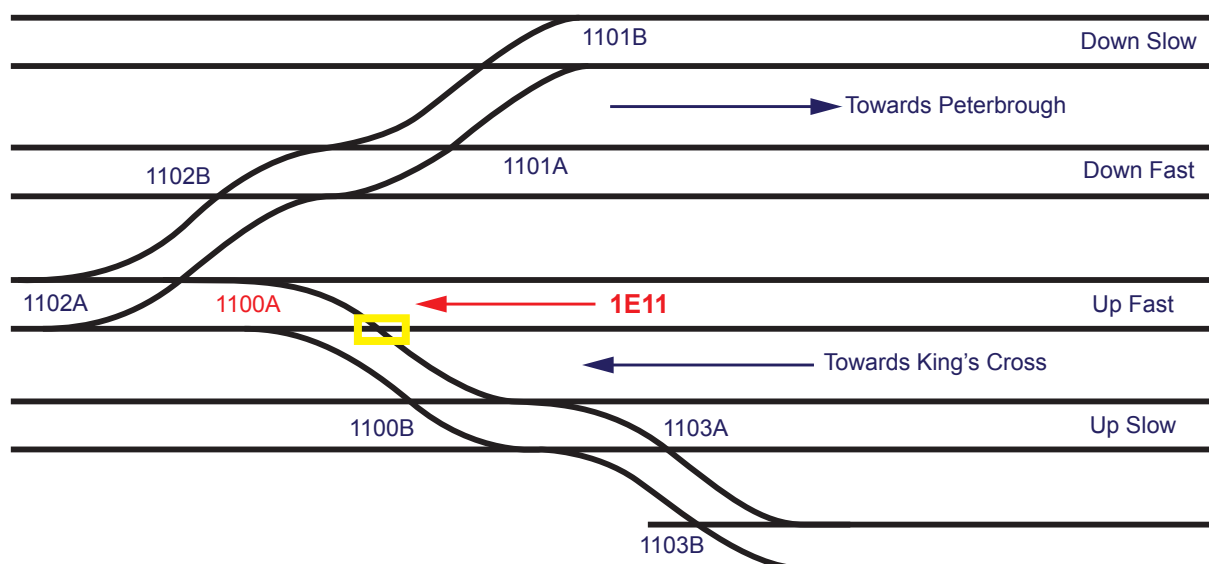
Figure 4: Sandy South Junction, with yellow box around the relevant crossing

- 23 On 18 October 2018 at around 10:00 hrs, a Network Rail patroller carrying out a basic visual inspection of the track identified a crack estimated to measure 60 mm long in the crossing of 1100A points at Sandy South Junction.

- 24 Network Rail's maintenance delivery unit sent out a team to implement a 40/70² mph speed restriction, in accordance with the Network Rail company standard governing such situations. Around 13:30 hrs a member of this team measured the crack at 85 mm in length.

- 25 Due to the length of the crack, the 40/70 mph emergency speed restriction was no longer appropriate and, in accordance with Network Rail standard, NR/L2/TRK/1054, a 20 mph (32 km/h) emergency speed restriction was imposed. Hourly line blockages were also imposed to enable an inspection of the crack, and a watchman was appointed to keep a watch on the crossing and the trains traversing the points.
