Rail Accident Report

Freight train derailment at East Somerset Junction 20 March 2017

Report 19/2017
December 2017

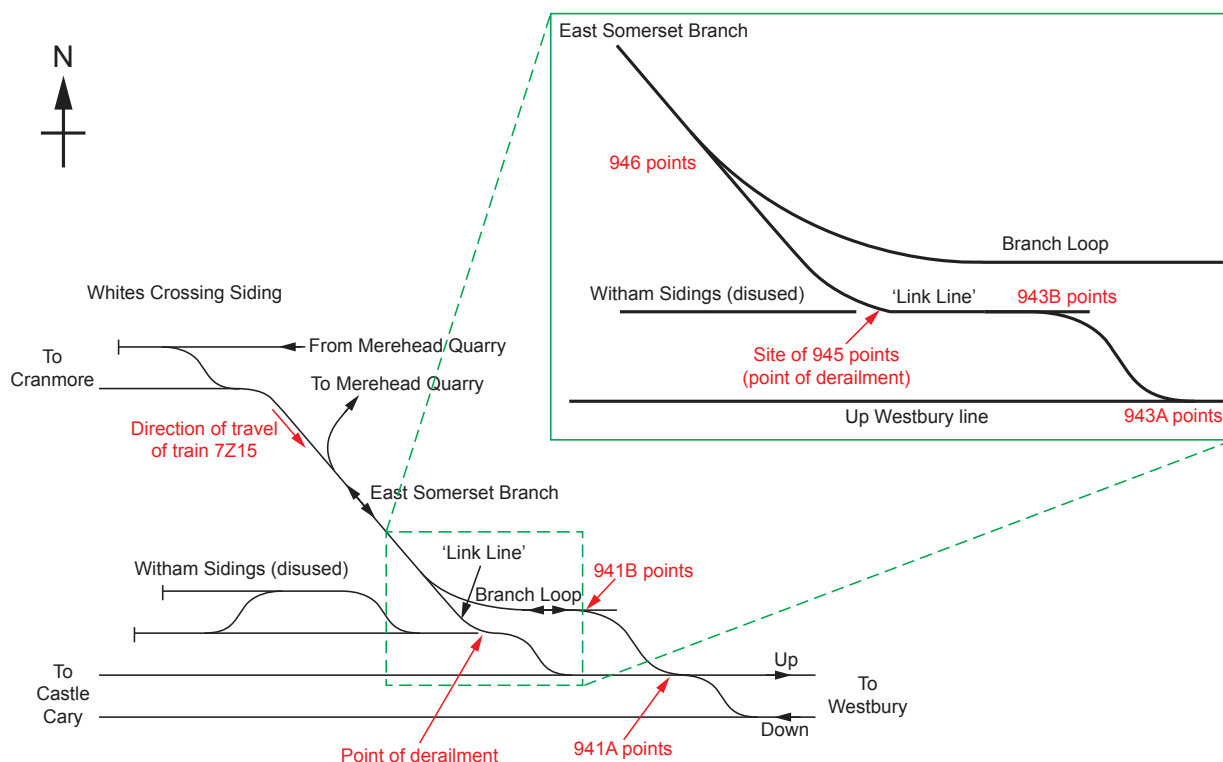
Figure 3: East Somerset Junction schematic layout of track

- 8 The East Somerset Branch line (also known as the Merehead Single line) diverges from the Up Westbury line at 943A *points* (figure 3). The branch line has an ELR (*engineer's line reference*) of 'ESB', while the ELR for the Up and Down Westbury lines is 'WEY'. A set of *trap points*, 943B, protects the junction; this was the site of a previous derailment on 10 November 2008 ([RAIB report number 28/2009](#)). The derailment on 20 March 2017 occurred at the site of the former 945 points, which used to connect Witham Sidings to the branch line; these had been *plain-lined* in 2010 (see paragraph 32).

- 10 The 'Link Line' is the section of the East Somerset Branch lying between 943A points and 946 points; it is approximately 260 metres long, too short to accommodate a 'jumbo train'. Both the Branch Loop and the Link Line are bi-directional, and trains running to or from Merehead Quarry may be routed along either line.

- 64 Witness evidence indicates that track maintenance staff at all levels believed that the Link Line was generally in poor condition, but their focus was on the adjacent section of track (between the site of 945 and 946 points, refer to figure 3). They believed that the track at the site of 945 points was in relatively good condition because it consisted of continuously welded rail that had been installed fairly recently on good condition timber bearers (paragraph 32). It is possible that this perception led them to overlook the signs of gauge spread.

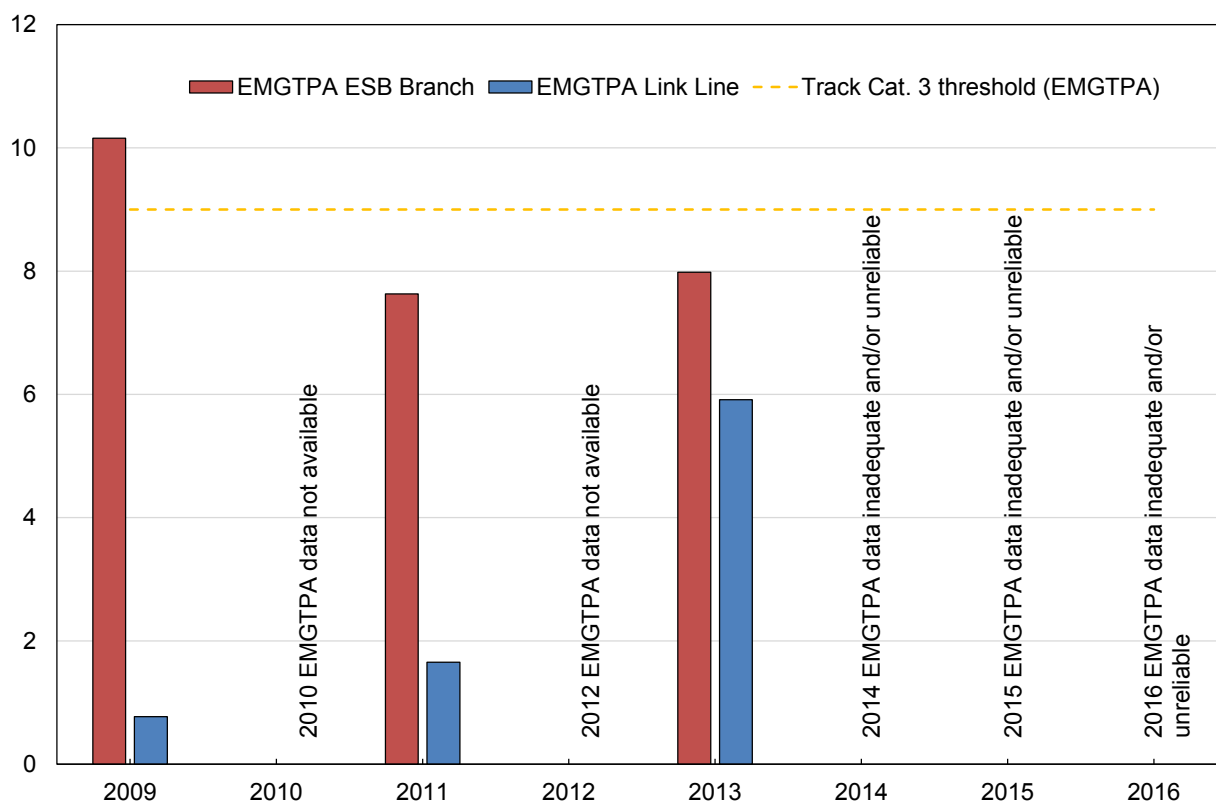
Figure 13a: Equivalent million gross tonnes per annum (Network Rail data)

78 Increasing freight traffic added to the track maintenance workload at Westbury due to the wear and tear on the track. Witnesses report that track damage in the Westbury area is principally caused by loaded stone trains travelling on the Up line.

- 79 The RAM team publishes figures that enable each section of track to be categorised for inspection purposes, based on the tonnage carried (expressed as equivalent gross tonnes per annum (EMGTPA)). At the time of the derailment on 20 March 2017, no EMGTPA figures had been published for the Western Route since 2013 (figure 13a). Data from Mendip Rail show the tonnage carried from Merehead Quarry in 2016 was 38% higher than in 2013 (figure 13b). Although there is no direct correlation between the Mendip Rail data and EMGTPA, the increase in traffic would probably have raised the inspection category of the East Somerset Branch from Cat. 4 to 3. The increased tonnages would also probably have resulted in the track categories for both the Link Line and the Branch Loop being Cat. 4 (at the time of the derailment they were Cat. 4 and Cat. 6). These changes in category would not have made any practical difference to the required inspection frequencies for the East Somerset Branch, although they might have drawn attention to the associated increase in the wear and tear on the track.

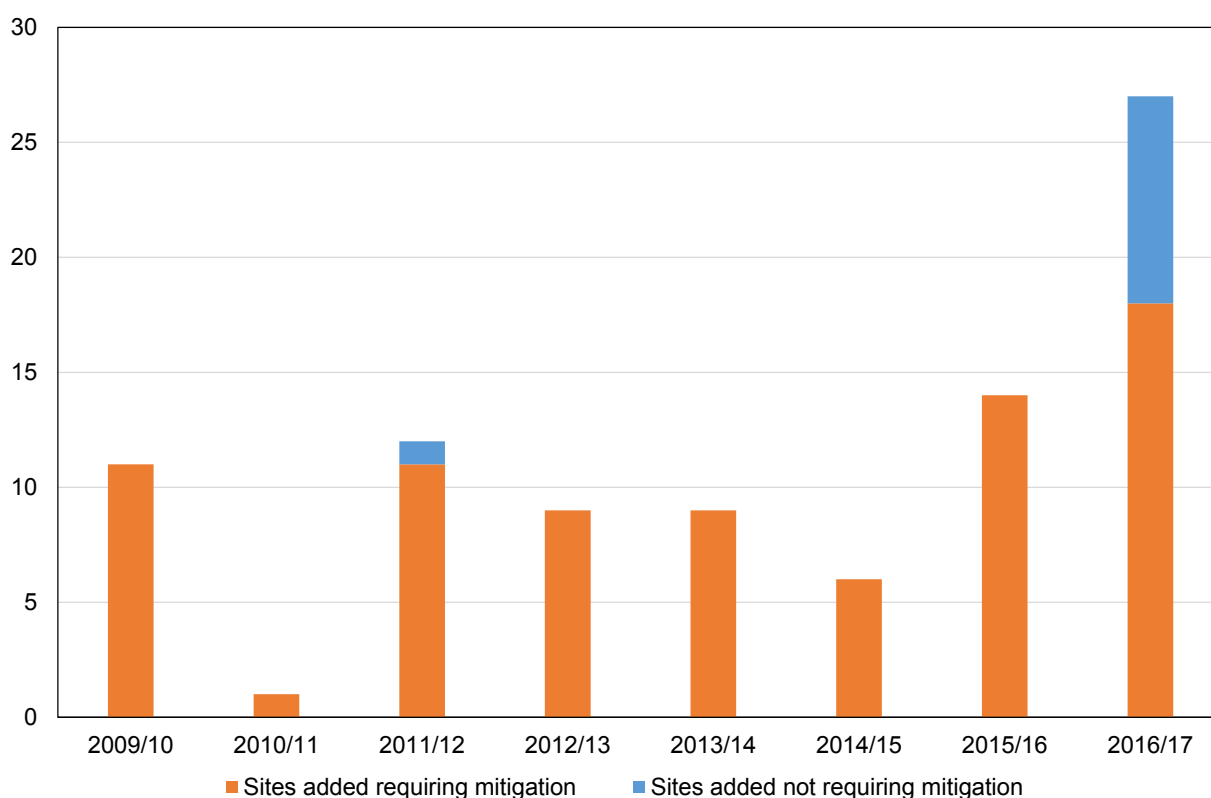
Figure 14: Additional deferred renewal sites, Westbury track maintenance depot

- Work associated with *deferred renewals*. Such work may include the need to carry out ‘mitigations’ (interim refurbishment of assets such as points)¹², as well as managing the poorer reliability of life-extended assets. Although Network Rail has been unable to provide data on trends in the overall number of deferred renewal sites in the Westbury area, it has provided data on the rate of numbers of sites added each year (figure 14); this increased in 2015/16 and again in 2016/17. This data does not include renewals that have been identified as being necessary but which have not been given a planned delivery date (Network Rail does not regard these as ‘deferred renewals’ even though the TME may have indicated when they should be delivered).

- The Swindon works delivery unit was unable to deliver some minor works, such as deferred renewal mitigations, effectively. As a result, it had been restricted to delivery of simple, plain line, mitigation works and led to some jobs being carried out by track maintenance staff.

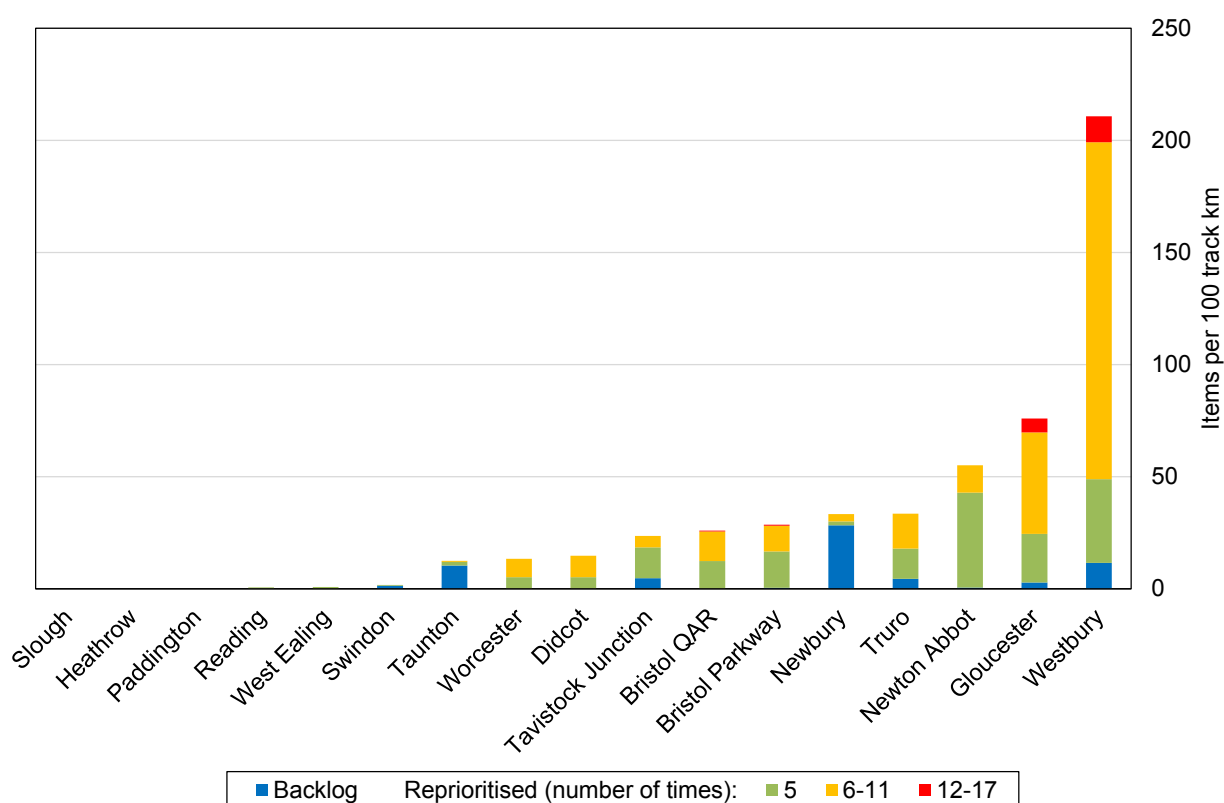
Figure 15: Reprioritised and backlog items in Ellipse by track maintenance depot (Western Route) as at 9 July 2017

- 82 The numbers of Ellipse items that are overdue (in 'backlog') are tracked daily. However, there is less visibility of items that have been reprioritised and given a new completion date. These are controlled by the TSM in accordance with NR/L3/MTC/MG0176/11, 'Prioritisations, reprioritisations and cancellations', and must be approved by the TME on every sixth occasion. Westbury has the highest number of Ellipse work items that have been repeatedly reprioritised for any track maintenance depot on Western Route (normalised by track km, figure 15; this includes backlog items). This is an indication that staff at Westbury track maintenance depot may have been struggling with the volume of work. Had this not been the case, it is possible that depot management would have identified that track geometry of the Link Line was not being measured.

- 83 Following the derailment, and in recognition that Westbury track maintenance depot faced some specific challenges (paragraph 80), the Swindon infrastructure maintenance delivery manager has established a special track asset stewardship review meeting, with the intention that this would meet on a six-weekly basis. This is intended to 'support an improving and sustainable asset condition in the Westbury TME area'.

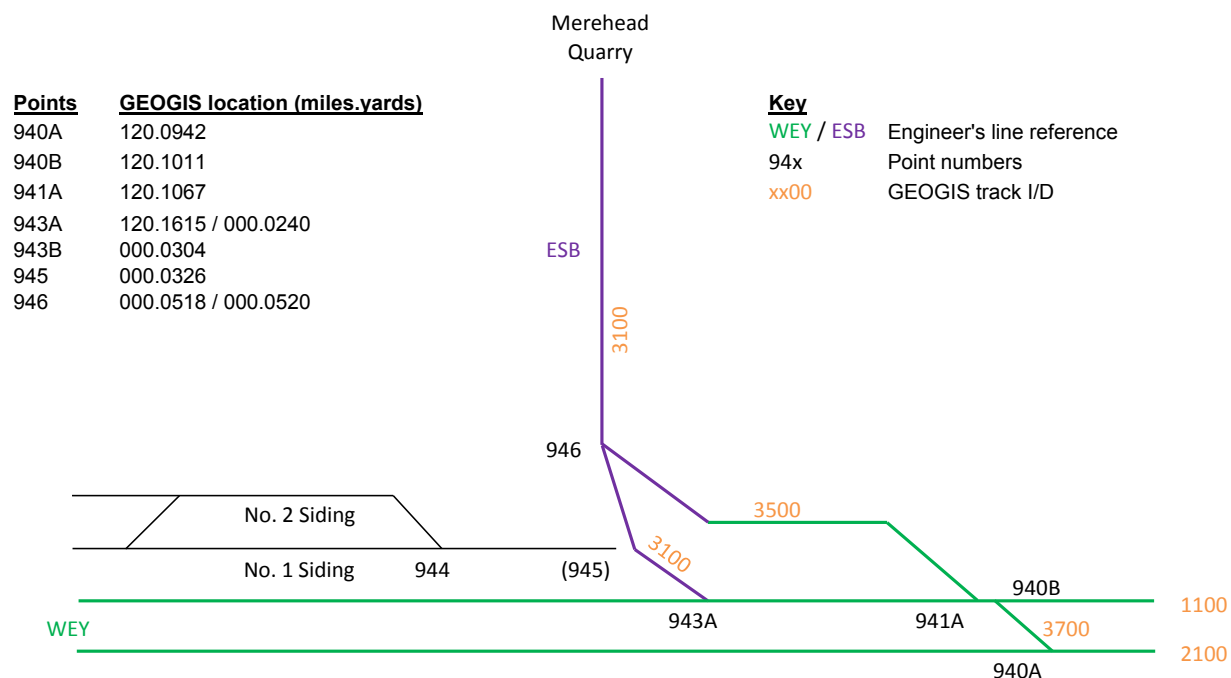
Figure 16: Track identification

D1 Figure 16 is a schematic representation of East Somerset Junction. The ELR for both the Link Line and the Branch Loop changes from 'WEY' to 'ESB' in line with 943A points. The Link Line has the same *GEOGIS* track I/D as the rest of the East Somerset Branch (3100), whereas the Branch Loop has a unique I/D (3500).

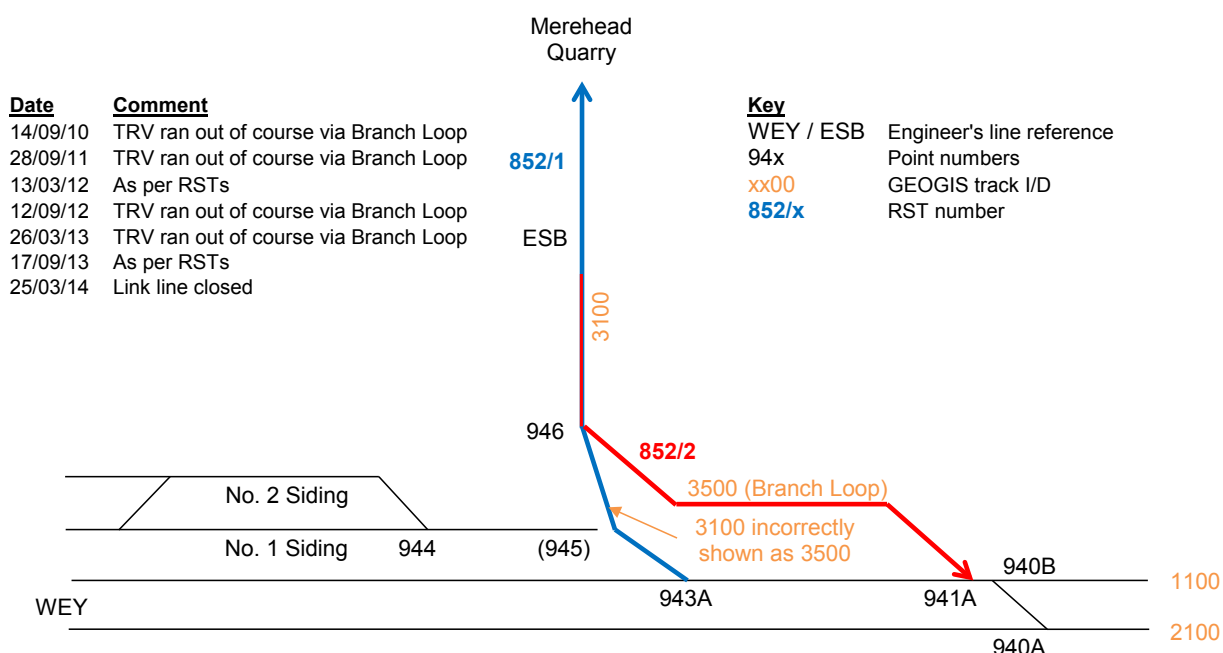
Figure 17: East Somerset Branch RSTs prior to August 2014

D3 The TRV was planned to run using both RSTs. However, four of the six runs that took place in the three years from September 2010 ran in both directions over the Branch Loop and therefore did not measure the geometry of the Link Line.
